# New Jersey Beach Profile Network

## Monmouth County

Raritan Bay and Sandy Hook  
to Manasquan Inlet

**NJBPN Profile #'s  
187 - 256**

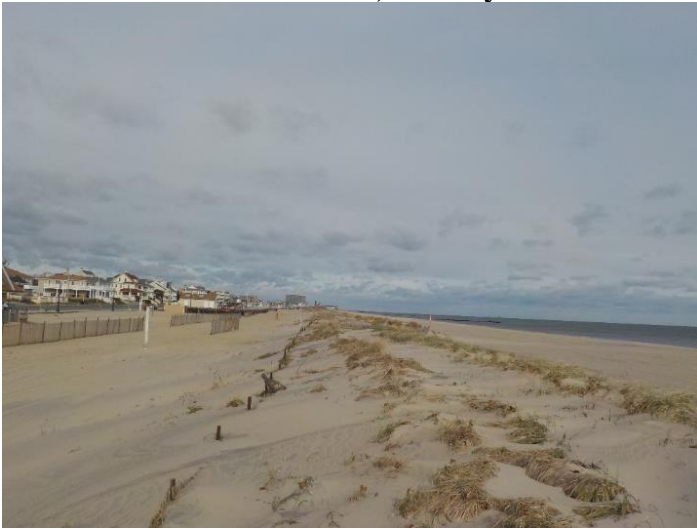
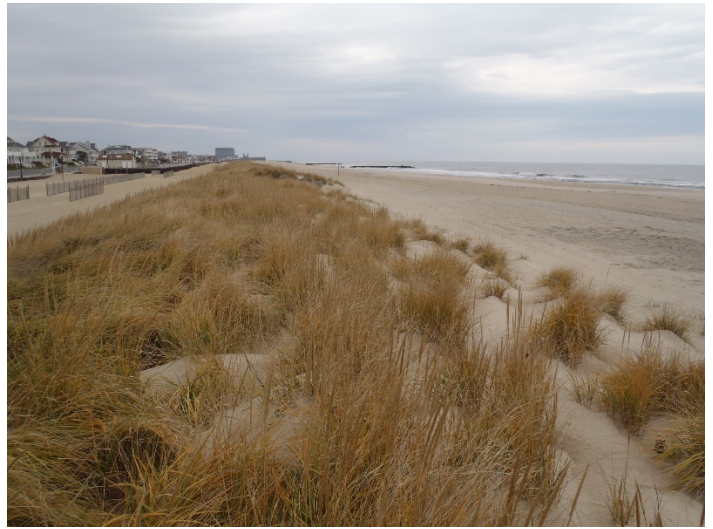
**NJBPN 16401 – 2<sup>nd</sup> Avenue, Bradley Beach**

The left picture from Nov. 28, 2018 shows the dunes considerably seaward of the promenade in Bradley Beach while the Nov. 22, 2019 view on the right shows extensive grass growth over the year and sand added to the seaward slope as well.

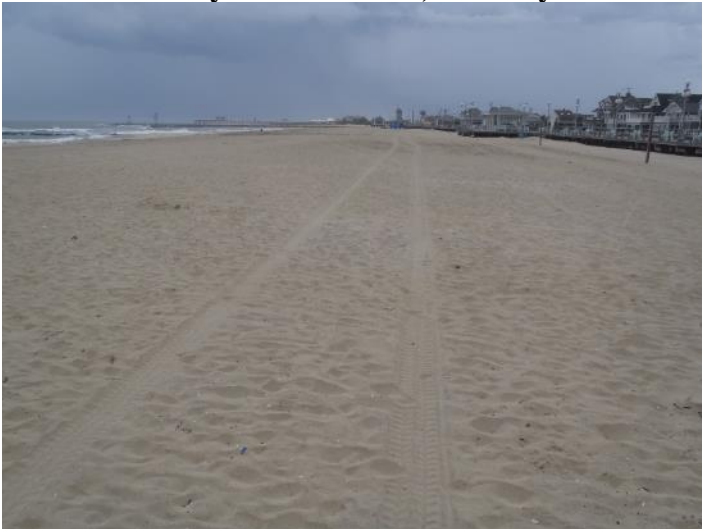
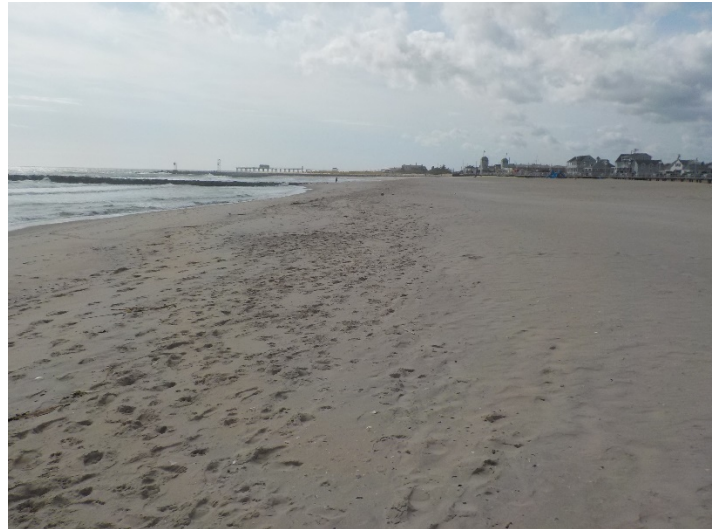
**NJBPN 164 – Sylvania Avenue, Avon-by-the Sea**

This site is located north of the Shark River Inlet. The left view shows the beach looking south toward the inlet on September 18, 2018. On October 11, 2019 the view from the berm crest shows the beach width and configuration around the groins on the beach north of the inlet jetties.

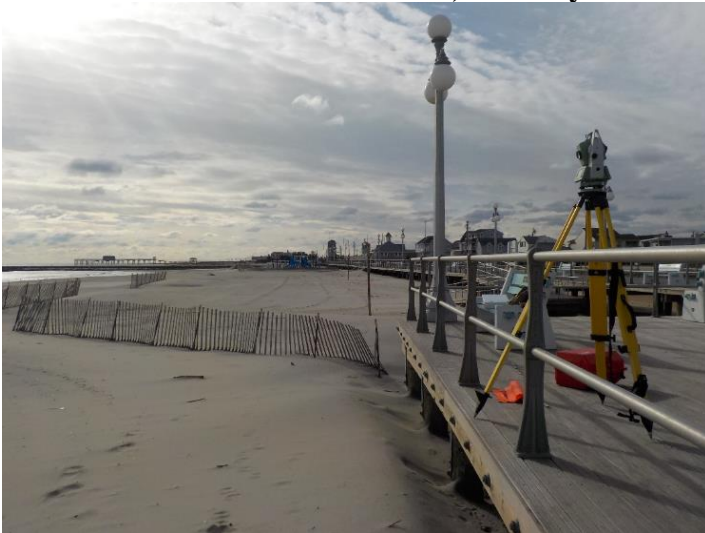
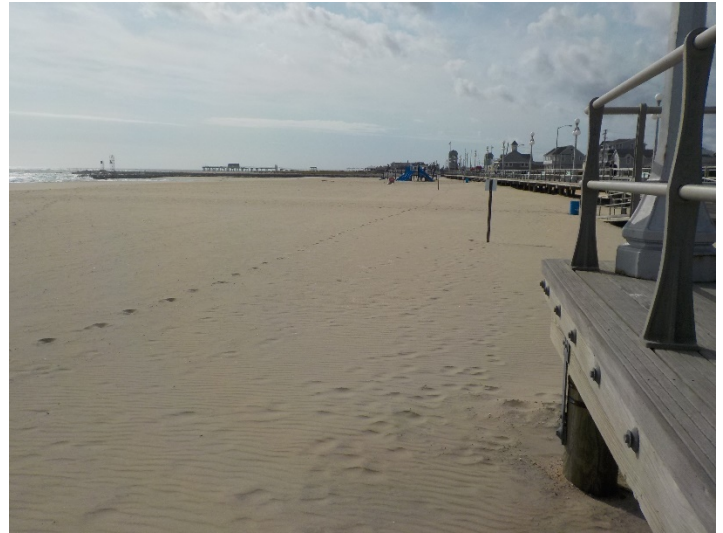
**NJBPN 16303 – Garfield Avenue, Avon-by-the Sea**

Sand has accumulated at the boardwalk in the absence of any dune system. The Nov. 28, 2018 view to the south shows sand fencing on the beach. The beach as of Oct. 10, 2019 is free of the fencing and the dry beach width is substantial.

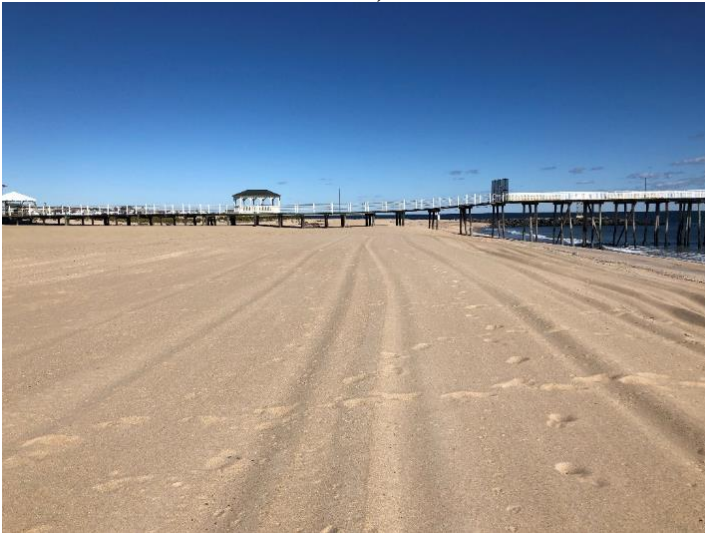
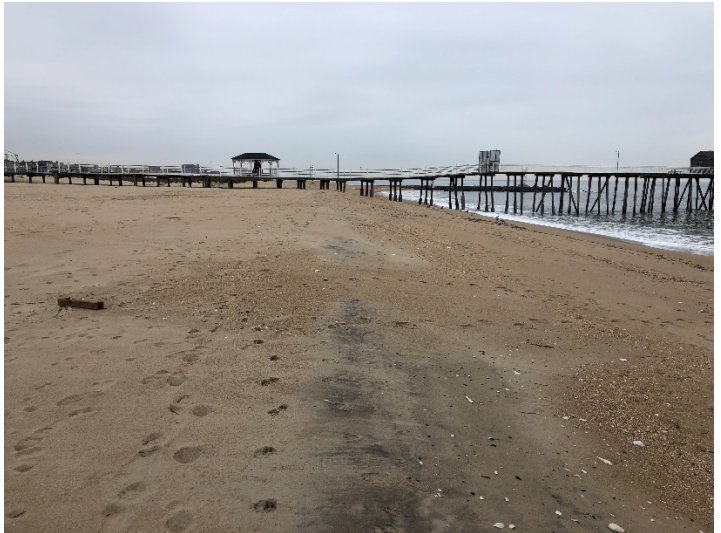
**NJBPN 16301 – 2<sup>nd</sup> Avenue, Belmar**

The northernmost site in Belmar includes a 450-ft wide beach with no dune. The Shark River Inlet jetty can be seen behind the pier supports north of this site. The beach width as measured by the pier pilings as of Oct. 18, 2018 is slightly seaward of the same view on the right taken Oct. 7, 2019.

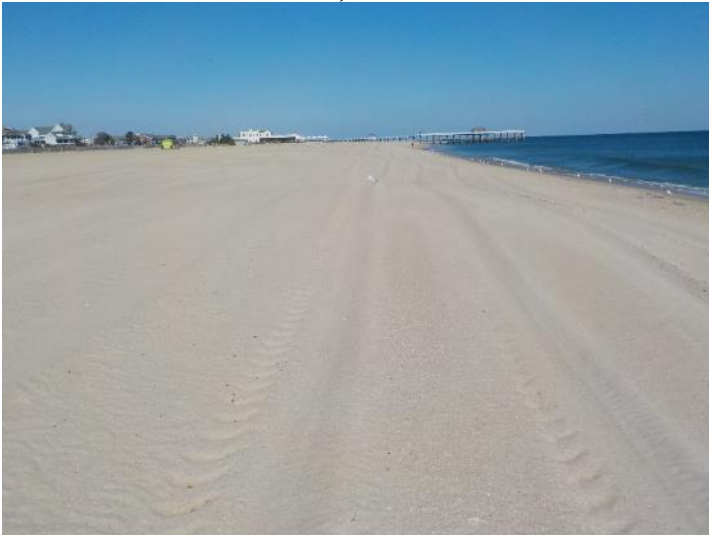
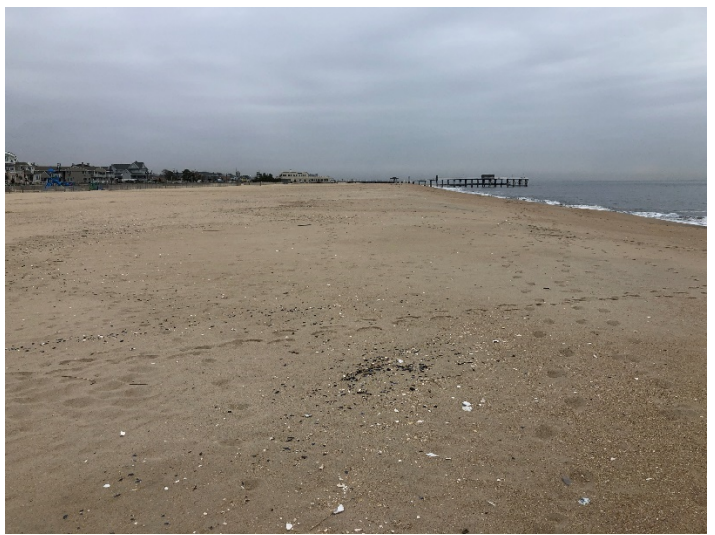
NJBPN 163 – 5<sup>th</sup> Avenue, Belmar

This site never has had a dune but had a wide, dry beach. The north view on October 17, 2018 (left photo) shows this wider than normal beach due to sand trapping by the Shark River Inlet jetty. By October 7, 2019 (right photo) the shoreline was in a similar position.

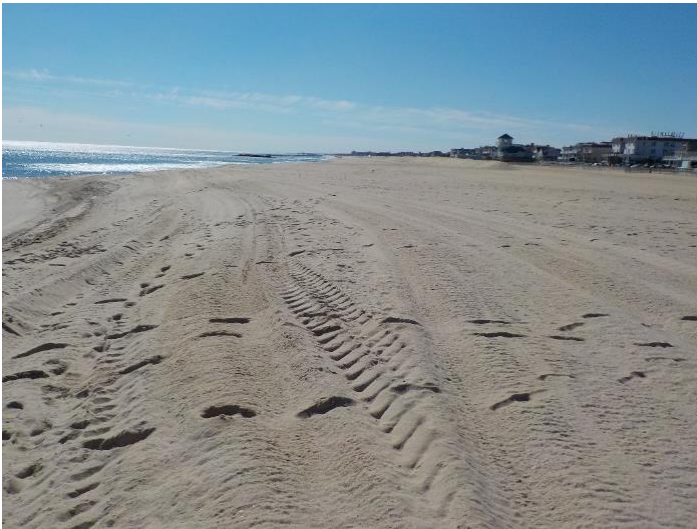
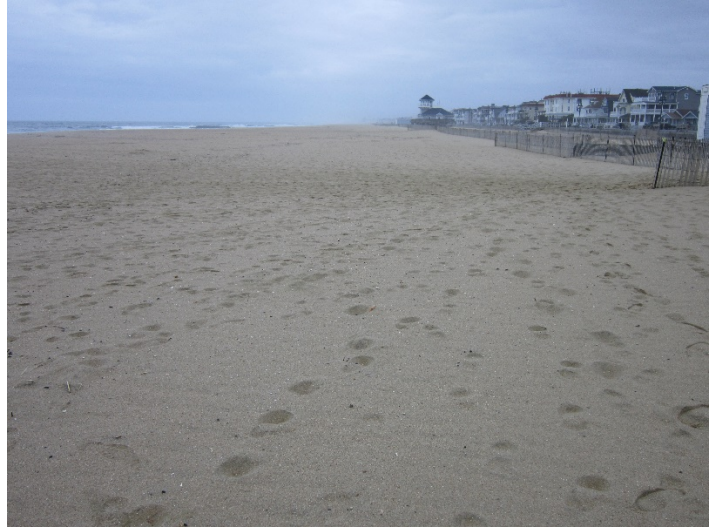
**NJBPN 16202 – 8<sup>th</sup> Avenue, Belmar**

The boardwalk is the backstop for the beach, since there is no dune system. The left photograph from Oct. 17, 2018 shows the dry beach width. The Dec. 13, 2019 view on the right shows the fencing at the boardwalk put in to lessen wind transport into Ocean Avenue during the winter.

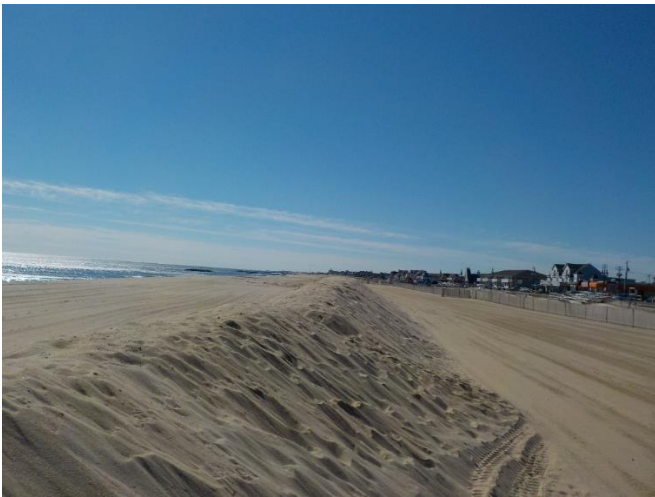
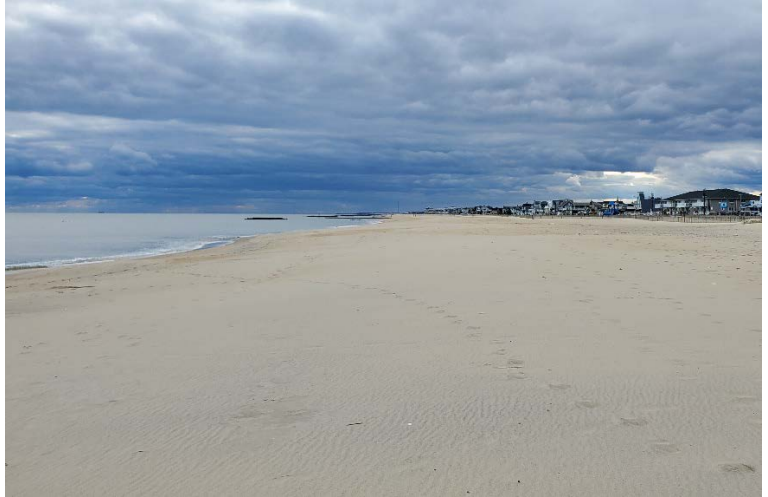
NJBPN 16201 – 14<sup>th</sup> Avenue, Belmar

The 14<sup>th</sup> Avenue site does have a tiny dune feature immediately seaward of the boardwalk. As of Oct. 17, 2018, there was a large storm ridge pushed up on the mid beach area. As of Dec. 5, 2019, this ridge was absent with the beach width entirely open to the boardwalk.

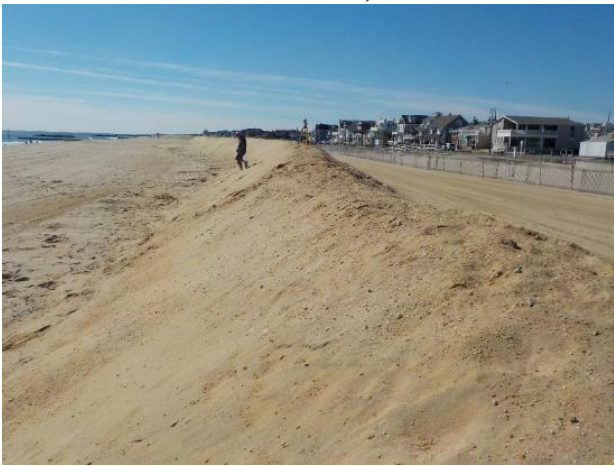
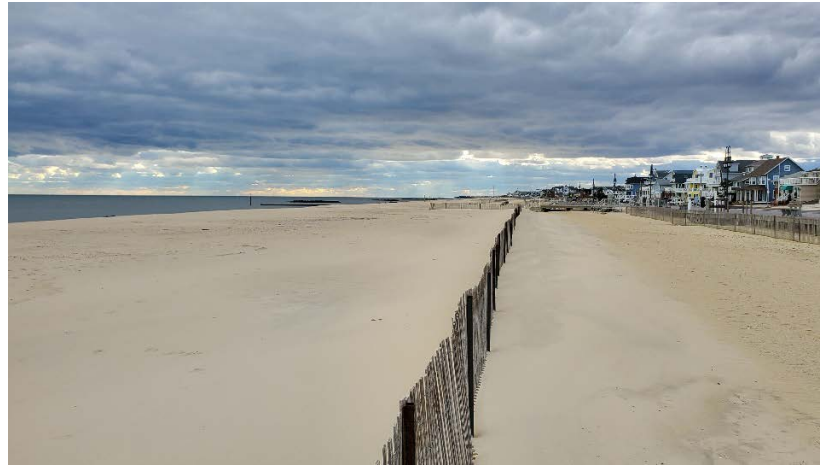
**NJBPN 162 – 18th Avenue, Belmar**

The October 17, 2018 view on the left shows the new boardwalk and facilities built since Sandy with the storm ridge pushed up for the winter. The December 5, 2019 view taken at a sand fence put in place to collect material from blowing into Ocean Avenue show an un-cluttered dry beach seaward.

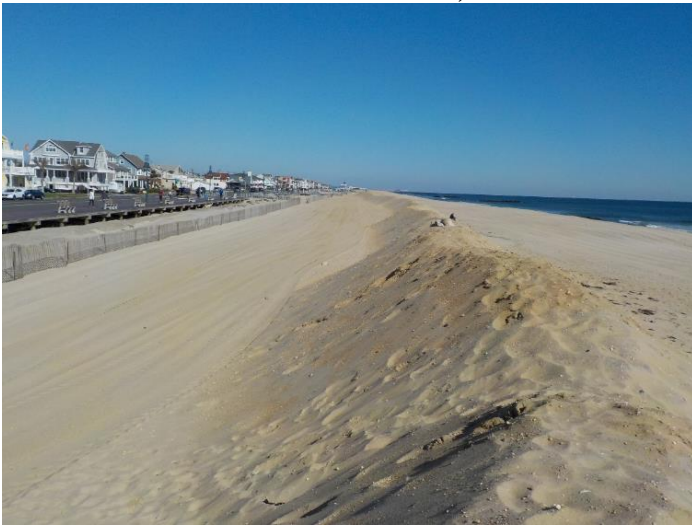
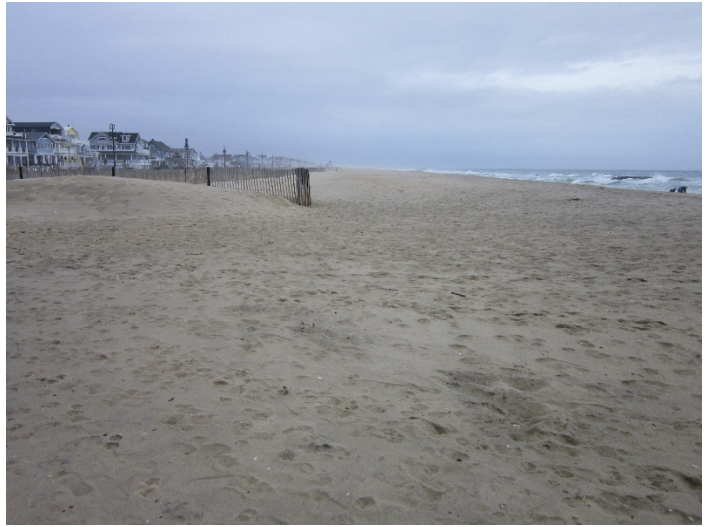
**NJBPN 16104 – North Boulevard, Belmar**

This site is located on the north side of Lake Como, the estuary lake between Belmar and Spring Lake. The left view shows a storm ridge pushed up as of Oct. 17, 2018 along the Belmar oceanfront. The Dec. 13, 2019 view on the right shows sand fencing instead of a storm ridge along this beachfront in southernmost Belmar.

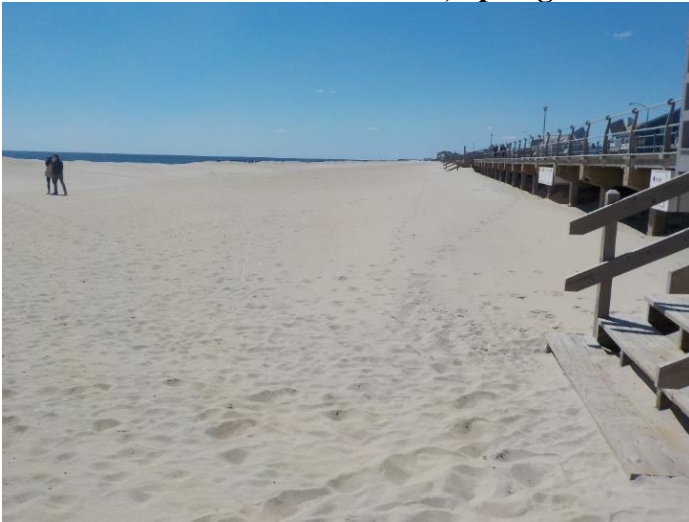
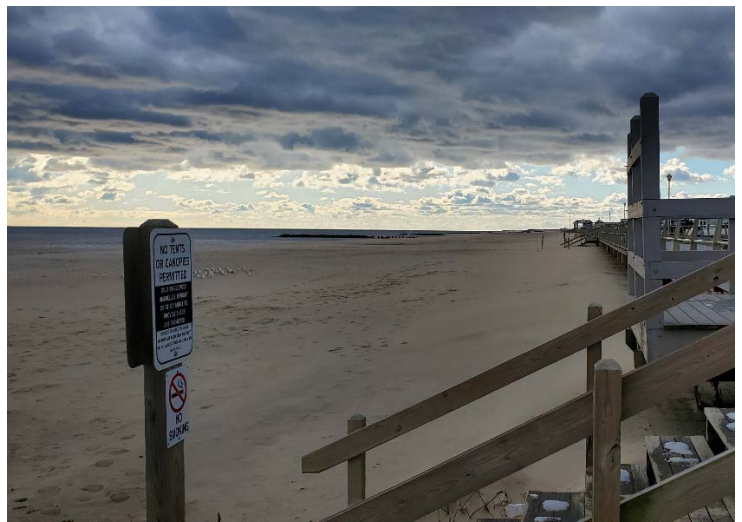
**NJBPN 16103 – Remsen Avenue, Spring Lake**

A grass strip separates Ocean Avenue and the boardwalk. The left photograph taken Oct. 18, 2018 shows the boardwalk and dry beach seaward of the boardwalk. As of December 3, 2019, sand had ramped up under the boardwalk as wind transport moved it landward. In Spring Lake and dunes exist landward of the boardwalk between it and Ocean Avenue.

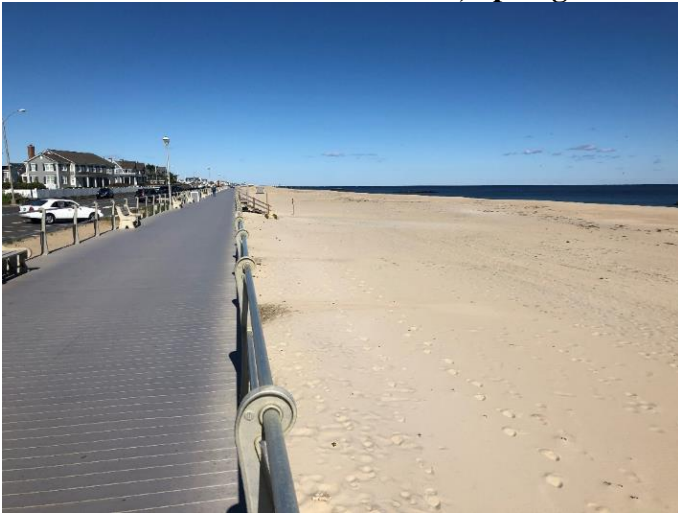
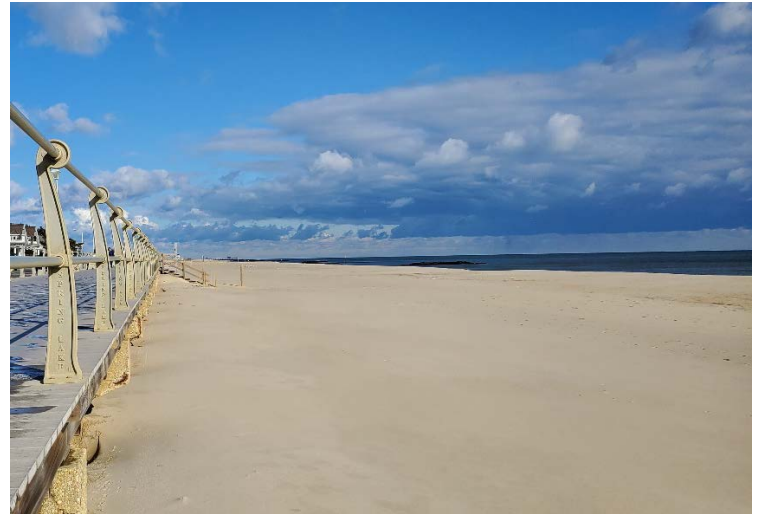
**NJBPN 16102 – Lorraine Avenue, Spring Lake**

This site follows the same pattern as the site to the north with a boardwalk fronted by a 250-foot wide beach. The grass strip between the boardwalk and Ocean Avenue has no dune. The left photograph in Oct. 18, 2018 shows the wide, dry beach, while the Dec. 5, 2019 view on the right shows a similar scene with little change in a year.

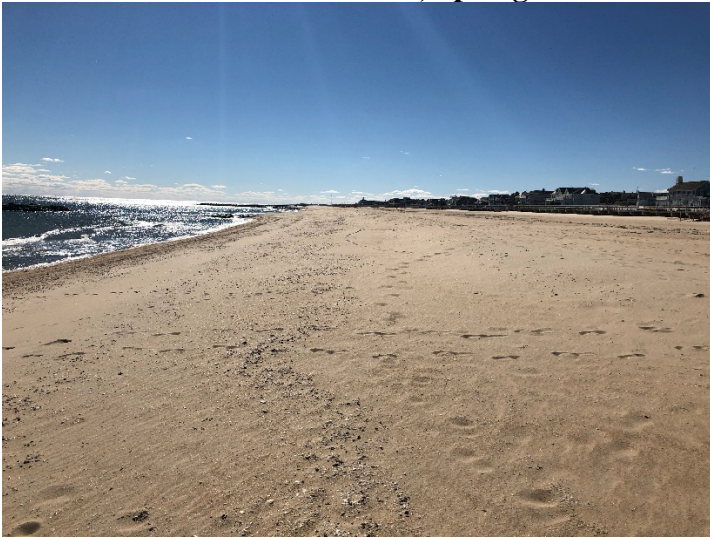
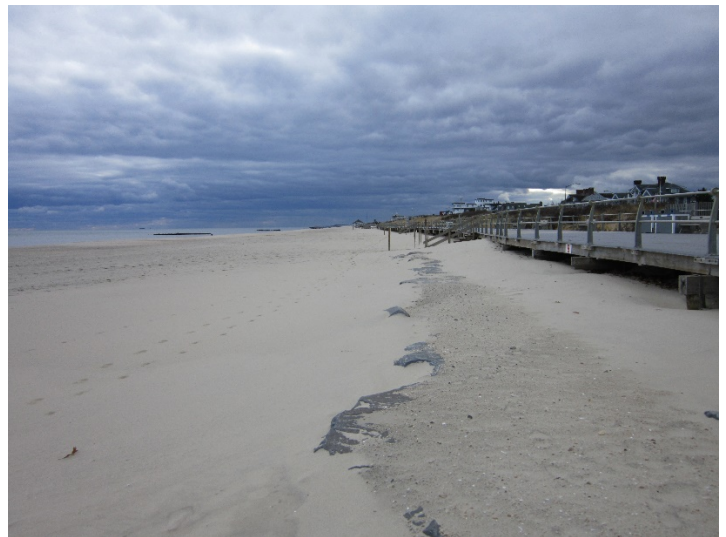
NJBPN 16101 – Tuttle Avenue, Spring Lake

The Oct. 18, 2018 view on the left shows the wide dry beach, while the Dec. 5, 2019 view shows sand accumulating under the boardwalk as the wind deposits the material there and some into the vegetated dunes present landward of the boardwalk.

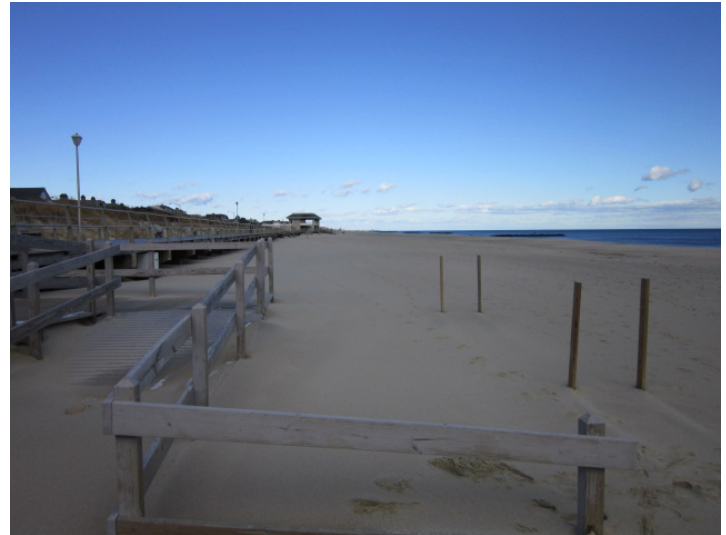
**NJBPN 161 – Brighton Avenue, Spring Lake**

The left photo shows the beach as of Nov. 14, 2018 looking north in Spring Lake from the center of the dry beach. The right photo was taken Dec. 5, 2019 from the base of the boardwalk showing wind deposition at the structure because the dune is landward in Spring Lake.

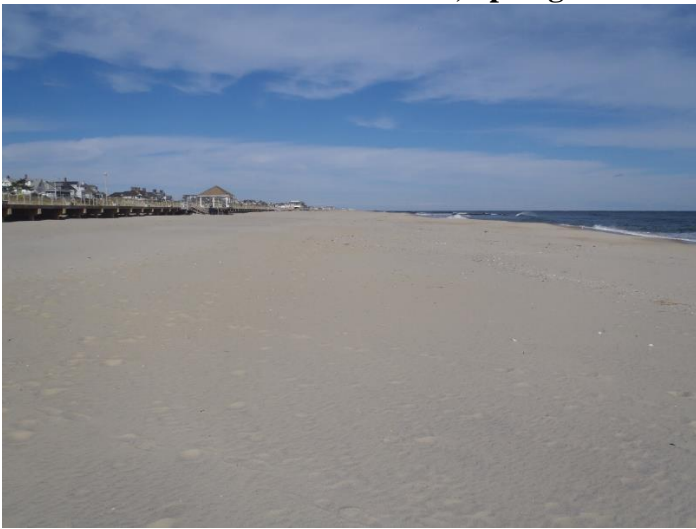
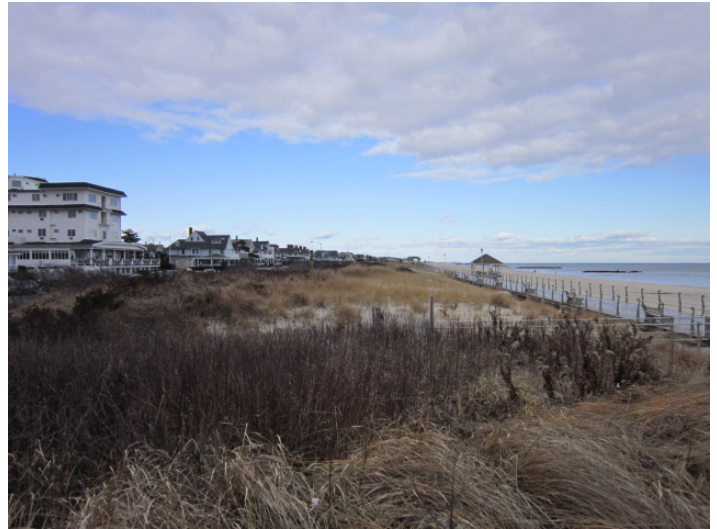
**NJBPN 16004 – Madison Avenue, Spring Lake**

The dune is robust between Ocean Avenue and the boardwalk. The Nov. 14, 2018 view was taken on the dry beach showing its width on the left. The dune present at this site shows in the right photograph including the boardwalk and just a glimpse of the beach seaward. This dune view on Dec. 5, 2019 is to illustrate the Spring Lake dune system relative to the shoreline development.

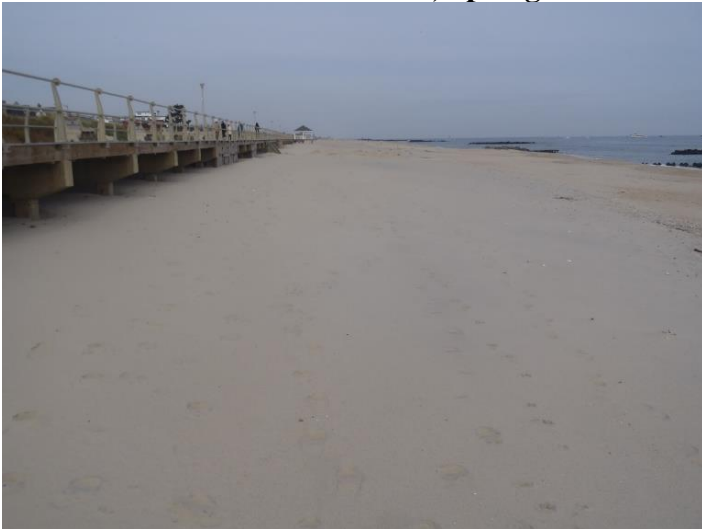
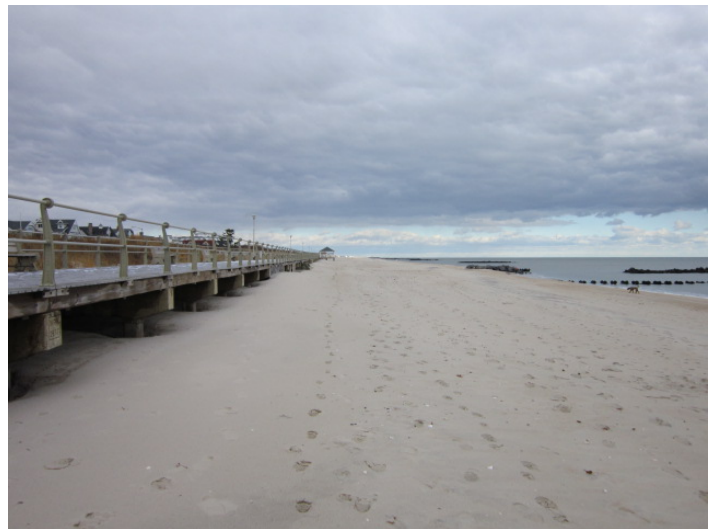
**NJBPN 16003 – Morris Avenue, Spring Lake**

The left photograph was taken Nov. 12, 2018 on the beach just seaward of the boardwalk. The righthand photograph, taken on Dec. 5, 2019, shows the sand accumulating under the boardwalk, but some retreat in the beach width has occurred.

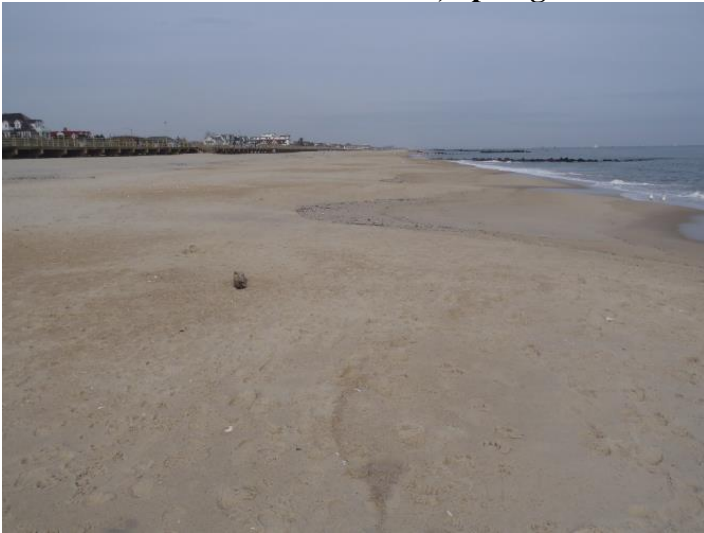
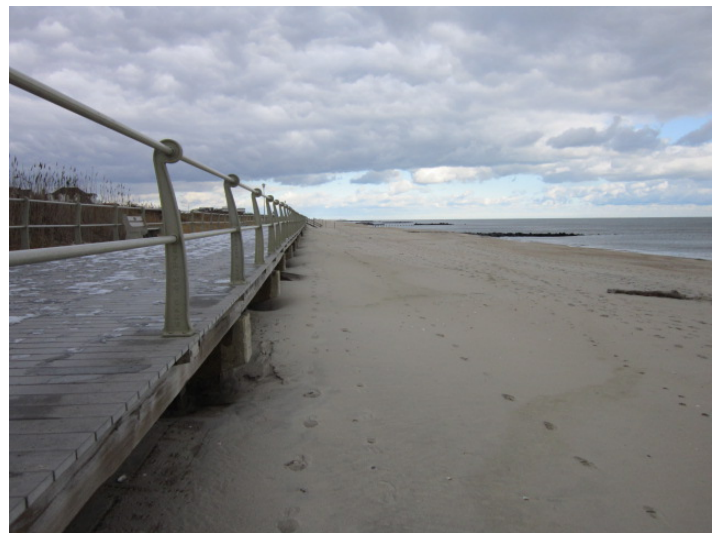
**NJBPN 16002 – Mercer Avenue, Spring Lake**

The dune is slightly lower and narrower at Mercer Avenue with a distinct separation from the boardwalk. The Nov. 12, 2018 view on the left shows the beach width close to the limit of wave runoff on the beach. The Dec. 5, 2019 view depicts the beach at the base of the boardwalk and it appears to indicate a narrower beach a year later.

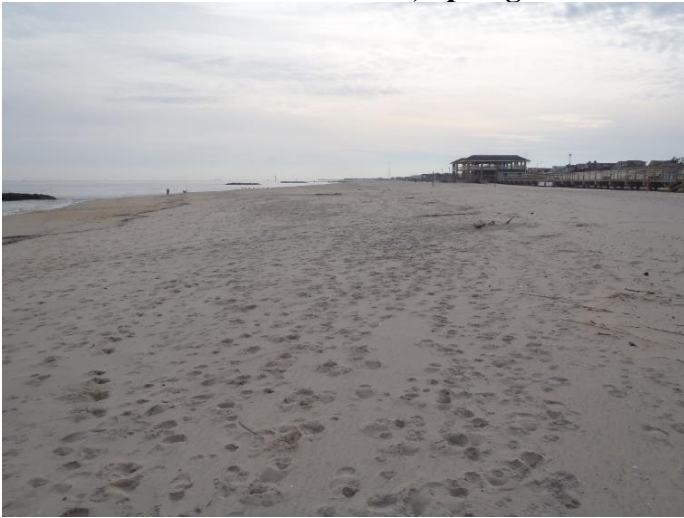
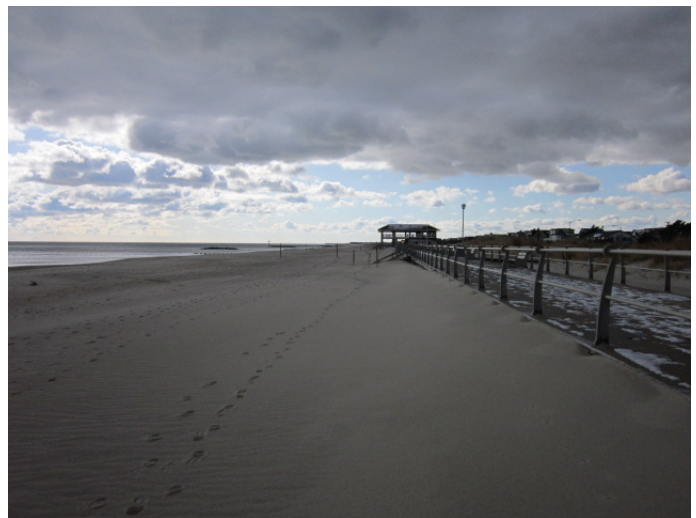
**NJBPN 16001 – Essex Avenue, Spring Lake**

The dune/boardwalk combination are quite large as a storm barrier. However, past experiences have proven that the boardwalk seaward of the dunes increases the likelihood that it will be destroyed in a serious storm (Irene and Sandy most recently). The left view taken in Nov. 12, 2018 shows the dry beach and the dunes to the right. The Dec. 5, 2019 view on the right demonstrates the sand deposition at the boardwalk ramping to the surface at this site. This would save the boardwalk in a storm, but makes maintenance very difficult.

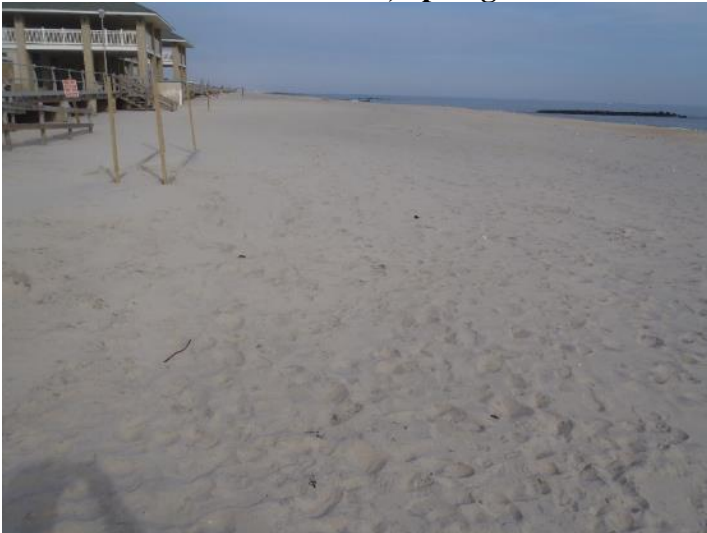
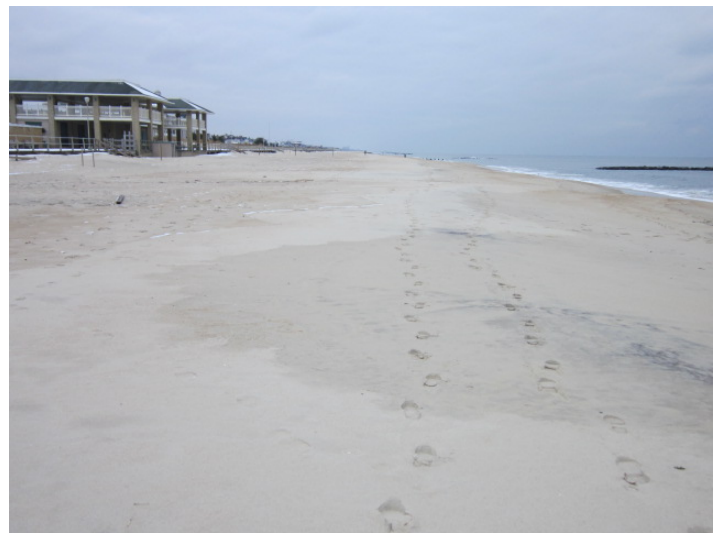
**NJBPN 160 – Salem Avenue, Spring Lake**

The Salem Avenue beach site lies just south of one of the municipal beach facilities. The left photo was taken Nov. 12, 2018 showing a decent berm and wide, dry beach. On the right, the Dec. 3, 2019 view shows a similar beach in place with snow on the boardwalk.

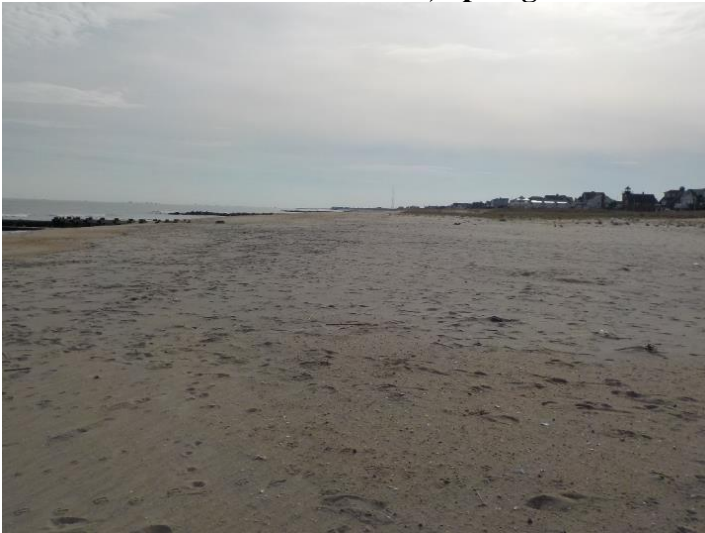
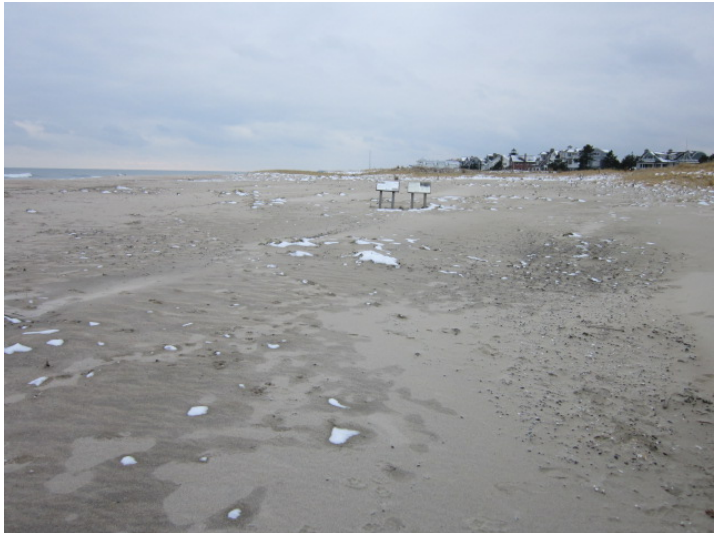
**NJBPN 15901 – Brown Avenue, Spring Lake**

At the south end of Spring Lake, the dune is not significantly higher than the surface of the boardwalk. The left view from Nov. 12, 2018 shows the beach with a timber groin exposed on the beach. The Dec. 4, 2019 view on the right shows the boardwalk and dune system to the right and a wide beach to the center of the view.

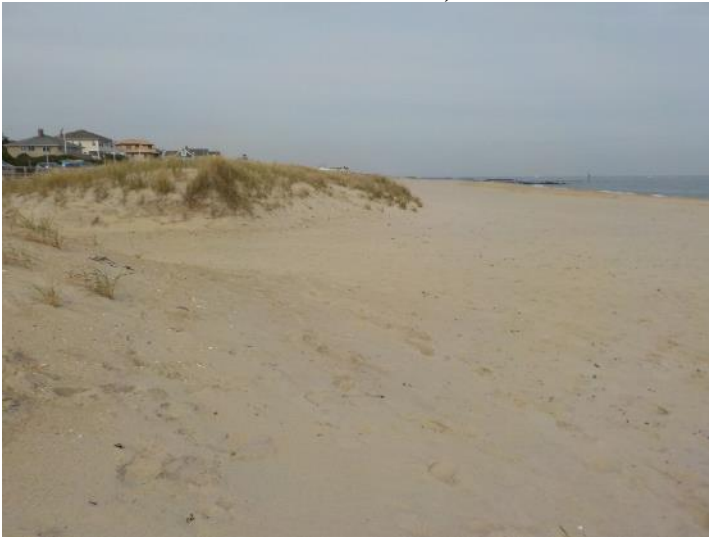
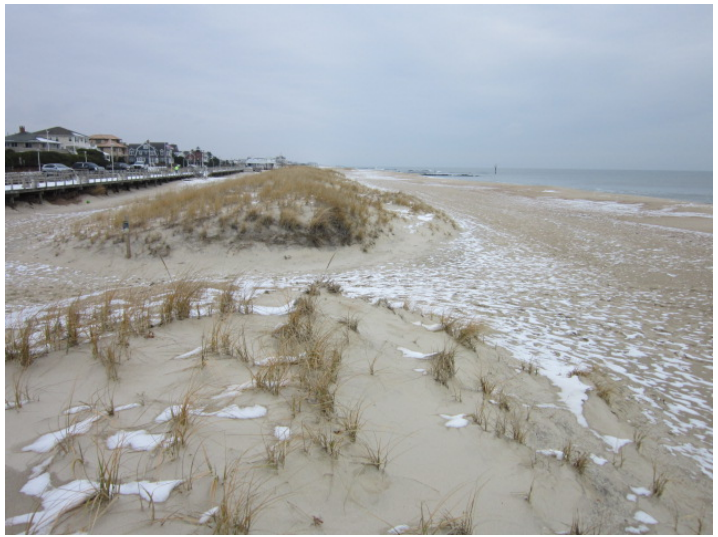
**NJBPN 159 – New York Avenue, Sea Girt**

The left view, taken Nov. 12, 2018 shows the post-Sandy dune and the beach at New York Ave. The Dec. 4, 2019 view on the right followed a snow storm that dusted the beach. The dune toe lobe on the left appears a bit truncated in 2019, but damage was minimal.

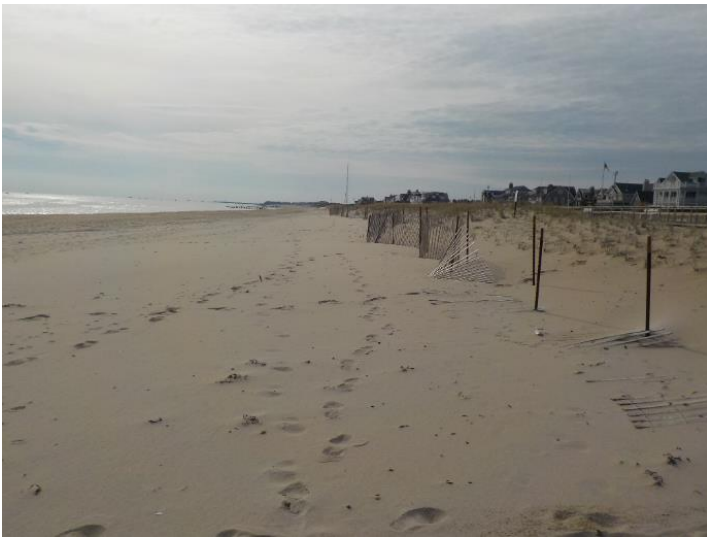
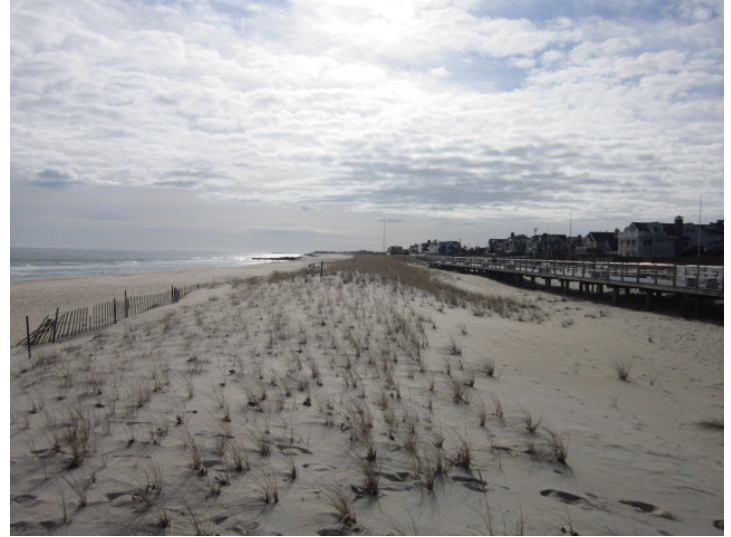
**NJBPN 15801 – Crescent Park, Sea Girt**

The dune was fenced by Nov. 12, 2018, but fence damage may have been storm induced, but the beach and dune system appear to be fine. By Jan 10, 2020 on the right the grass was partially buried by added wind deposition and the damaged fence was still unrepaired over a year later with no further storm wave impacts.

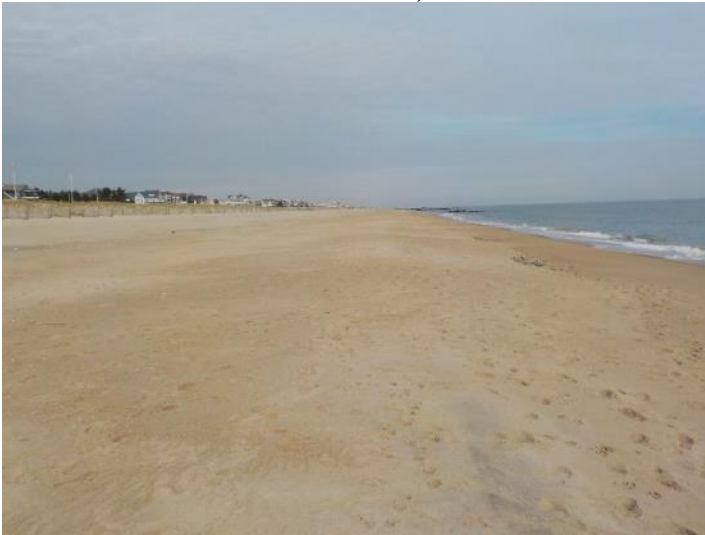
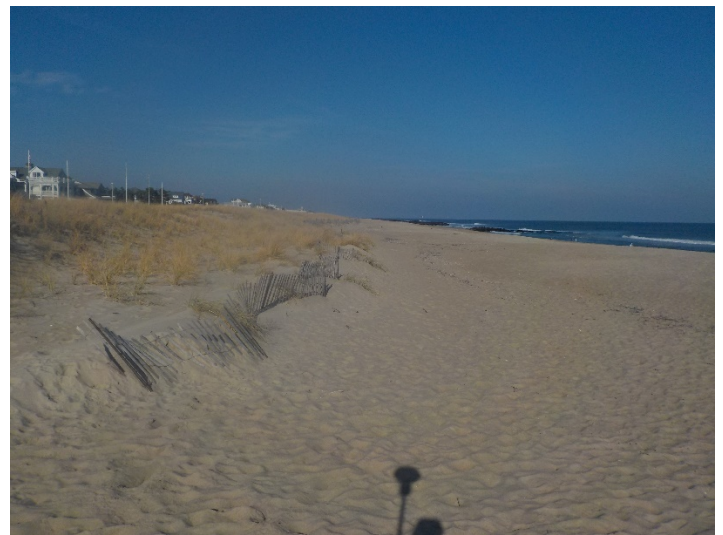
**NJBPN 158 – Trenton Avenue, Sea Girt**

The Nov. 12, 2018 view on the left shows the beach at the berm crest with the dune toe to the extreme left in the photograph. The Nov. 25, 2019 view (right photo) is at the toe of the dunes showing minor scarping and fence damage similar to that seen to the north at site 15801.

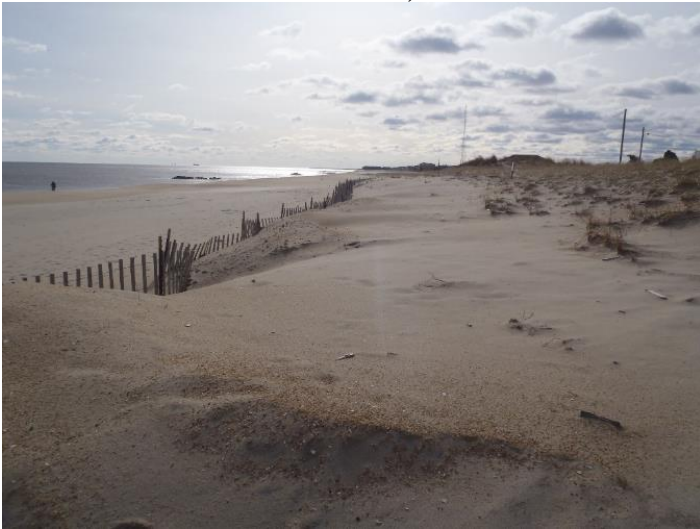
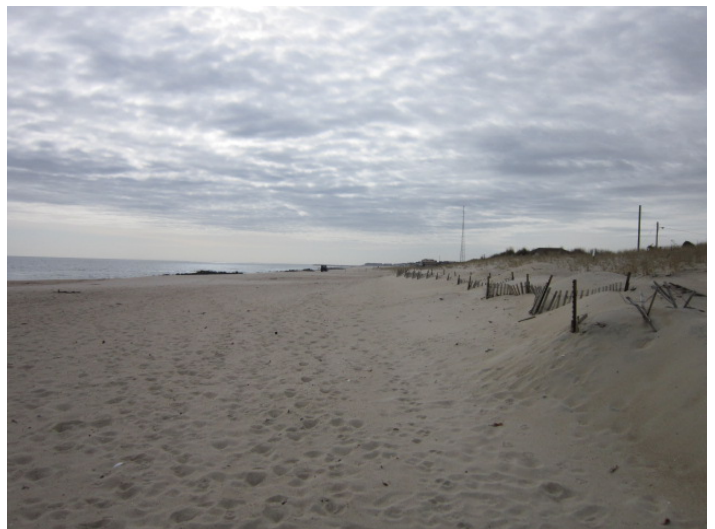
**NJBPN 15703 – Seaside Place, Sea Girt**

Located at the southern limit of Sea Girt, the site was clipped by dune erosion as of Nov. 28, 2018, as indicated in the left photograph. Wind transport appears to have replaced some dune toe sand as of Jan. 10, 2020 in the right photograph.

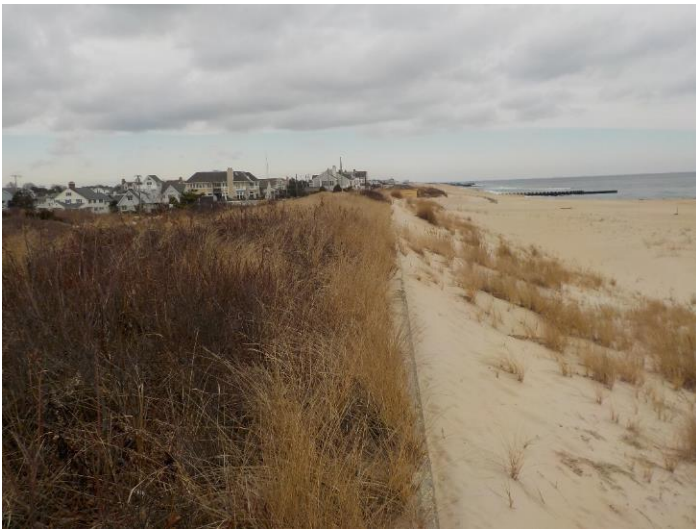
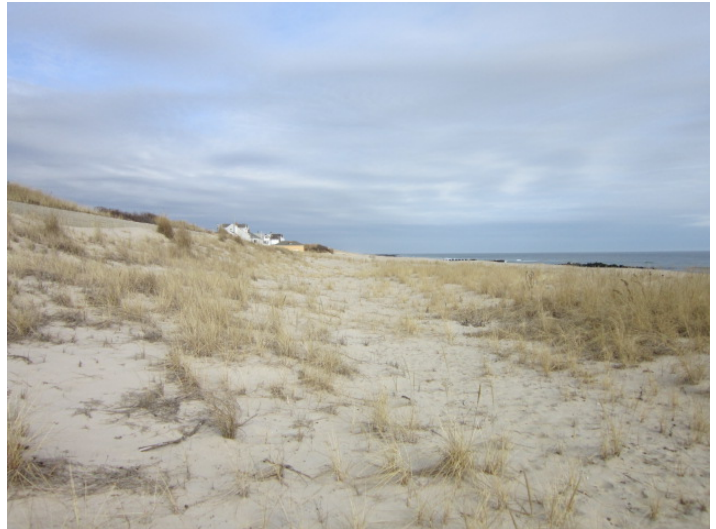
**NJBPN 15702 – NGTC - North, Sea Girt**

The extraordinary dune elevation is because the National Guard shooting range ends at its landward side, so the extra height was added to stop bullets. The Jan. 3, 2019 view to the north on the left shows the beach width and modest foredune at the seaward toe of the primary dune. As of Jan. 10, 2020, the site continued to accumulate sand in the foredune zone as the main dune remained unchanged.

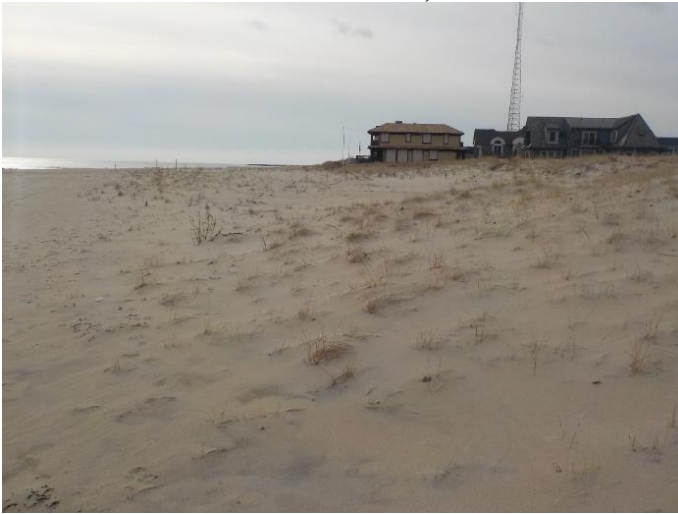
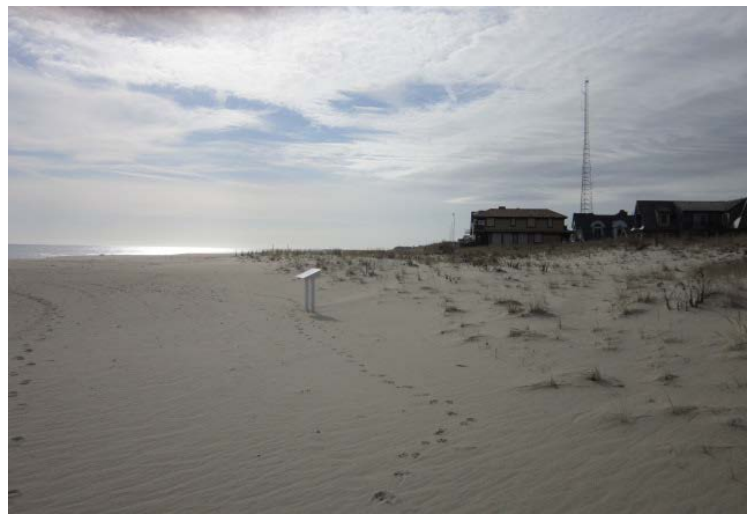
**NJBPN 15701 – NGTC - South, Sea Girt**

This site is located at the south end of the National Guard training facility beachfront. The dune is lower because it is outside the rifle range aiming area. The Jan. 3, 2019 view on the left is the southern dune toe and dry beach looking into Manasquan. The right photo was taken Jan. 10, 2020 in the same perspective showing little change in the upper beach and dune.

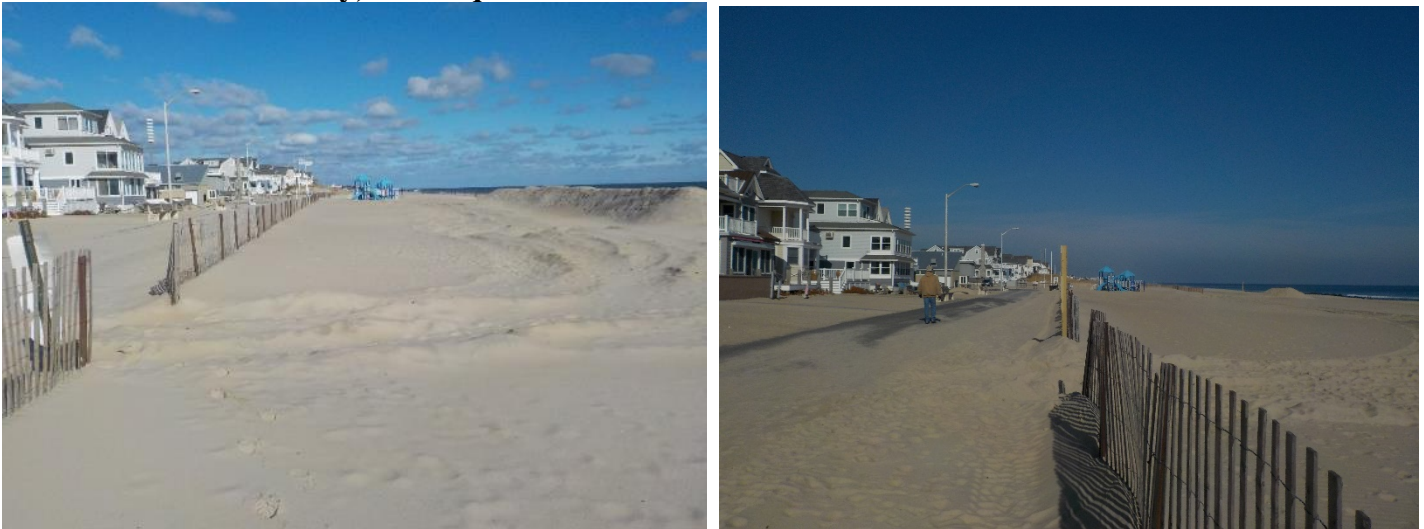
The Nov 27, 2018 view to the north in Manasquan (left photo) shows the row of fencing placed in an attempt to keep the sand off the promenade along with a ridge of sand pushed up to reduce potential storm wave damage. On the right is a view taken Nov. 25, 2019 showing the relative inadequacy of the single row of sand fence in stopping wind transport into both the promenade and development at Riddle Way. The storm ridge was absent as of the survey date.

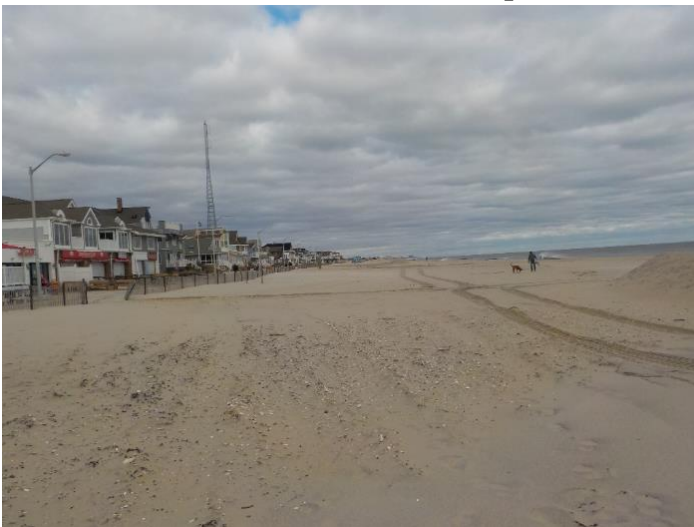
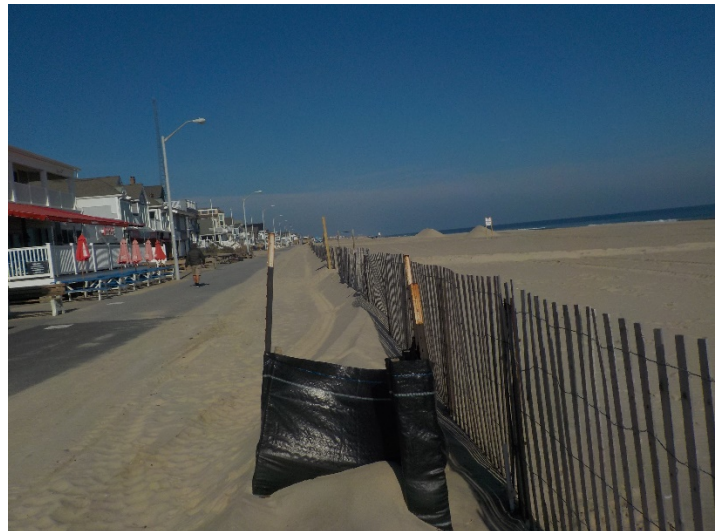
NJBPN 25602 – Main Street, Manasquan

The Nov. 27, 2018 view on the left shows that the pushed up sand ridge was not universally installed with no dune present at the sand fencing seaward of the paved promenade. On the right, a year later (Nov. 25, 2019) sand has collected at the sand fencing largely having been pushed back off the promenade repeatedly. Sand hummocks appear on the open beach, but the storm ridge is absent.
