# New Jersey Beach Profile Network

## Monmouth County

Raritan Bay and Sandy Hook  
to Manasquan Inlet

**NJBPN Profile #'s  
187 - 256**

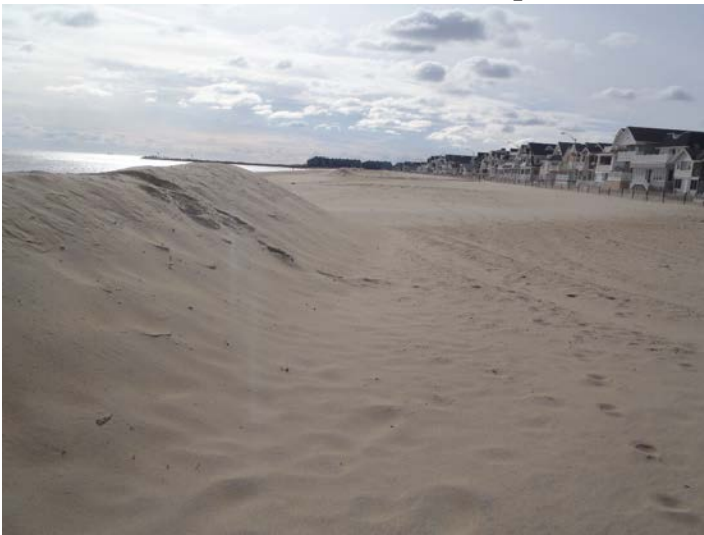
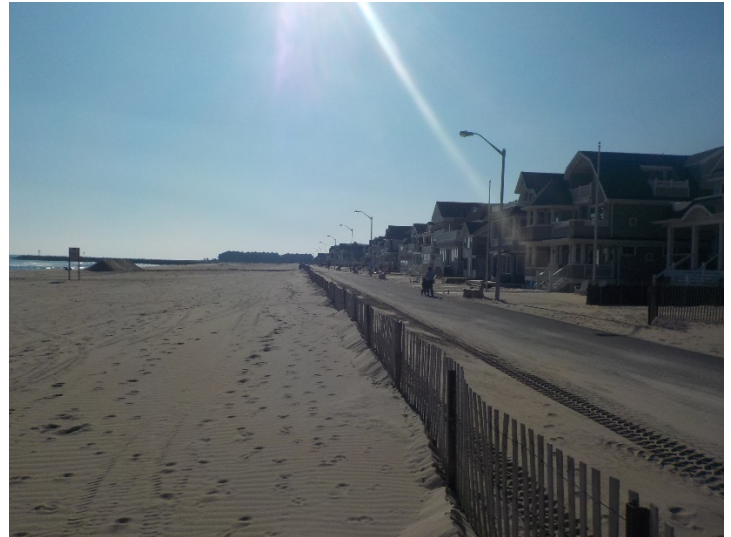
**NJBPN 25601 – Brielle Road, Manasquan**

This site did have a storm ridge pushed up as of Nov. 28, 2018, but it ended just south of the transect line. The Nov. 25, 2019 view on the right shows sand accumulating at the sand fencing by the promenade, but no dune present and no storm ridge as of the date of this survey.

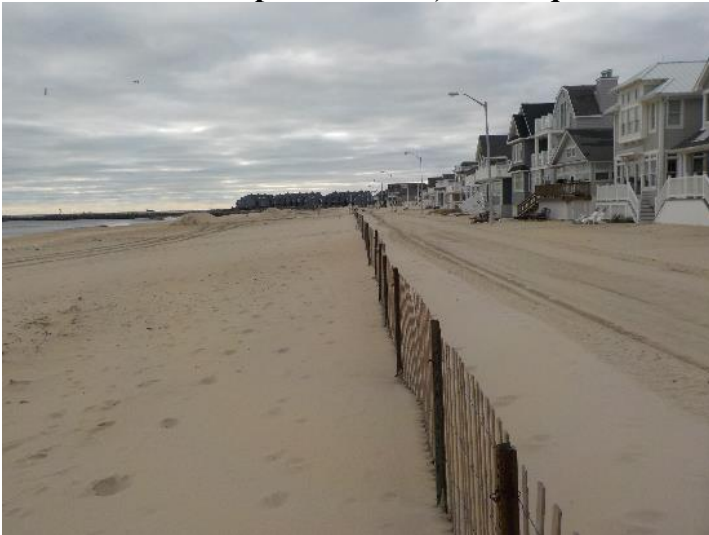
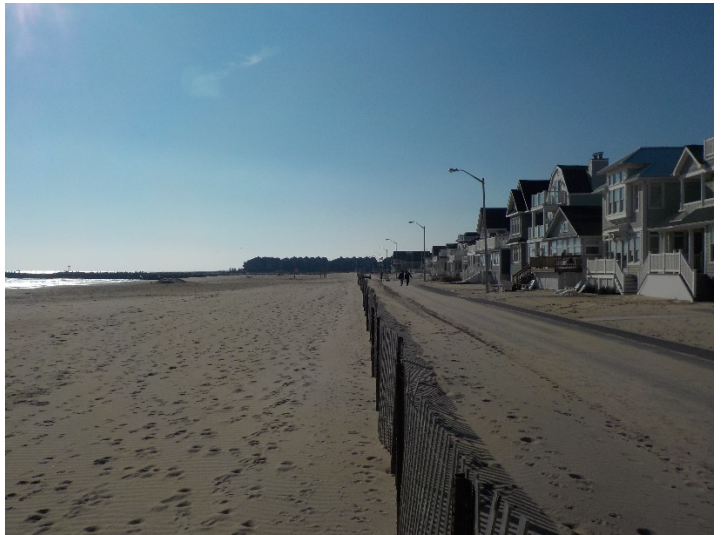
The Nov. 27, 2018 view (left photo) includes the promenade, houses, and the wind-transported sand causing problems because there was no dune system in the Borough. As of Nov. 25, 2019, conditions remained essentially the same where winds transport beach sand through the single line of fence adding material to the oceanfront “yards” of the homes facing the promenade.

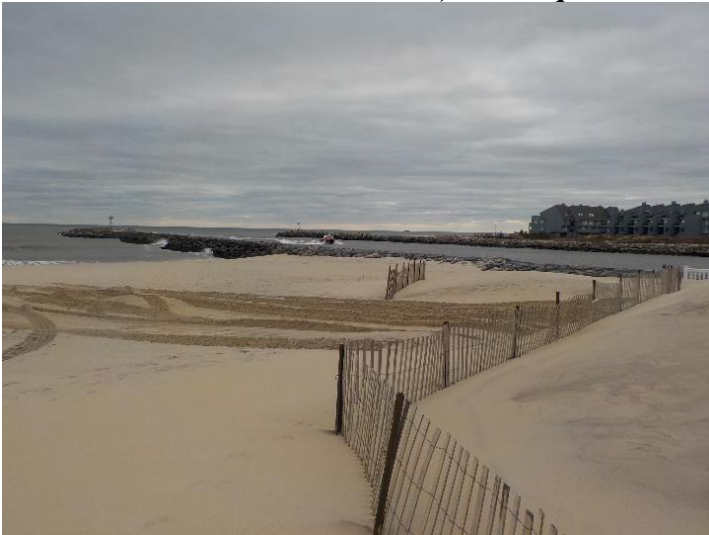
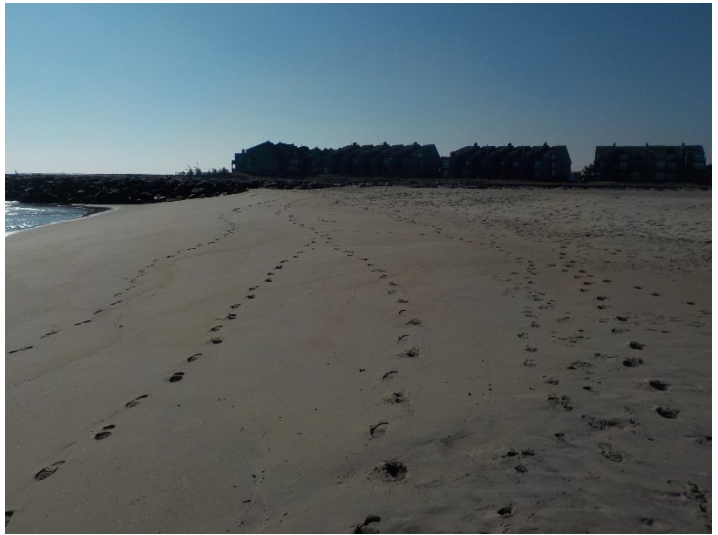
**NJBPN 15601 – Riverside Drive, Manasquan**

The southernmost survey site in Monmouth County lies a few hundred feet from the north Manasquan Inlet jetty. The Nov. 27, 2018 photograph on the left shows the toe of the only “dune” on a Manasquan transect. This feature is fenced but with minimal plants. The right photograph was taken Nov. 25, 2019 at the berm crest showing the very short distance between the transect line and the north jetty to Manasquan Inlet.
