# New Jersey Beach Profile Network

## Monmouth County

Raritan Bay and Sandy Hook  
to Manasquan Inlet

**NJBPN Profile #'s  
187 - 256**

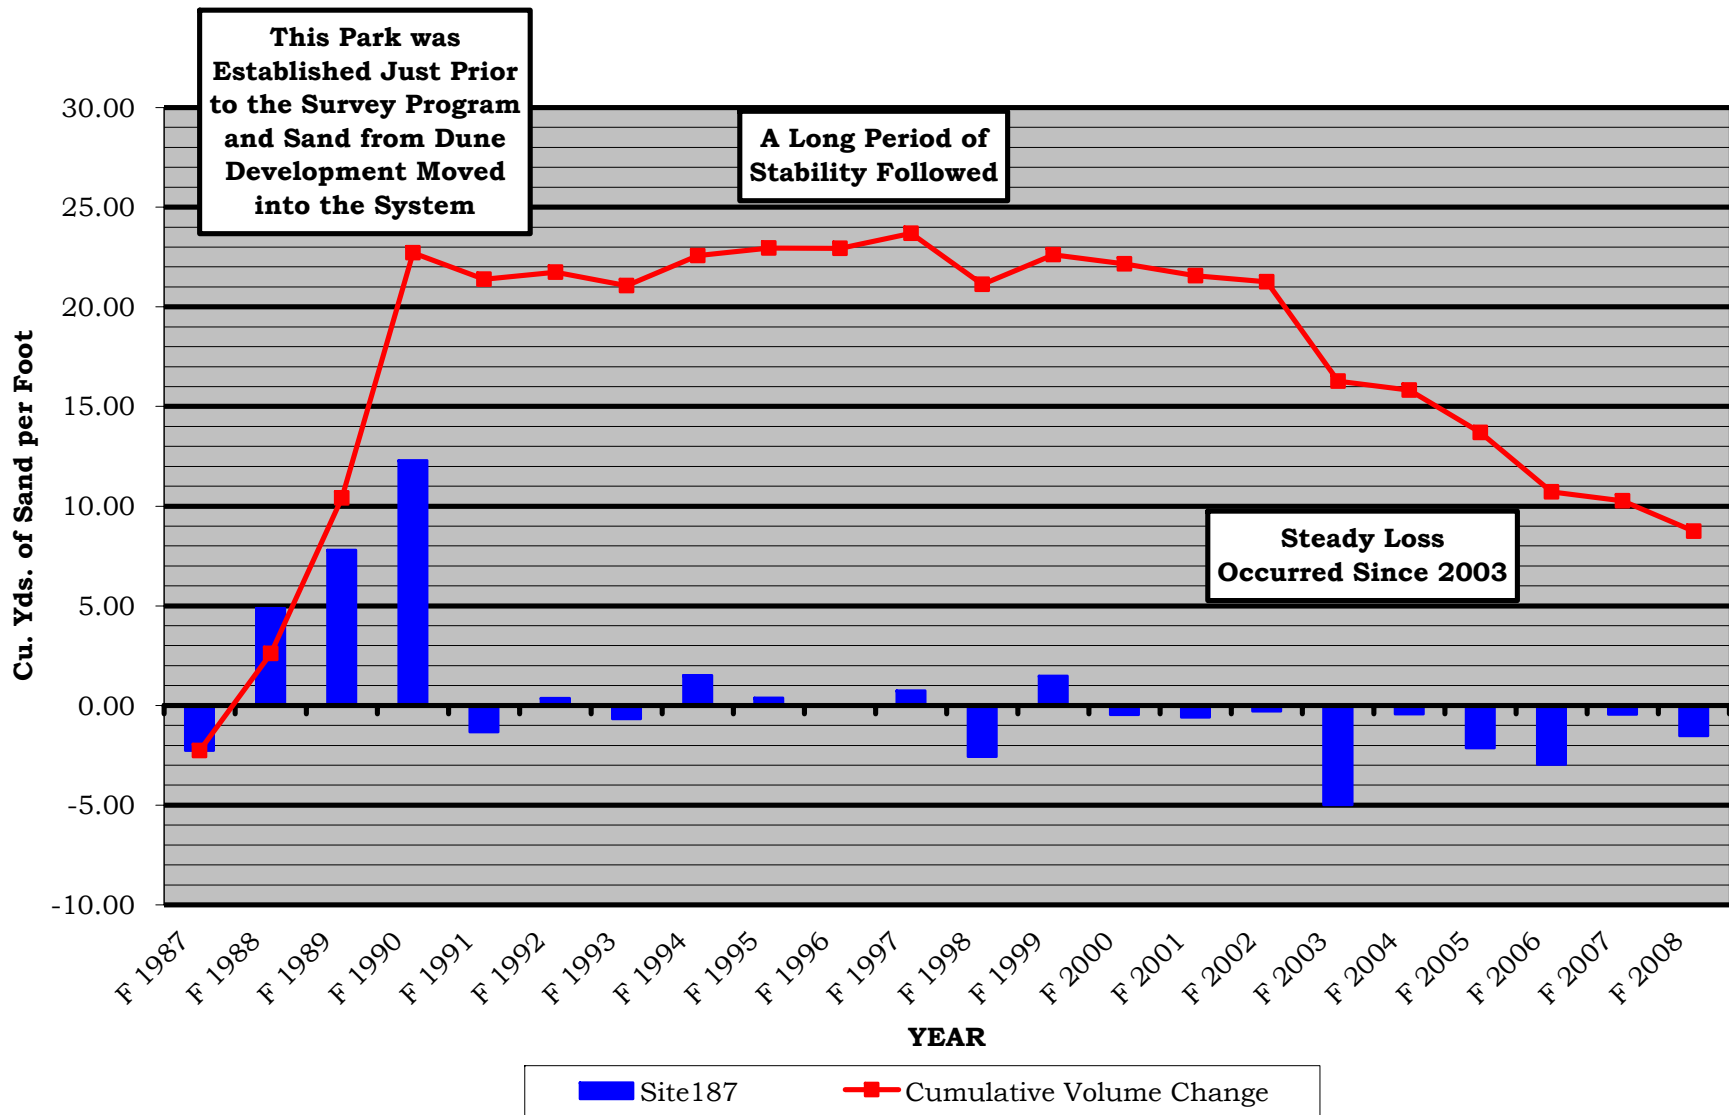
## 22-Year Sand Volume Changes at Site 187, Cliffwood Beach, Aberdeen

**Figure xx.** There are three sites along the eastern Raritan Bay shoreline in Monmouth County where Cliffwood Beach is the westernmost of the three. Located in a park created just before the establishment of the NJBPN program, the sand available in the system added to the beach/dune system during the three years following the initial pair of surveys. During the next 12 years the shoreline was stable in spite of northeast storms and other events. In 2003 a slow sand loss commenced that reduced the net gain by half by 2008.

The third illustration shows the 22-year change at the westernmost cross section established along the Monmouth County Raritan Bay shoreline. Wave activity on the bay is generated by northeast storms and strong northwest winds following storms. The bay is at most 7 miles wide, so the fetch limits the wave height and period so erosional impact is limited to about two feet below low tide. Surveys continue offshore, but there has never been any change to the outer 500 feet or so of any of the three cross sections. The Cliffwood Beach site remained stable after a three-year sand volume increase early in the program.

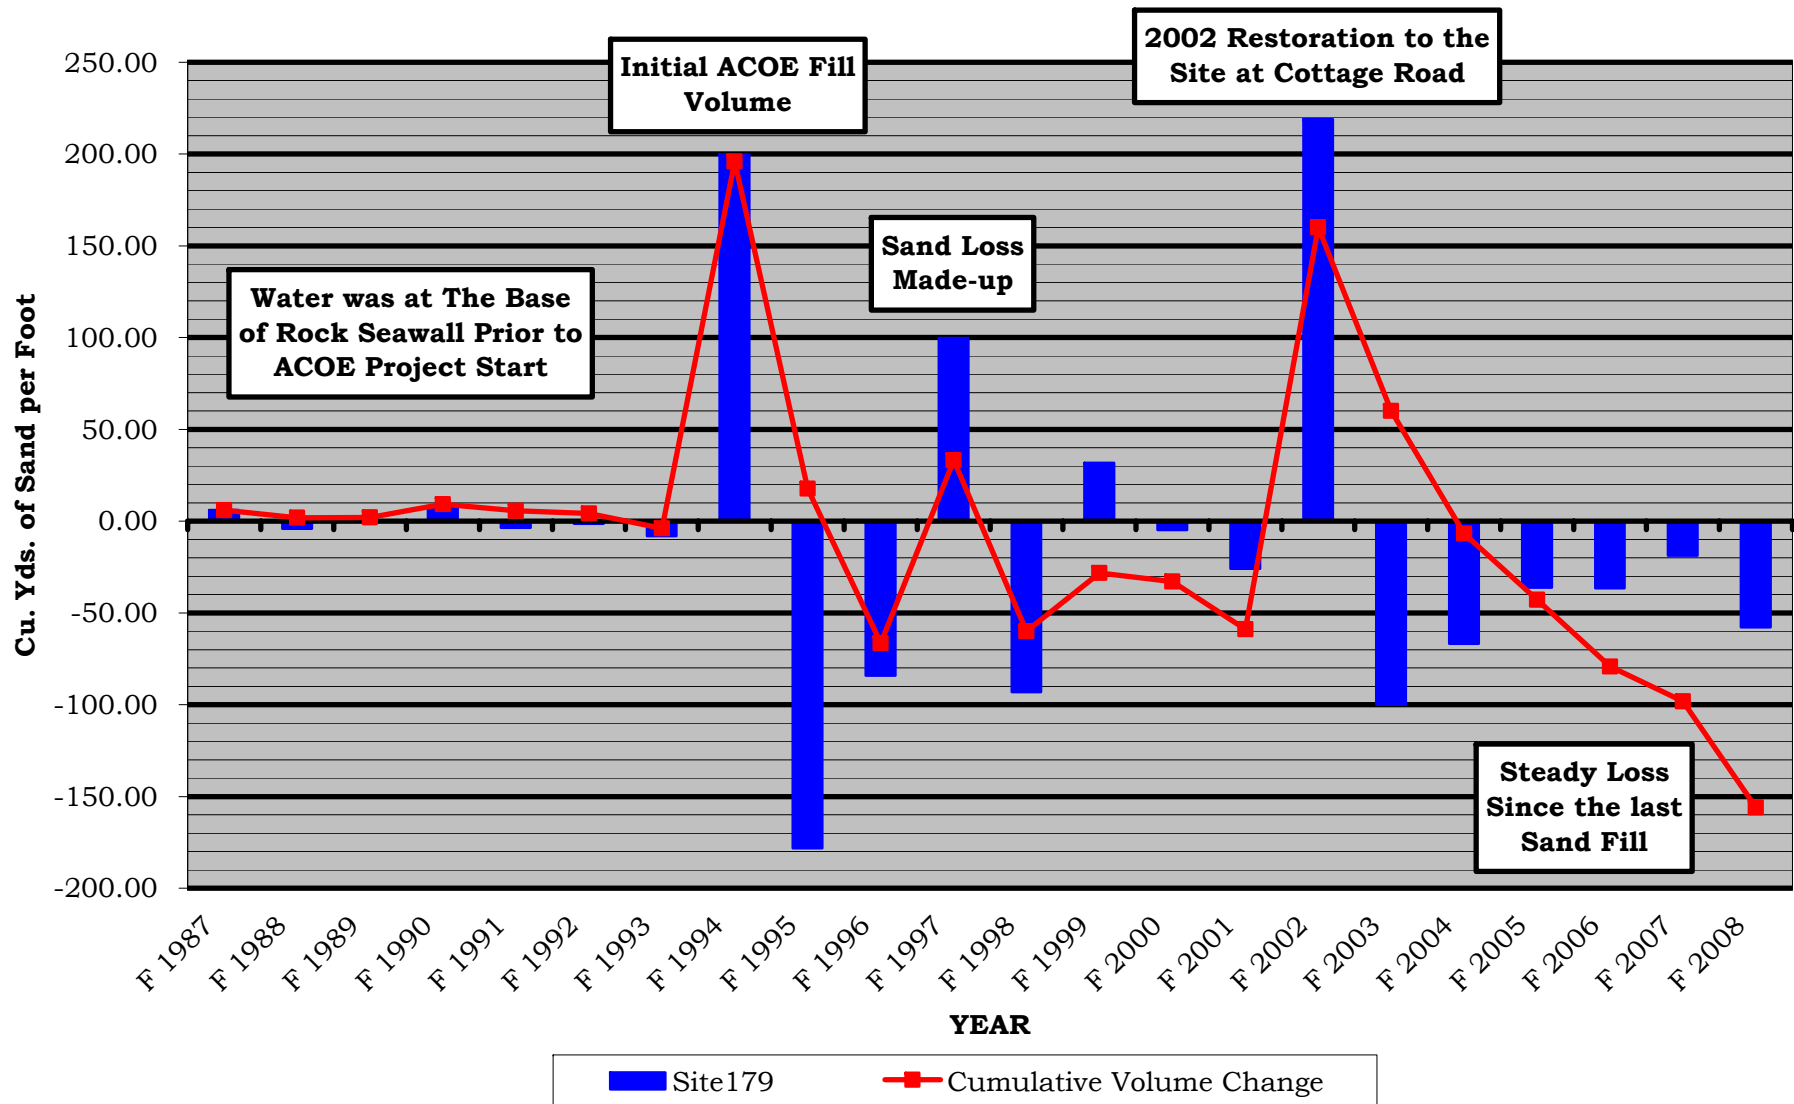
## 22- Year Sand Volume Changes at Site 178, Cottage Road, Monmouth Beach

Figure xx. Site #178 at Cottage Road in Monmouth Beach initially had several feet of water at the seaward base of the seawall rocks prior to the ACOE project starting in 1994. Storm losses were made up in 1997 followed by maintenance work in 2002. Chronic losses have piled up because the groins once the sole protection for the Monmouth Beach Club now prevent sand from reaching this site from the south.

Two figures below were selected to illustrate the extremes in the massive Monmouth County beach restoration project undertaken by the New York District of the US Army Corps of Engineers. The two areas subject to erosion were located at Cottage Road in Monmouth Beach and at the south end of the Long Branch section of the project. The artificial termination of the work at West End Avenue in Long Branch promoted end-effect losses in the fill cross section in the southern Long Branch beach. Sand moved south into Elberon and deposited offshore and seldom was observed on the beach as permanent improvements to the sand supply in Elberon. The Cottage Road situation is caused by extensive rock groin structures placed at the north end of the Monmouth Beach Club property. Sand simply is unable to pass around the structure to reach the Cottage Road beach segment. Since the sea has been dominated by southeast winds in the past two winters, the tendency for sand to move south under northeast storm influence has been limited. With no sand coming north around the groins, the southern beaches with sand cannot provide the sand which would produce equilibrium at Cottage Road. The net effect is rapid erosion to the Cottage Road site to the point where the dune has been stripped away. Northeast storm conditions would transport sand from Sea Bright south to the groin where it would be trapped and build the beach at Cottage Road.

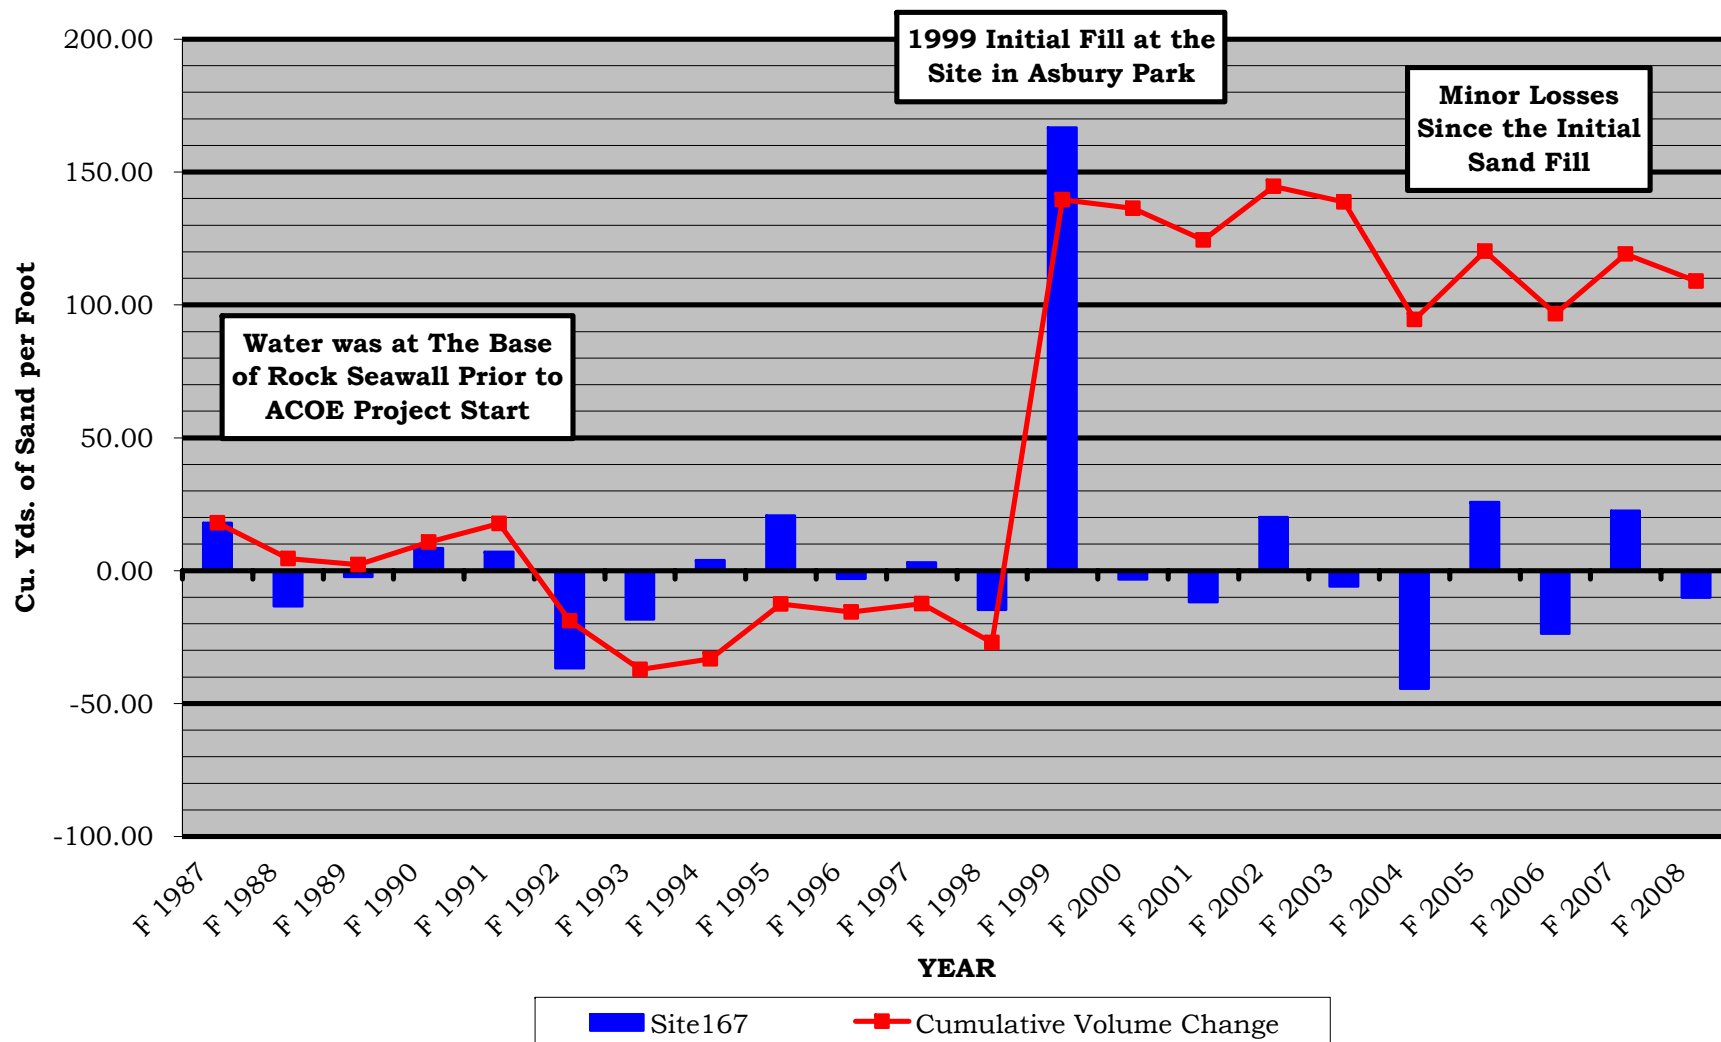
## 22- Year Sand Volume Changes at Site 167, 3rd Avenue, Asbury Park

**Figure xx. The Third Avenue location in Asbury Park received the Federal beach nourishment in 1999. No additional work has been required since. Three of the nine years since saw additional natural accretion that helped keep the beach near the ACOE sand placement volume seen in 1999.**

In Asbury Park the nourishment project arrived during 1999. The placement volume was about 167 cubic yards of sand per foot of shoreline. Since then there has been no added nourishment work. The beach has gained and lost sand in no particular pattern. In 11 years the beach has lost 30 cubic yards of sand per foot or about 18% of the placed volume. The southern portion from Asbury Park to Manasquan Inlet has remained at or above 75% sand remaining after 9 years following its placement. Some sand has moved north to augment Loch Arbor and Allenhurst beaches, but groins prevent distribution into Deal and beyond. The beaches in Deal remain as they were prior to the project.

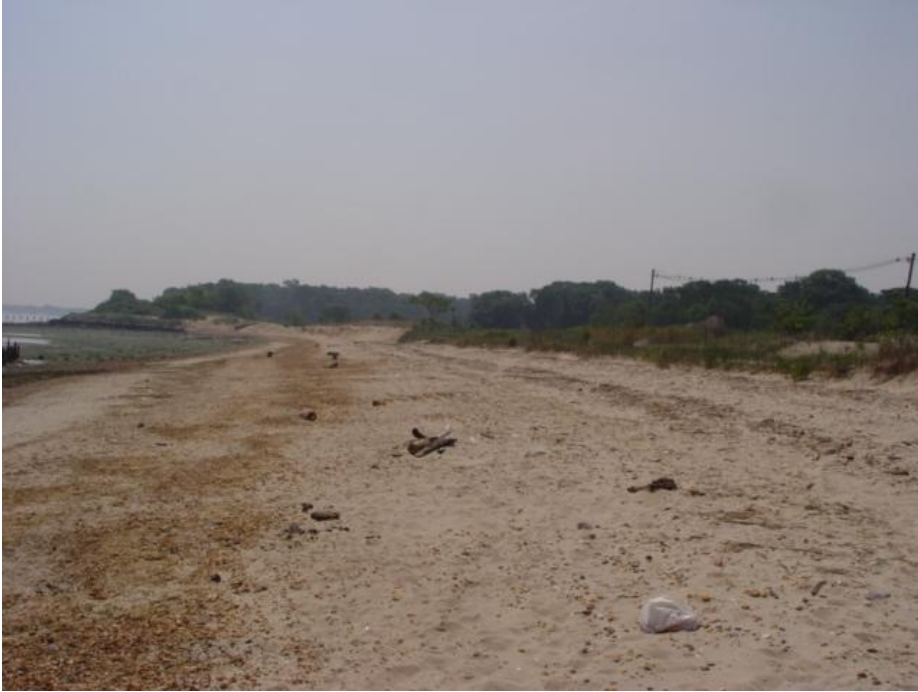
## CLIFFWOOD BEACH - SITE 187

There has been some shoreline retreat that has exposed an old timber structure on the beach June 26th 2007. The toe of the dune was trimmed back by erosion too.

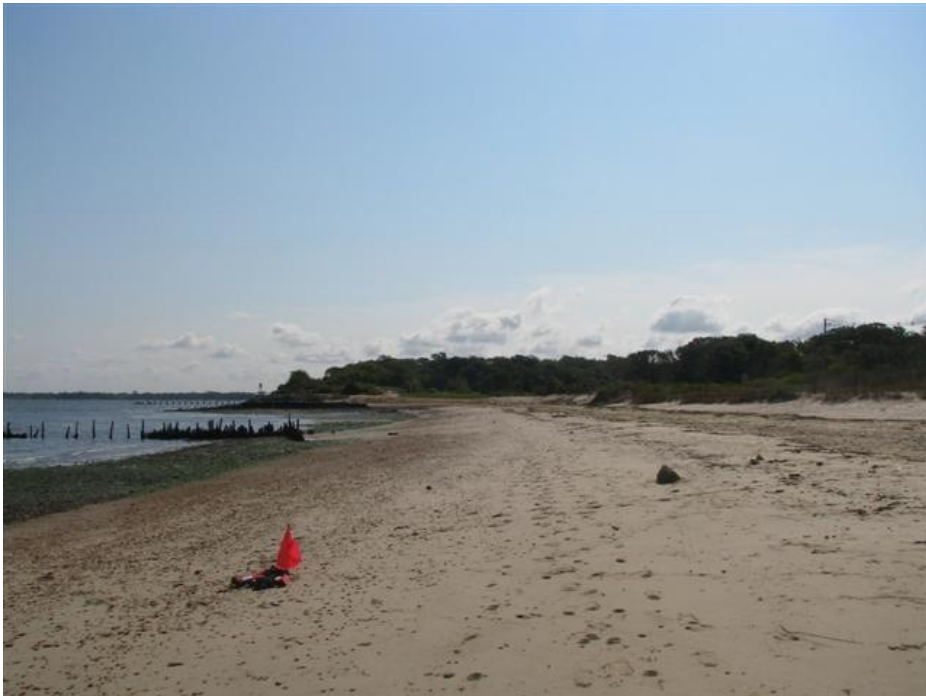
By September 24th 2008 the dune toe was restored by new sand, but the beach was slightly lower. The sand volume change was a loss of 2.77 yds<sup>3</sup>/ft. and a 5-foot shoreline advance. These bayshore sites do not change drastically and almost never show any differences below the -2.0 foot contour. The short period waves on Raritan Bay do not impact the bottom in water more than a foot deep.

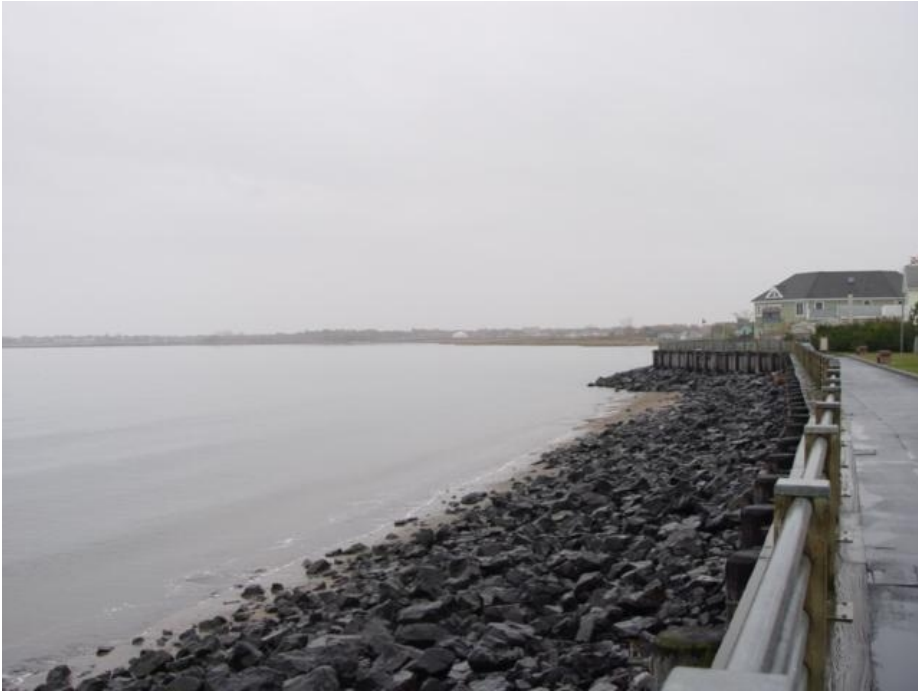
## UNION BEACH - SITE 186

This shoreline was upgraded with hard structures about a decade ago. This November 20<sup>th</sup> 2007 photograph shows the new bulkhead/railing and pedestrian walkway with an apron of medium stone extending to the low tide line. Since changes rarely occur beyond the low tide line in the 22 years of study, this site has become an exercise in futility to continue surveying.

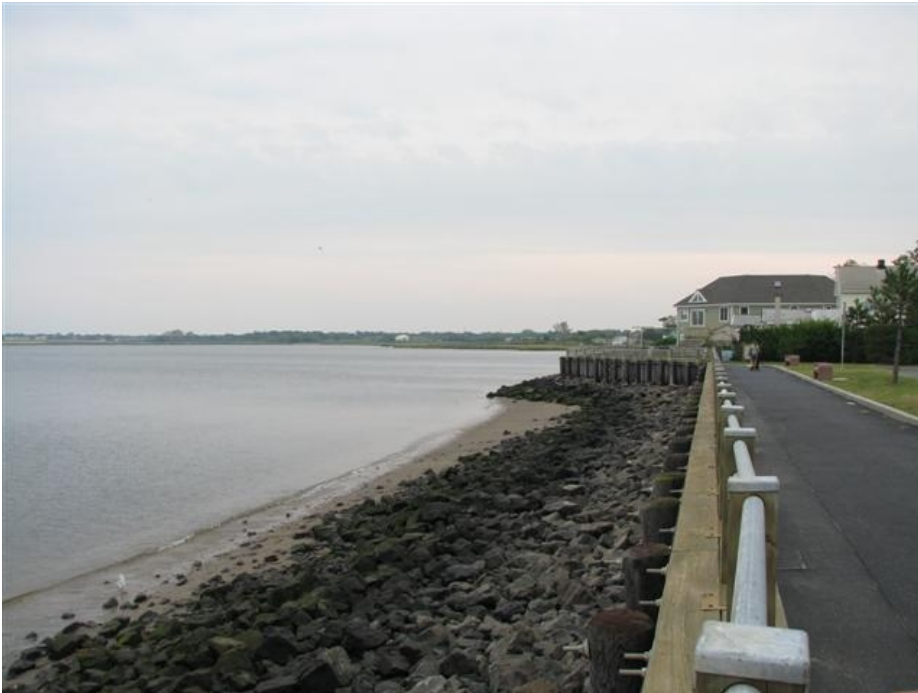
The September 9<sup>th</sup> 2008 view was taken at a slightly lower stage of the tide, but all other parameters are identical to those shown above. Following consultation with the staff at the Bureau of Engineering and Construction at the NJDEP, the site was moved about a quarter mile to the northwest along the shoreline to a public bathing beach so that more normal shoreline changes could be followed. The new site is near the intersection of Beach and Front Streets in Union Beach.

The last comparison calculation to be done on this site found that the sand volume changed by  $-1.31 \text{ yds}^3/\text{ft}$ . and the shoreline retreated 2 feet. In 2009 the new site's data will replace this location going forward.

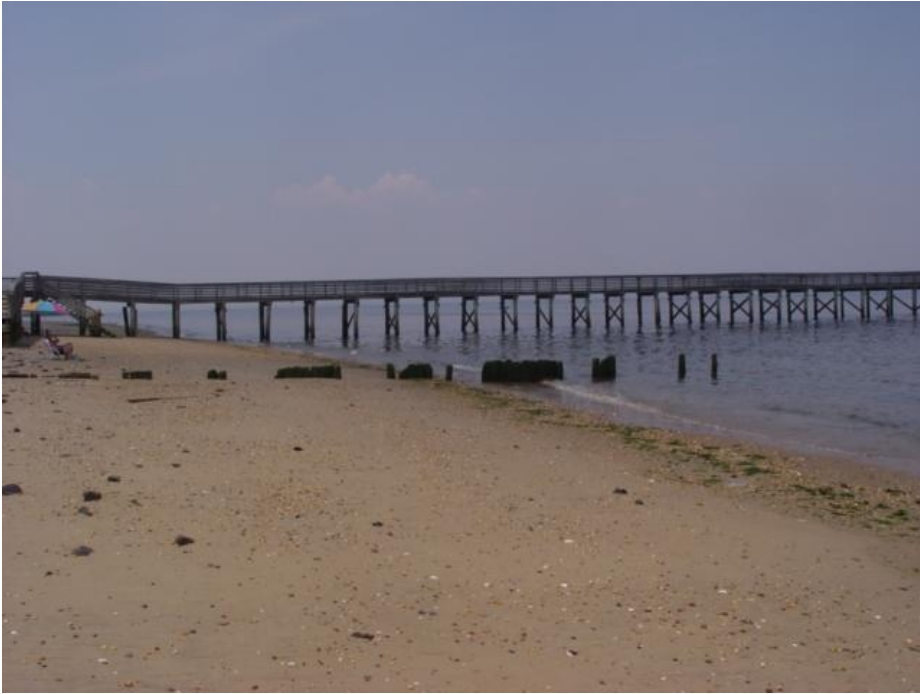
## SPY HOUSE MUSEUM - SITE 185

The museum site contains a bluff with wind blown sand mantling it. The beach has retreated over the years, but has been pretty stable for some time due to a lack of either frequent or intense northeast storms. The waves impacting the shoreline are just those generated by the 16-mile fetch across Raritan Bay, not oceanic waves. The picture was taken June 26<sup>th</sup> 2007 showing the new fishing pier and an old structure exposed near the low tide line.

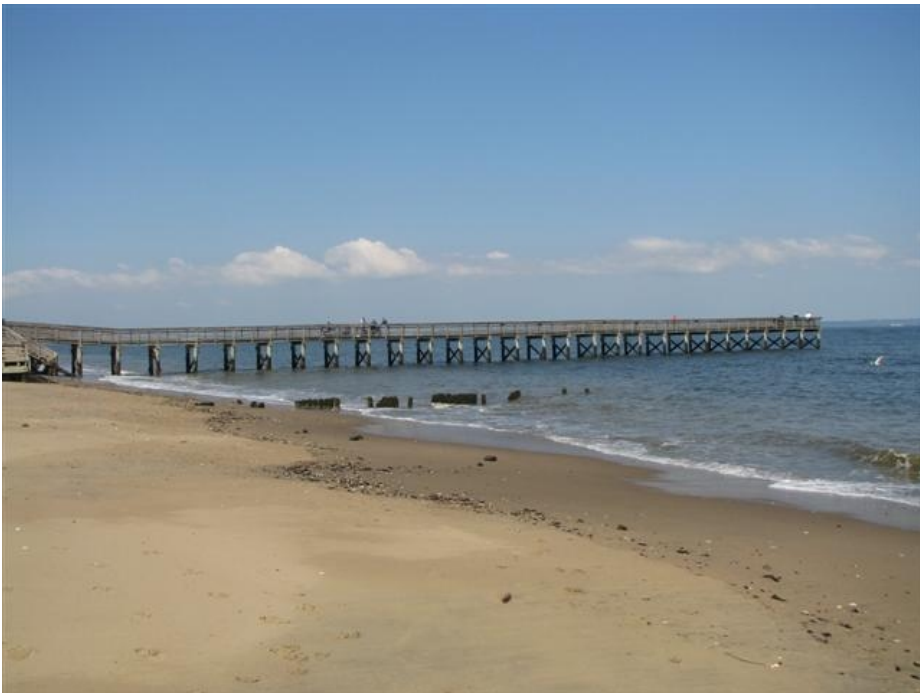
By September 24<sup>th</sup> 2008 the beach had recovered a minor amount of sand, but thus far the proposed re-construction of the bluff and dune by the County Park Service has not occurred. The shoreline retreated less than a half foot while the sand volume declined by 13.54 yds<sup>3</sup>/ft.

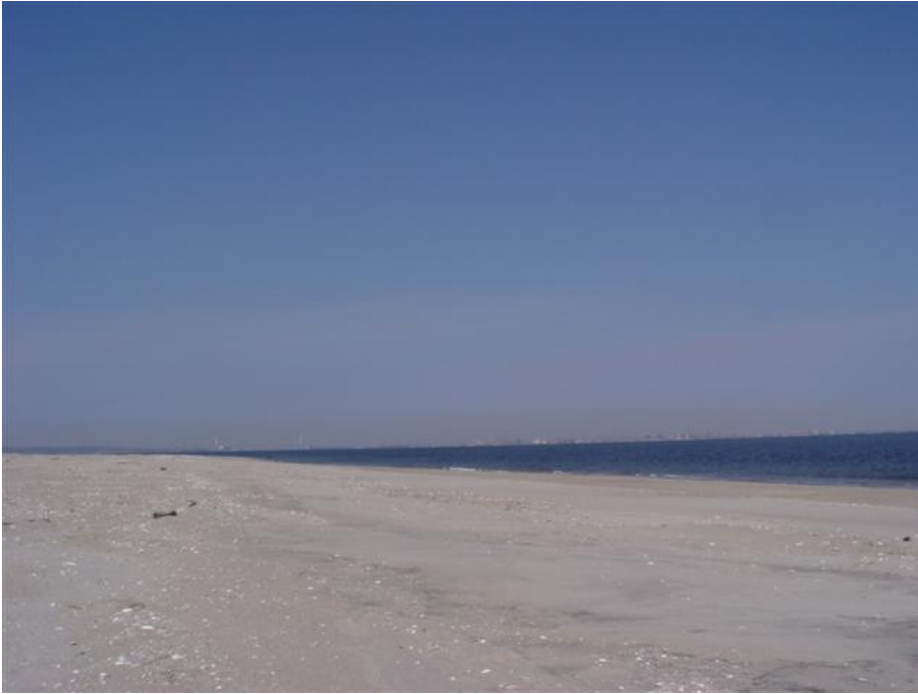
## SANDY HOOK NATIONAL SEASHORE - SITE 285

The northern end of the Sandy Hook spit looks like a vast sand plain that seems to grow ever wider. The view to the left was taken on March 1st 2007 looking toward the northeast across the berm and beachface. The dry beach is 1,200 feet wide between here and the seaward toe of the dunes. The net gain for the study interval was 16.05 yds<sup>3</sup>/ft. and a 54-foot shoreline retreat as the beach grew steeper.

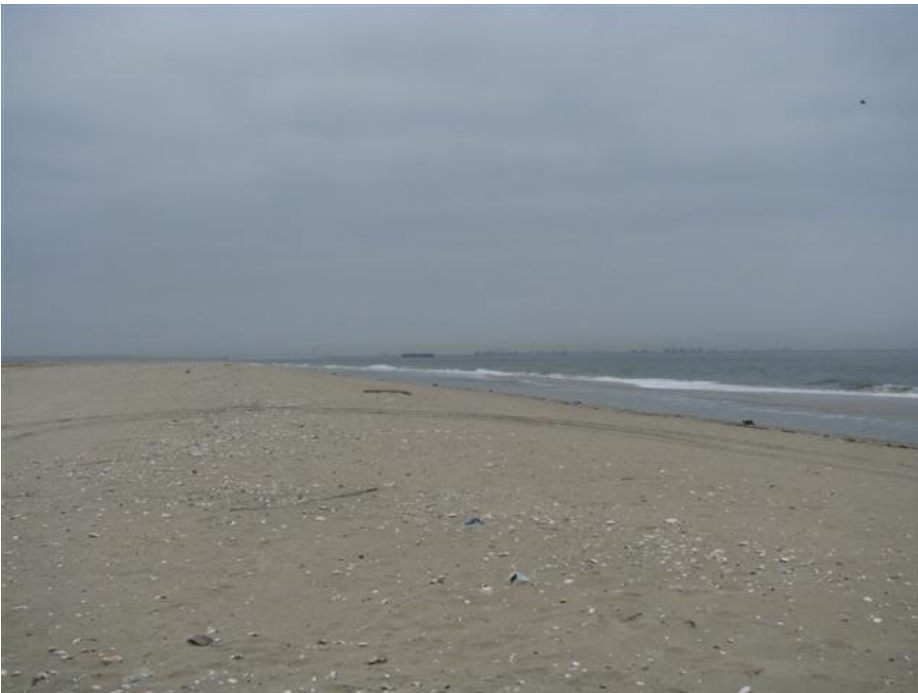
This November 3rd 2008 view shows the same shoreface with a bit more sand distributed across the dry upper beach and a higher berm elevation. The material is being carried from the ACOE project extending south into Sea Bright. This spit growth inside the National Seashore will continue until all the millions of cubic yards of sand pumped onto the beach between the park entrance and Long Branch are moved north to this shoreline.

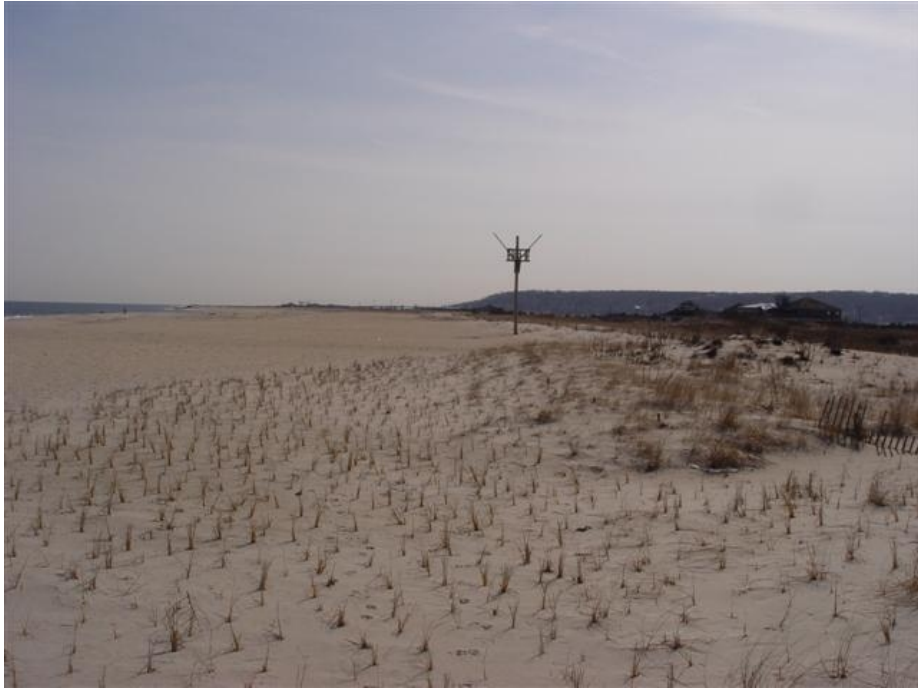
# SANDY HOOK NATIONAL SEASHORE, PARKING LOT E - SITE 284

March 1st 2007 looking south along the toe of the dunes at the major bathing beach parking area about a mile north of the entrance to Sandy Hook National Seashore.

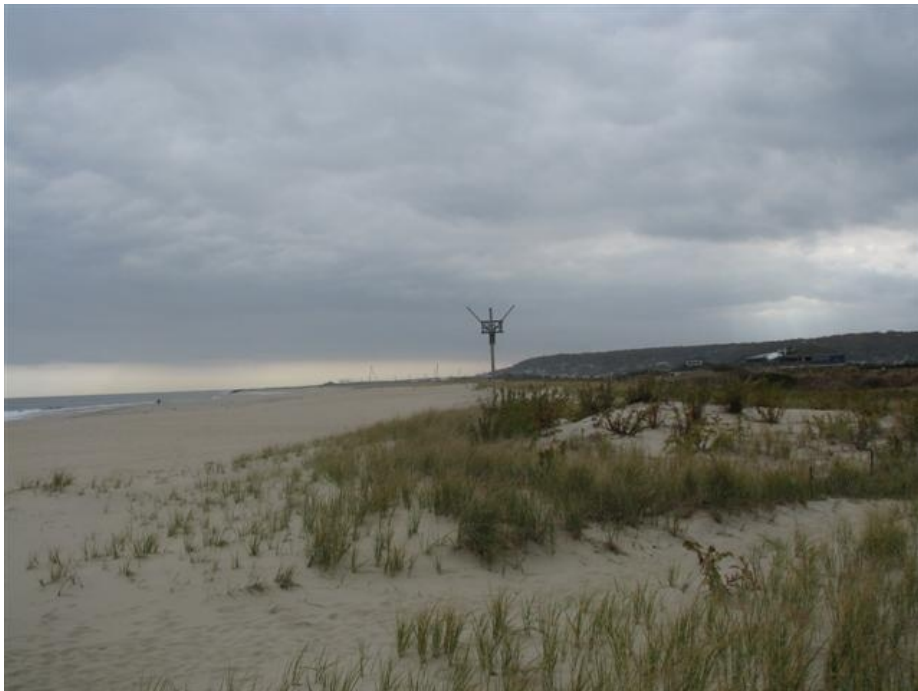
By November 3rd 2008 expansion of the grass plants had covered the foredune with new growth. The beach was 19 feet wider and 19.78 yds<sup>3</sup>/ft. of new sand had been added to the surveyed cross section. Loss to the south in Sea Bright contributed to these gains seen in the Sandy Hook park.

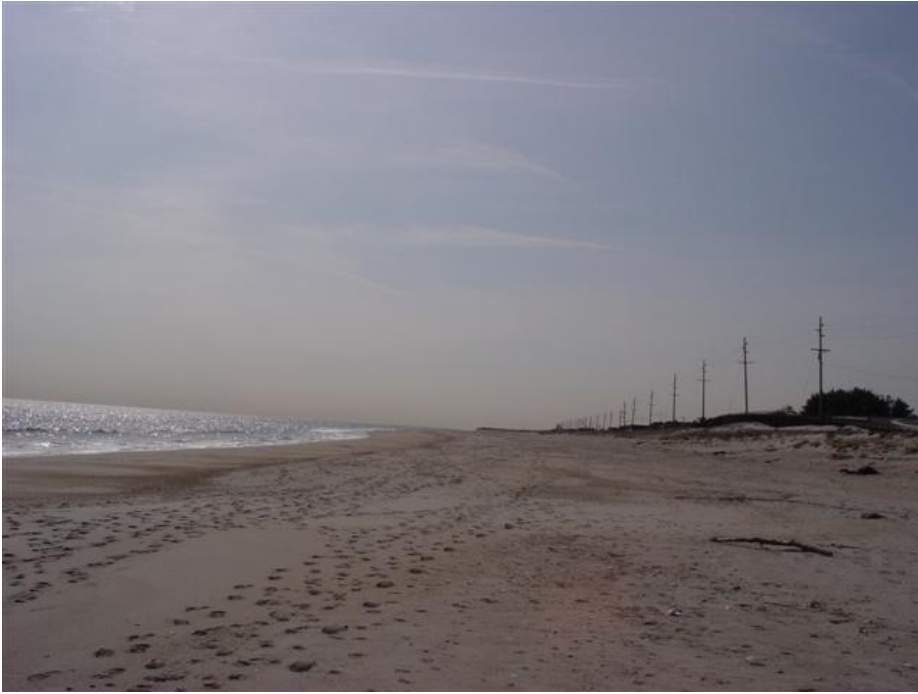
## SANDY HOOK, HIGHLANDS BEACH - SITE 184

At the north end of the Sea Bright sea wall the beach still looked pretty good with this view to the south on March 1st 2007. The berm and dry beach maintained a constant width with dune growth continuing.

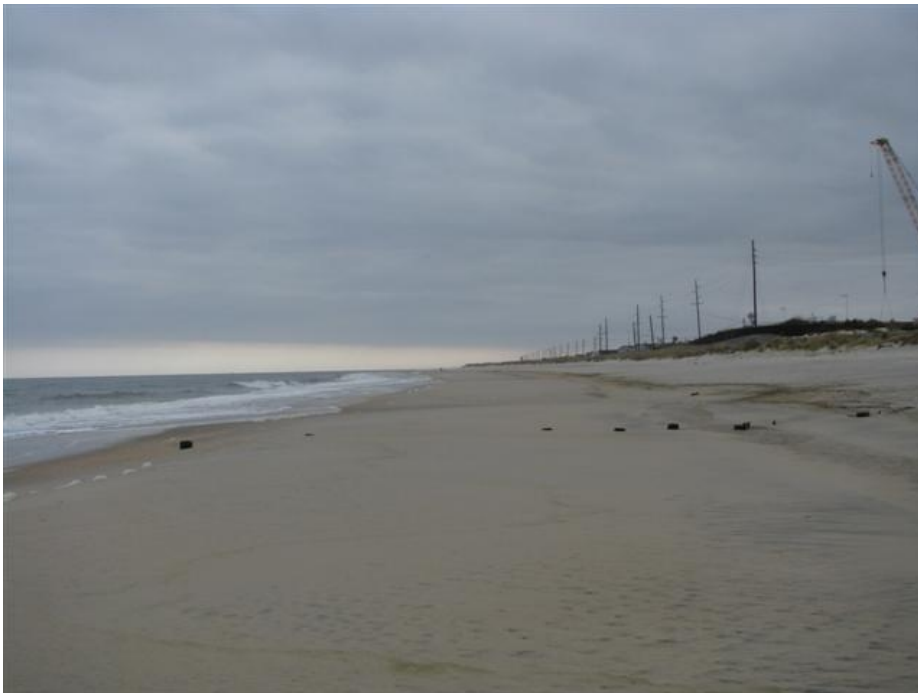
On November 3rd 2008 the beach had advanced 13 feet but the sand volume on the beach had declined by 9.11 yds<sup>3</sup>/ft. These changes were minimal because the site is transitional between Sandy Hook where the sand is depositing and further south where it is being removed for transport north.

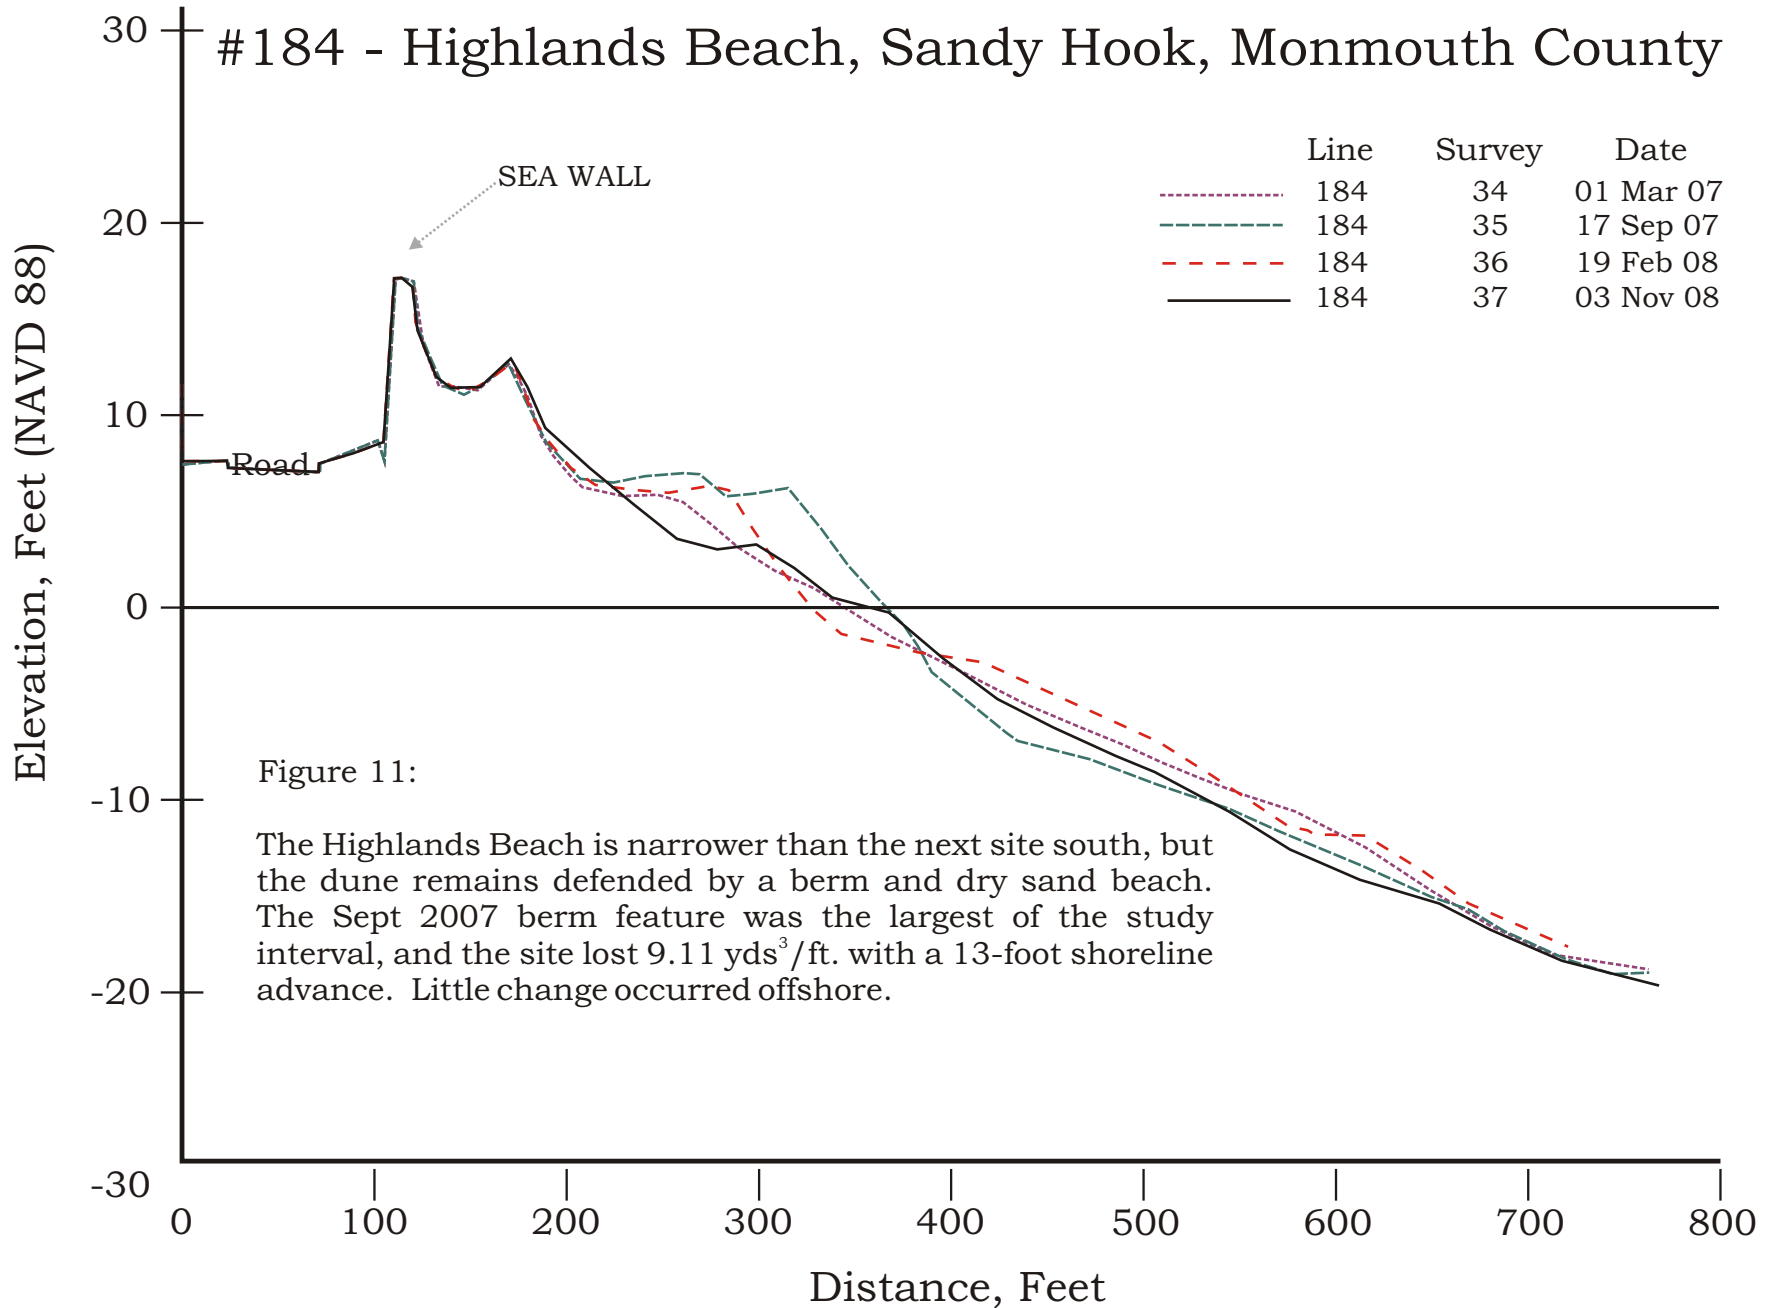
#184 - Highlands Beach, Sandy Hook, Monmouth County

The Highlands Beach is narrower than the next site south, but the dune remains defended by a berm and dry sand beach. The Sept 2007 berm feature was the largest of the study interval, and the site lost 9.11 yds<sup>3</sup>/ft. with a 13-foot shoreline advance. Little change occurred offshore.

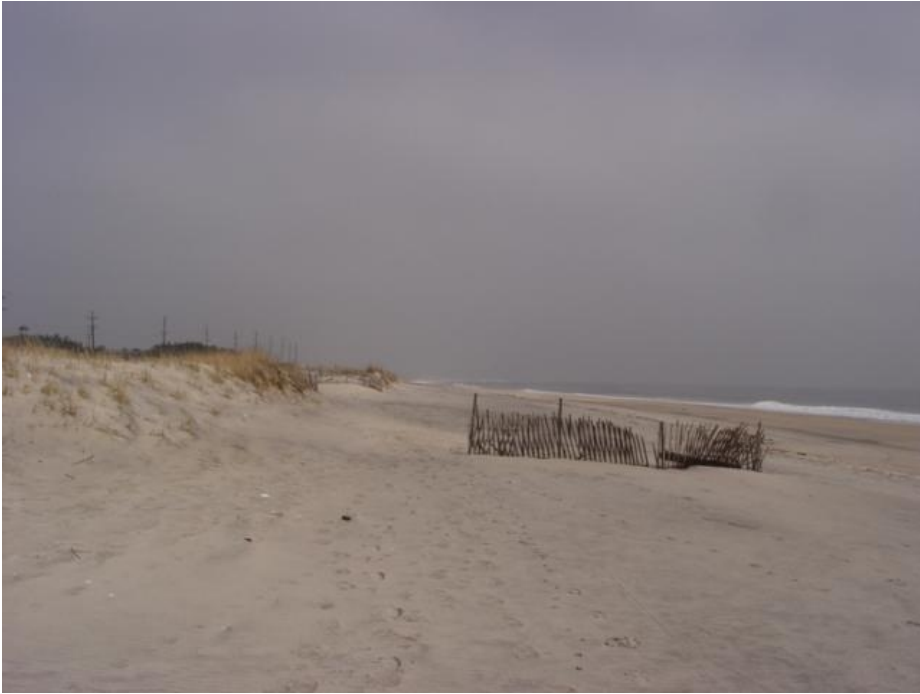
## VIA RIPA STREET, SEA BRIGHT - SITE 183

The Via Ripa Street site also has a nice dune system that has been growing naturally since 1998. The municipality provided a row or two of snow fencing following the completion of the beach fill and that has been all. Grass is now advancing nicely across the dunes and this shoreline is far different from the pre-fill version. The view to the left was taken April 3rd 2007.

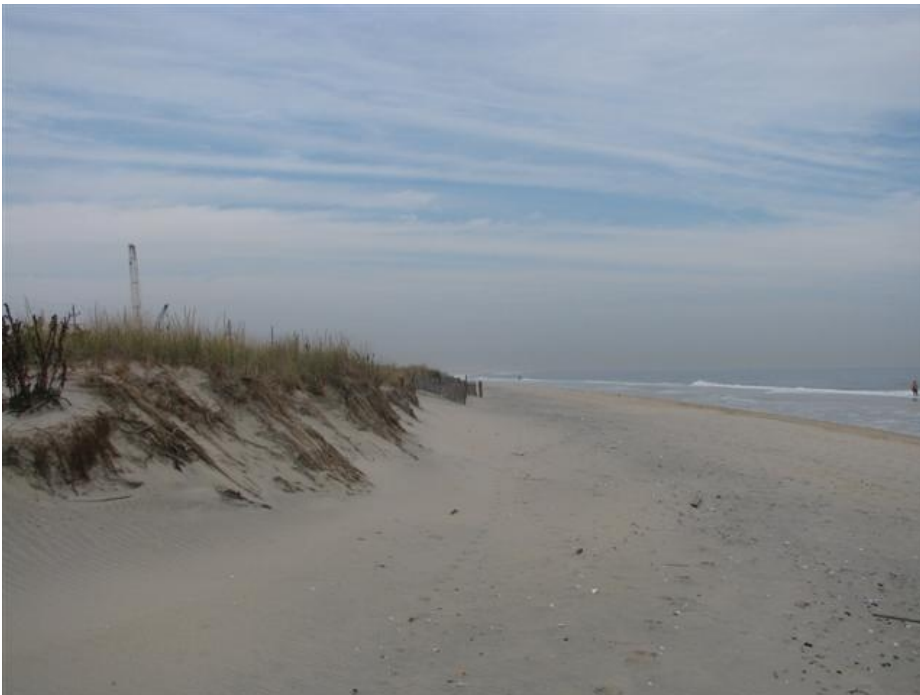
November 4th 2008 finds the beach 6 feet narrower to the zero elevation line with 16.12 fewer cubic yards of sand on each foot of the shore. This loss is insignificant, but the absence of strong northeast storms has helped preserve the stability of this shoreline.

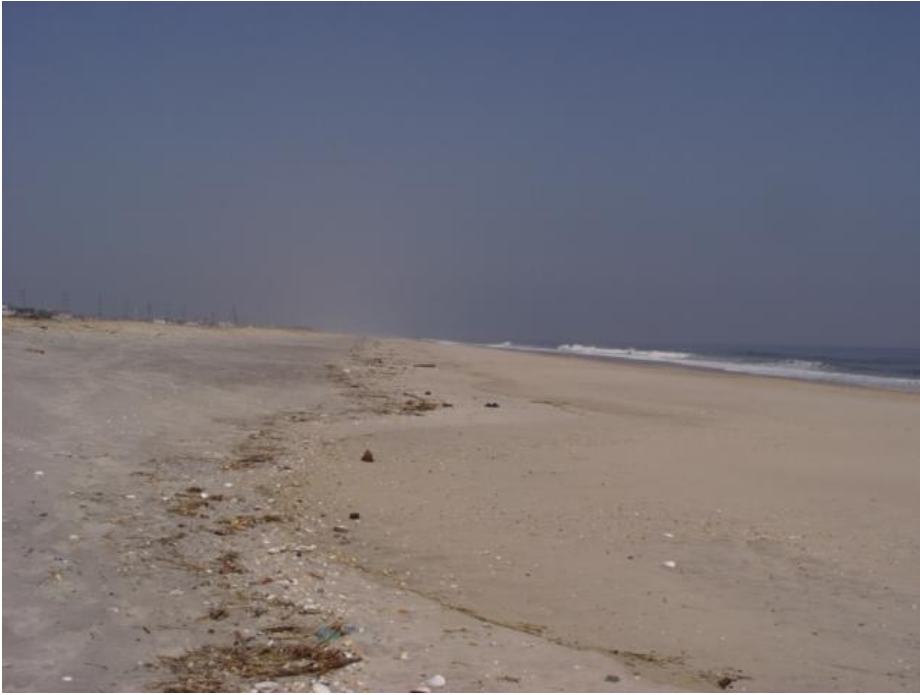
## SHREWSBURY WAY, SEA BRIGHT - SITE 282

This is a wider beach than the two sites to the north. The dune system is low, but wide and provides a distinct separation from the traffic on the other side of the sea wall. The view is from April 3rd 2007.

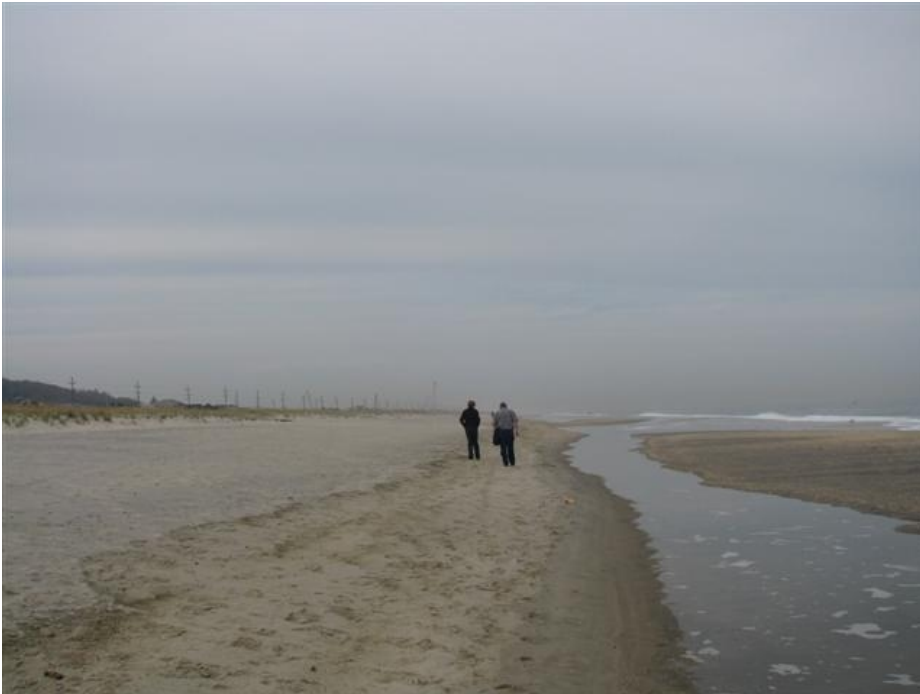
Eighteen months of change produced a net gain of 10.12 yds<sup>3</sup>/ft. and a 63-foot shoreline advance at this site. The view was taken November 4th 2008.

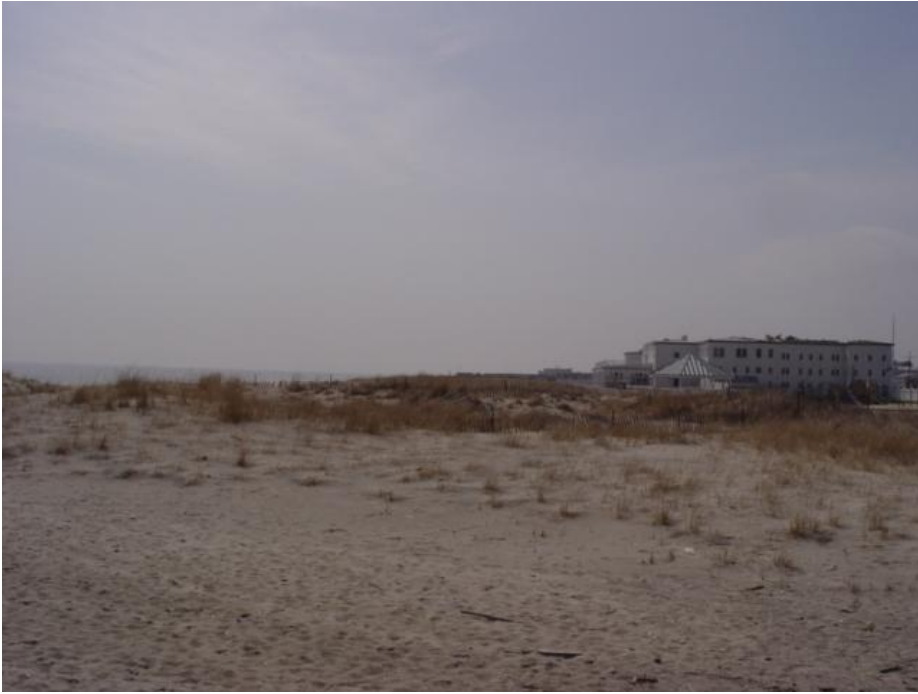
## PUBLIC BEACH, SEA BRIGHT - SITE 182

The beach was added to the public ownership listing about 20 years ago. The shortage of parking is the largest problem for extensive use. This view on April 3rd 2007 shows the dunes and the transition to a dry beach.

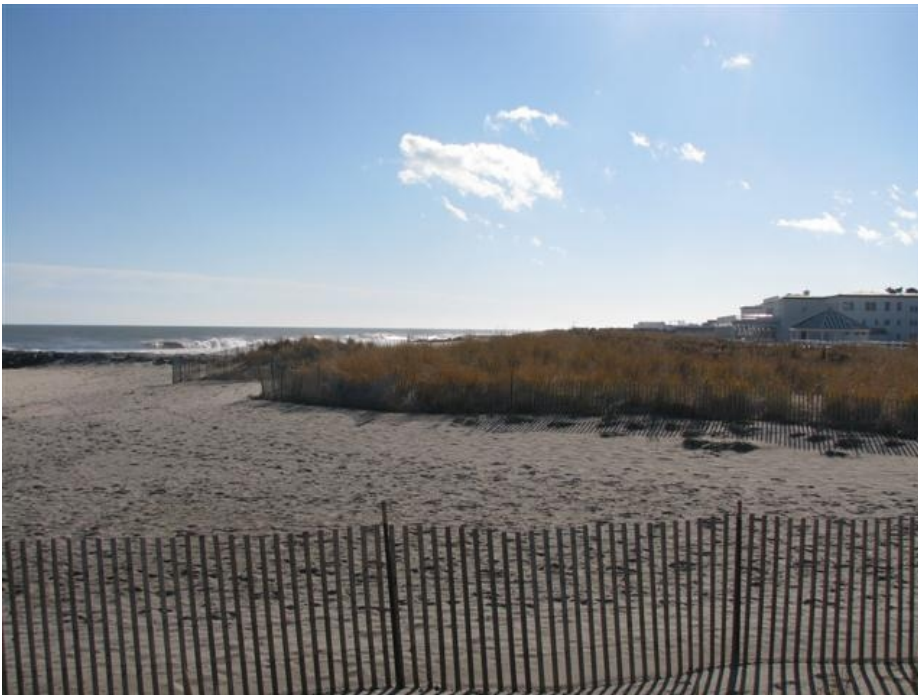
By December 1st 2008 the dune grass had been defined by fencing, but grass growth had filled in all bare spots on the dune. This site lost 22.72 yds<sup>3</sup>/ft. and the shoreline retreated 70 feet. This retreat was oriented toward the fall of 2008 because there was a 4-foot advance in shoreline position by spring 2008.
