# New Jersey Beach Profile Network

## Monmouth County

Raritan Bay and Sandy Hook  
to Manasquan Inlet

**NJBPN Profile #'s  
187 - 256**

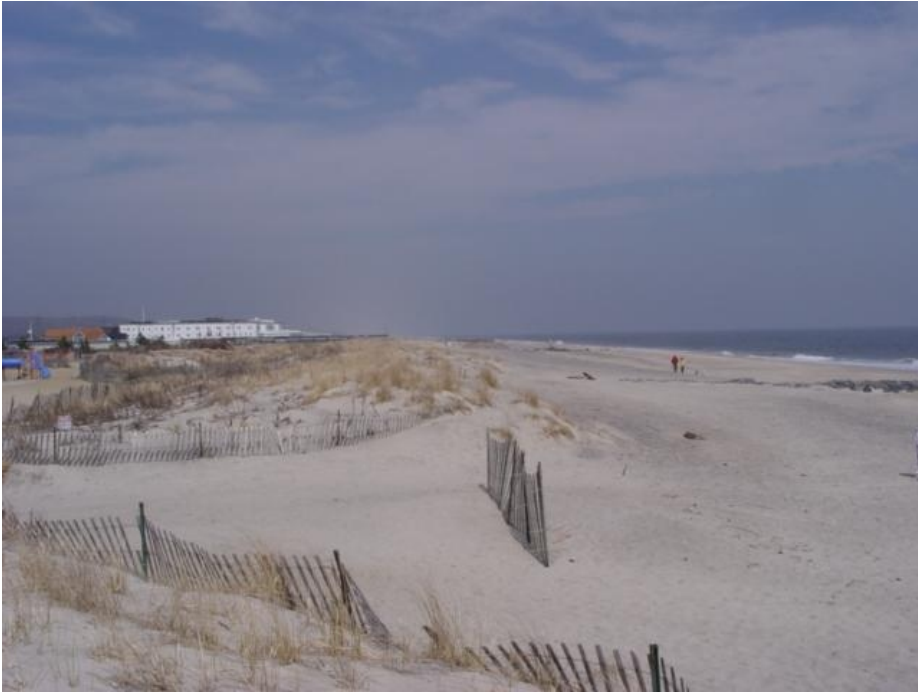
## MUNICIPAL BEACH, SEA BRIGHT - SITE 181

The municipal beach has heavy use each summer, but still supports a dune system developed to each side of the central pathway to the water's edge and lower dry beach where the blankets are spread out. This view on April 3, 2007 looks to the north toward the dune section on the north side of this beach. Note the sand elevation on the far side of the groin.

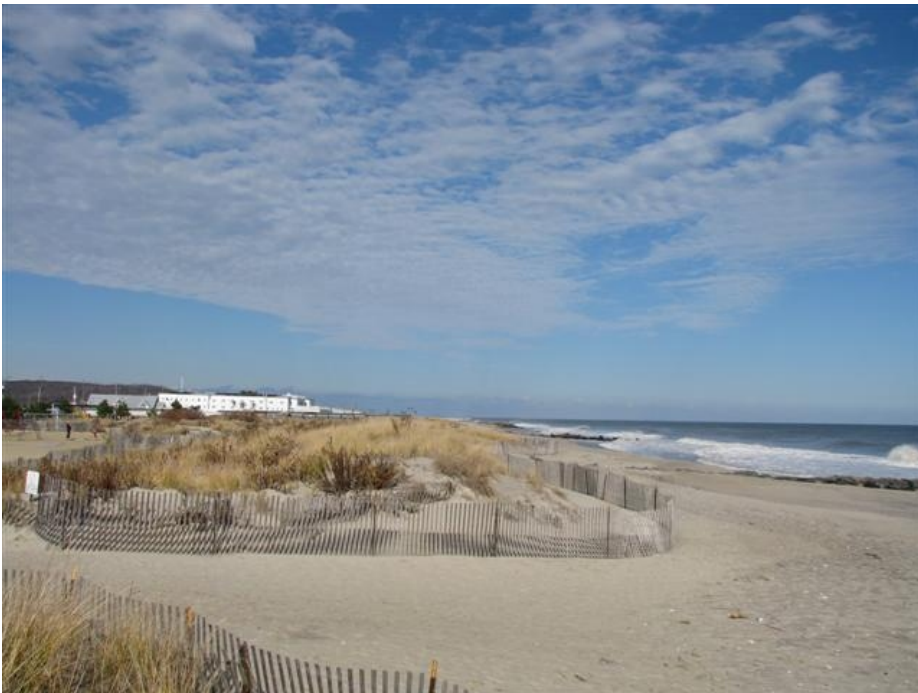
Eighteen months later on December 1, 2008 the dune had another row of fencing around it and the grass had matured considerably. The sand elevation on the far side of the groin in the distance had dropped considerably as evidenced by the white water showing where the picture above shows dry sand. The net change at this site was a sand volume loss of 25.05 yds<sup>3</sup>/ft. with a 44-foot shoreline retreat.

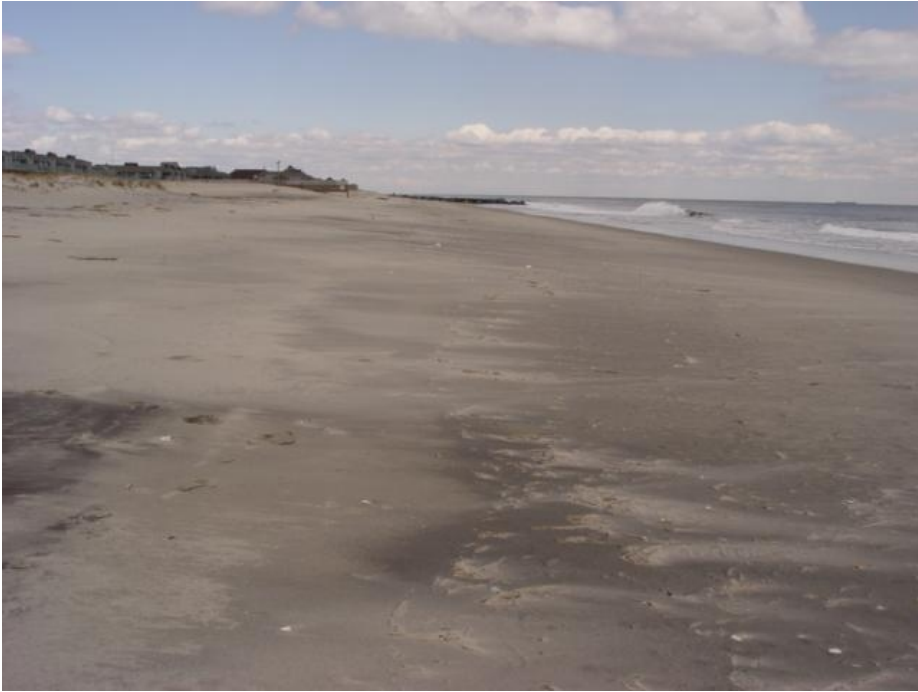
## SUNSET COURT, SEA BRIGHT - SITE 180

Moving into south Sea Bright, the beach appears to slope upward to the toe of the dune on April 5, 2007.

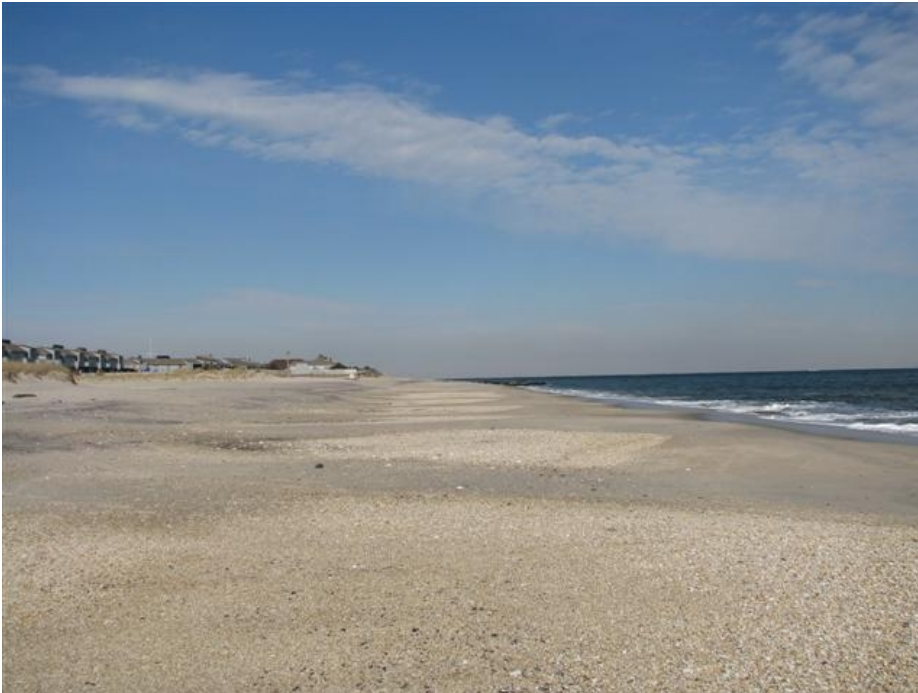
On November 21, 2008 the dunes are still doing well and the beach appears to be flatter and wider, but that is not the case. The shoreline retreated 10 feet while the sand volume declined by 42.13 yds<sup>3</sup>/ft. These beaches in the south are the source for material being transported north during episodes when the southeast wave climate dominates the littoral system. The past 24 months have been deficient in northeast storms with an impact showing in the pattern of deposition and erosion along the Monmouth County shoreline.

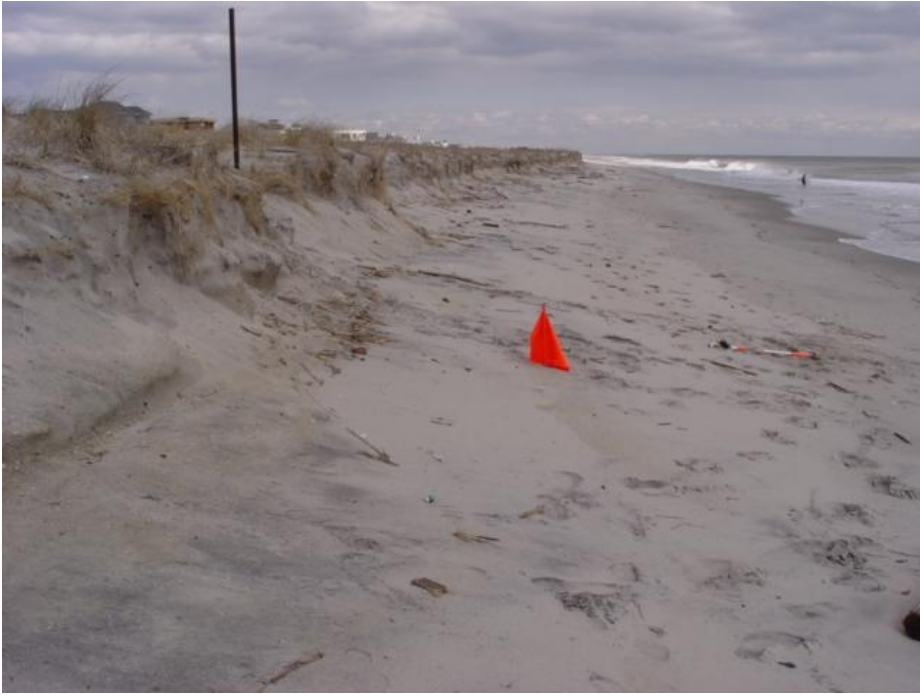
## COTTAGE ROAD, MONMOUTH BEACH - SITE 179

Cottage Road is the southern source area for sand when littoral currents are moving north toward Sandy Hook. This April 5, 2007 view shows a scarp in the dune toe and a narrow beach stretching to the north. The losses were just beginning at the end of 2006 and became considerably worse as the year moved along into 2008.

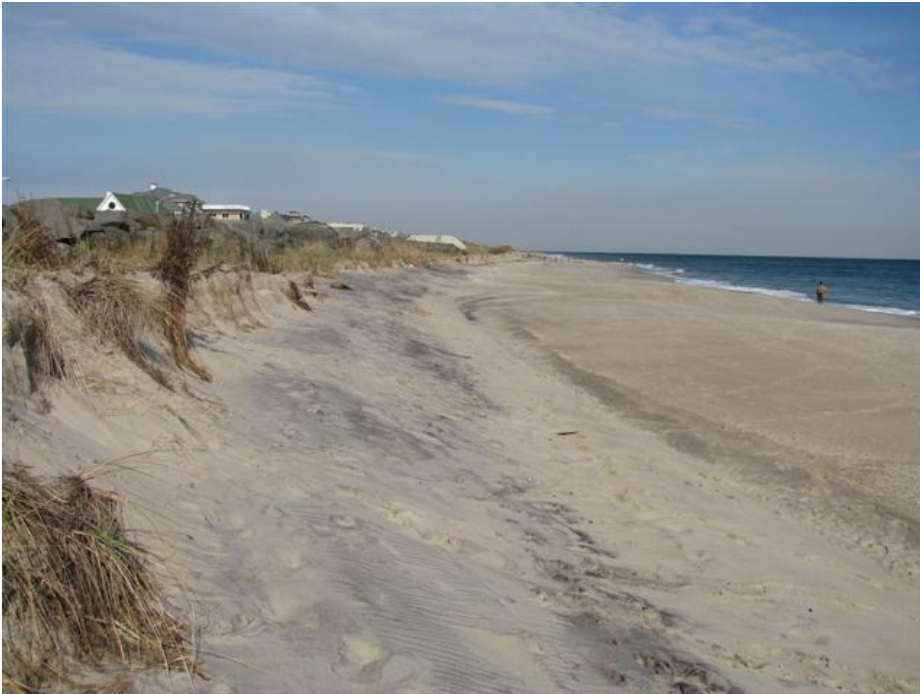
By November 21, 2008 the erosion had pushed the dune back to within 30 feet of the rock sea wall. The loss in just the dune was -2.90; -26.51; and -10.05 yds<sup>3</sup>/ft. at each of the six-month intervals between April 2007 and November 2008. The same interval total sand volume change was -40.46; -30.33; and -28.52 yds<sup>3</sup>/ft. for a total sand volume loss of 98.66 yds<sup>3</sup>/ft. Shoreline retreat was -7-feet; -47-feet; and +28-feet each interval. The last advance in shoreline was related to the flattening of the profile slope.

The last northeast storm was May 12, 2008, the fourth in a short series of mild storms that started in early April. There have been few instances with winds in excess of 20 MPH since 2005, so the balance of transport has shifted to sand movement from south to north, but the blocker is the groin system originally built to protect the Monmouth Beach Club from northeast storms prior to the beach fill. Today, little sand from the south can come around these structures, leaving site #179 as the source.

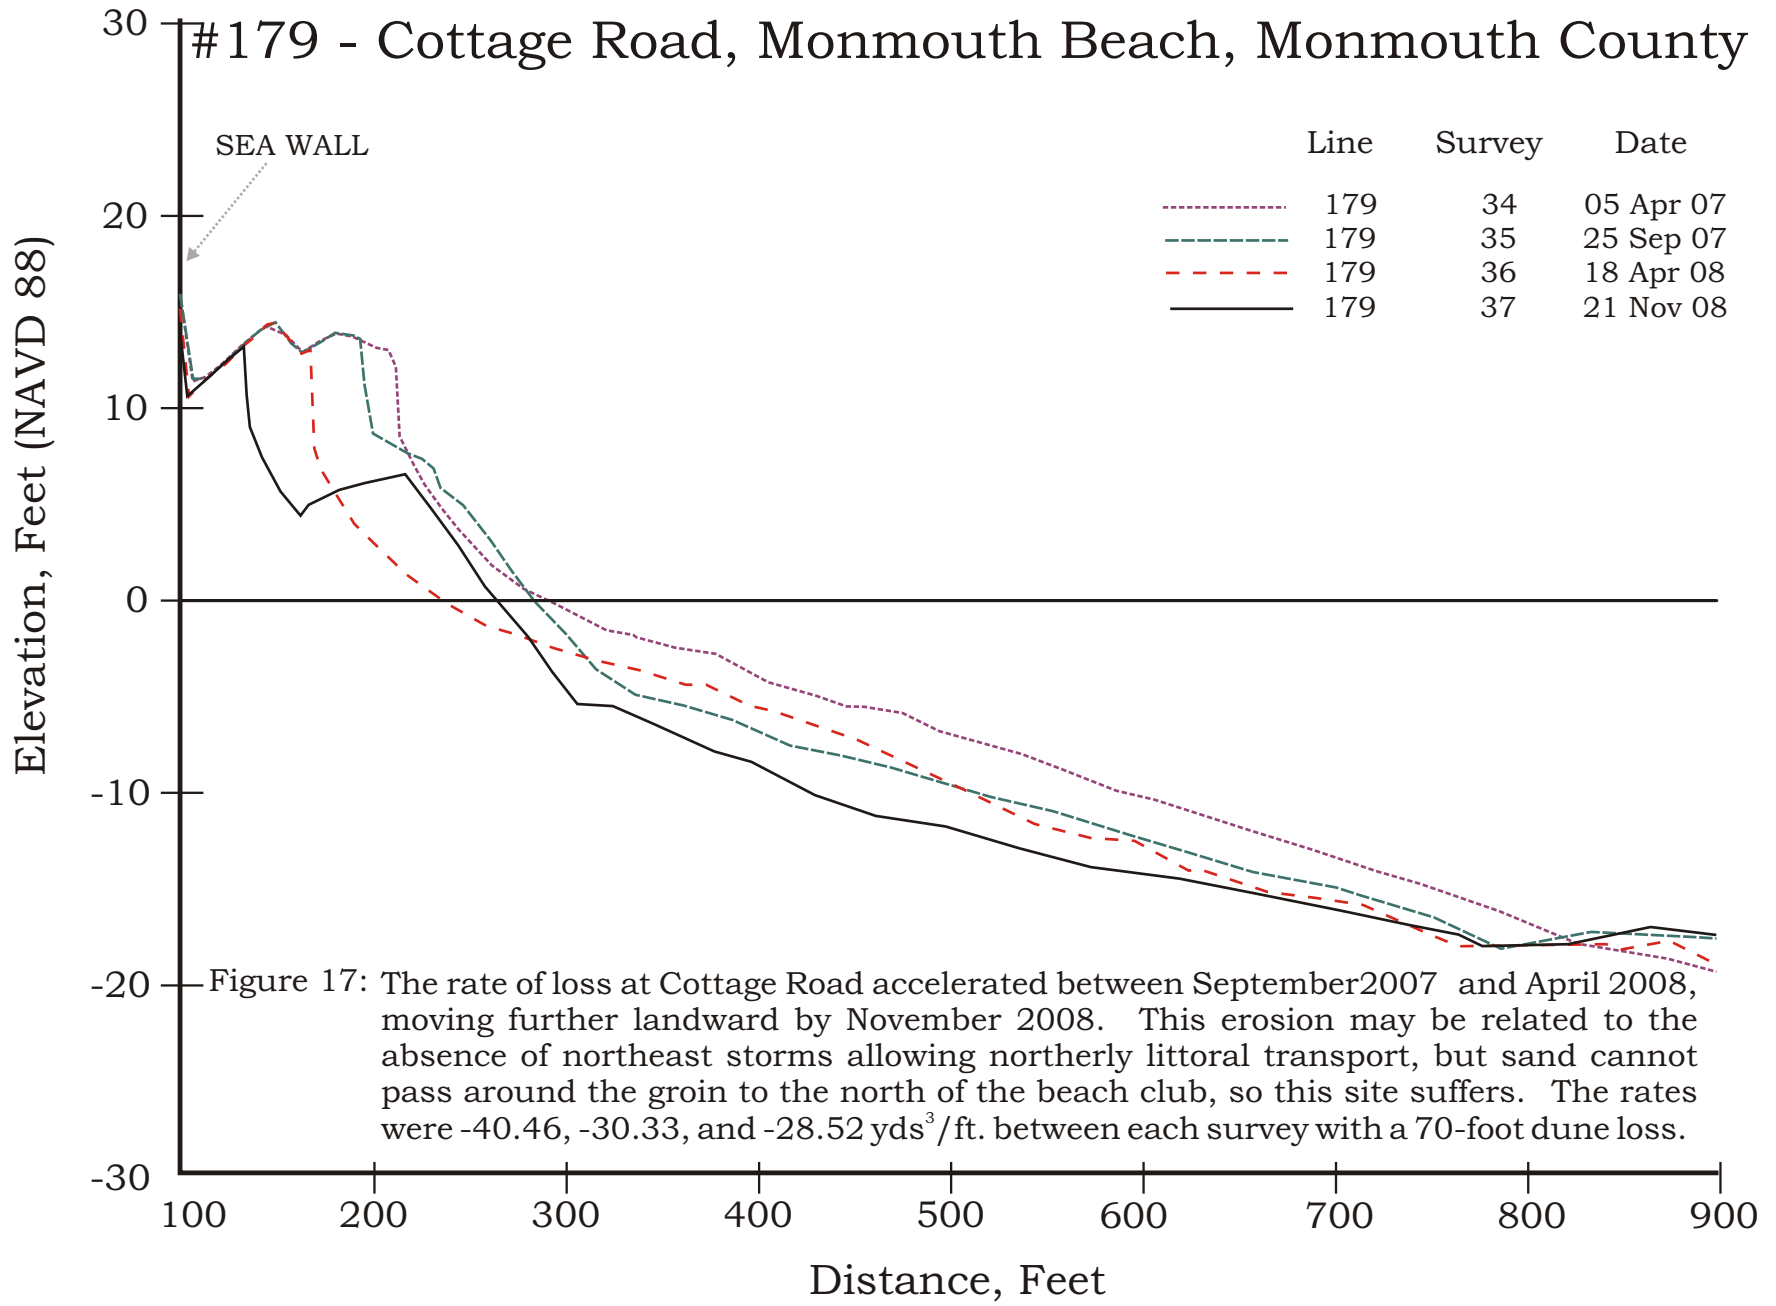
#179 - Cottage Road, Monmouth Beach, Monmouth County

Figure 17: The rate of loss at Cottage Road accelerated between September 2007 and April 2008, moving further landward by November 2008. This erosion may be related to the absence of northeast storms allowing northerly littoral transport, but sand cannot pass around the groin to the north of the beach club, so this site suffers. The rates were -40.46, -30.33, and -28.52 yds<sup>3</sup>/ft. between each survey with a 70-foot dune loss.

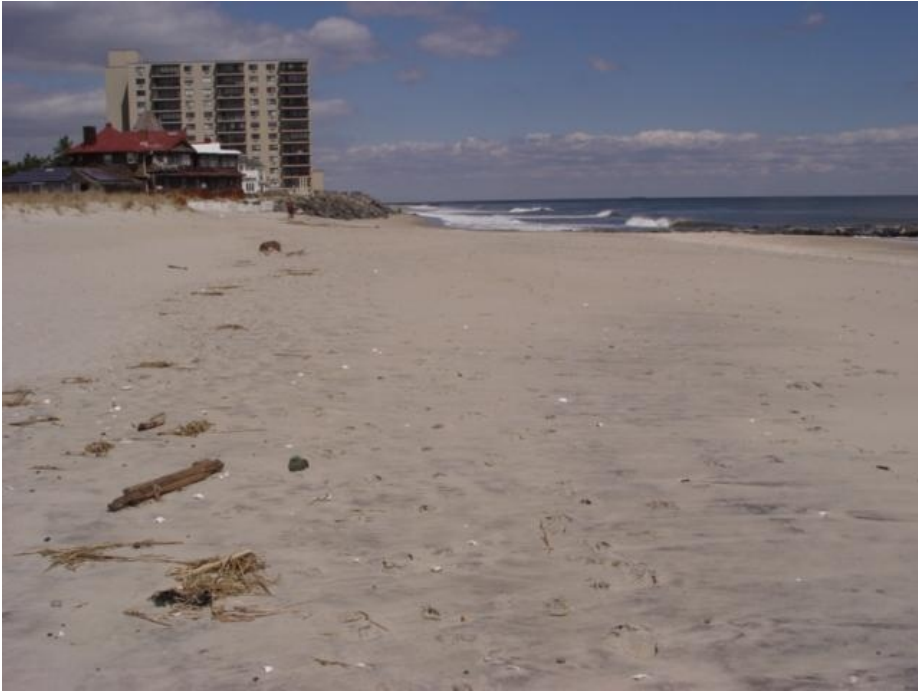
## MONMOUTH BEACH CLUB, MONMOUTH BEACH - SITE 178

The Monmouth Beach Club shoreline lies south of the big groin complex just south of Cottage Road. Here the beach gained sand between April 5, 2007 and November 20, 2008 (0.55 yds<sup>3</sup>/ft. with a 5-foot shoreline advance). While not terribly significant in terms of sand volume increases, this gain would indicate that something is radically different from conditions experienced about 5,000 feet north at Cottage Road.

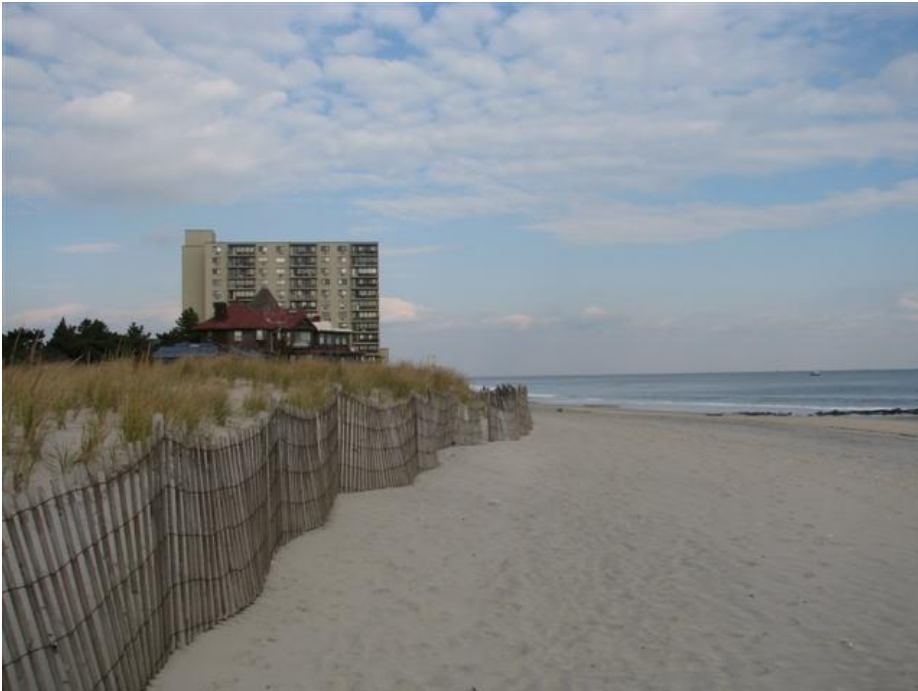
By November 20, 2008 the dune was re-fenced and the beach lost a 5.21 yds<sup>3</sup>/ft. sand volume from the berm to the offshore regions. The net change was very small, but still positive. Sand transport around the Monmouth Beach Club area has been continuously difficult since the ACOE project was built.

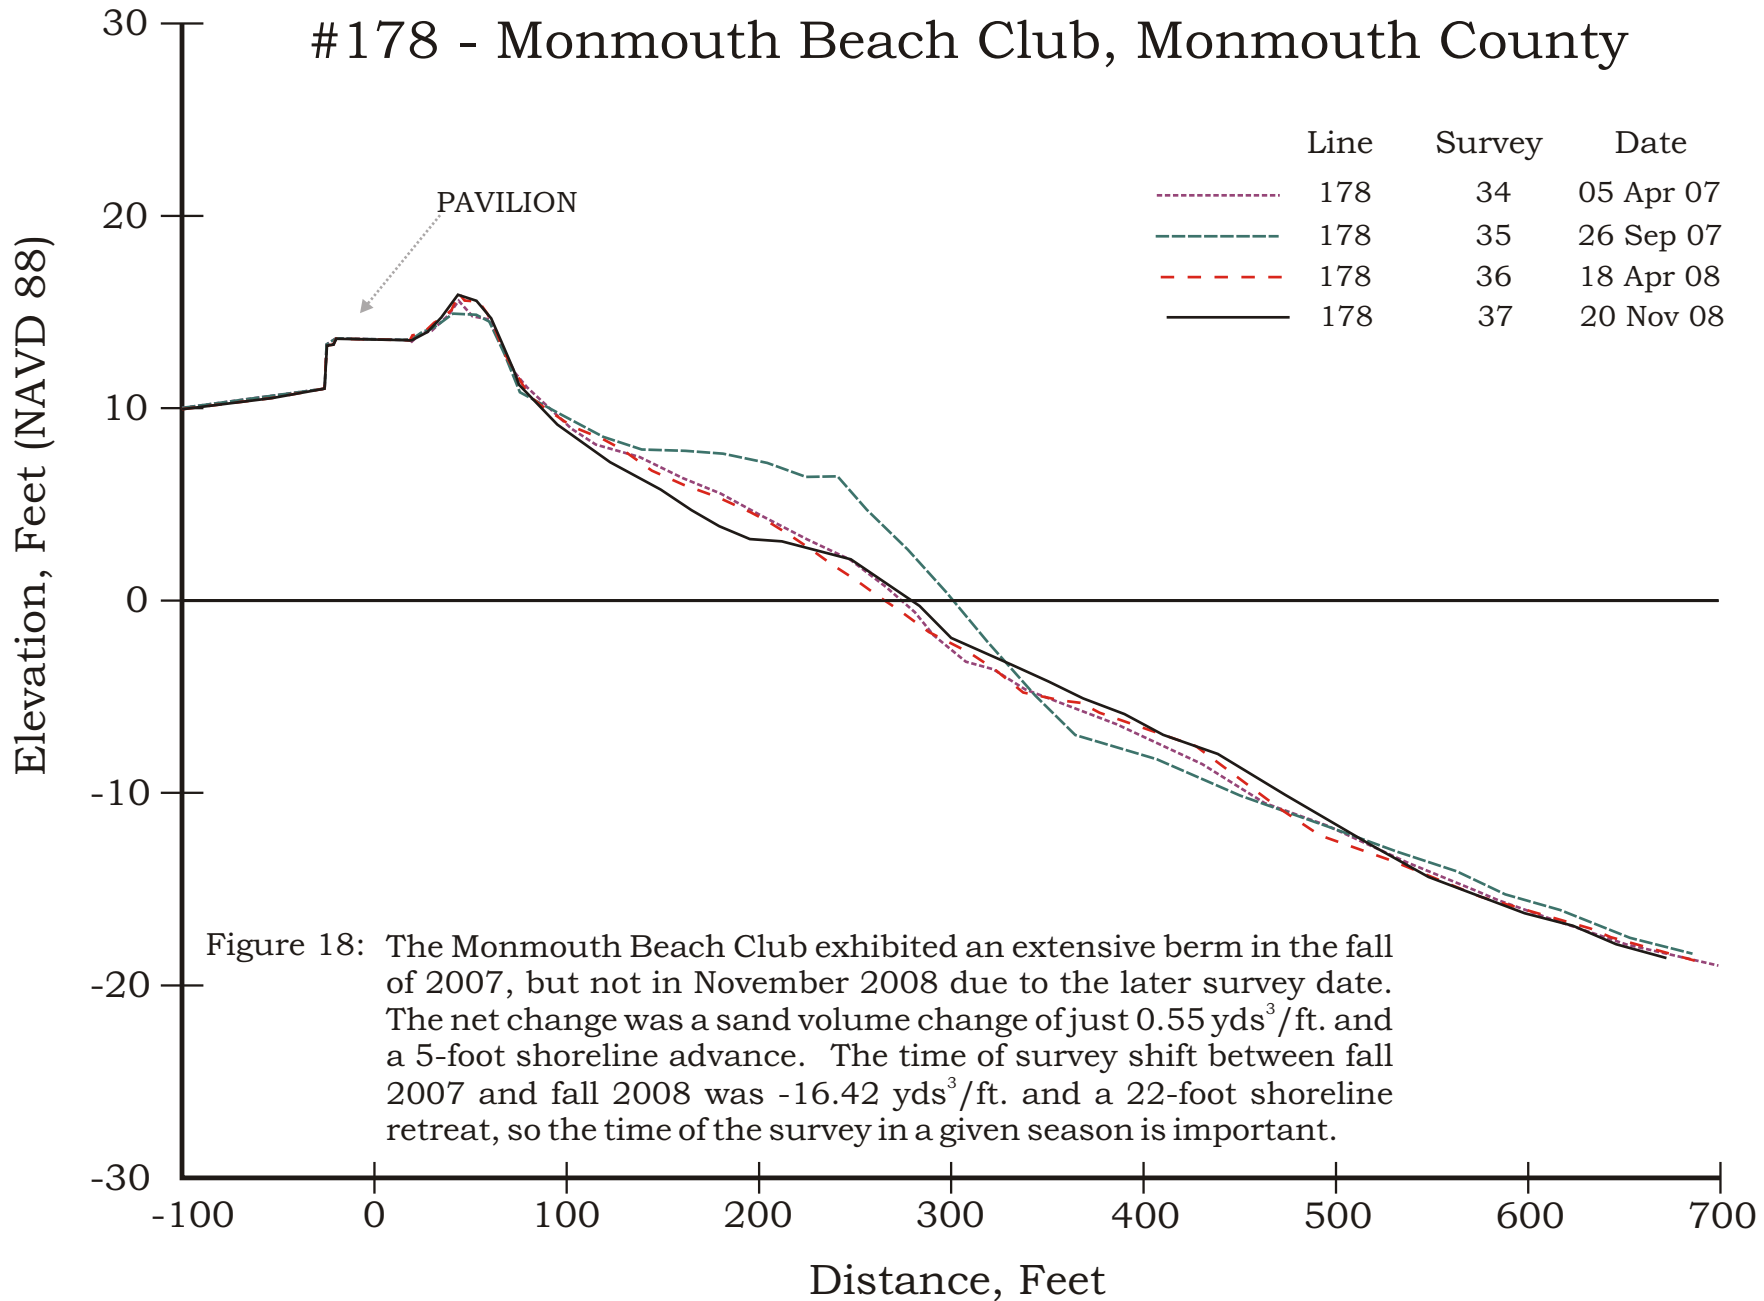
## #178 - Monmouth Beach Club, Monmouth County

Figure 18: The Monmouth Beach Club exhibited an extensive berm in the fall of 2007, but not in November 2008 due to the later survey date. The net change was a sand volume change of just 0.55 yds<sup>3</sup>/ft. and a 5-foot shoreline advance. The time of survey shift between fall 2007 and fall 2008 was -16.42 yds<sup>3</sup>/ft. and a 22-foot shoreline retreat, so the time of the survey in a given season is important.

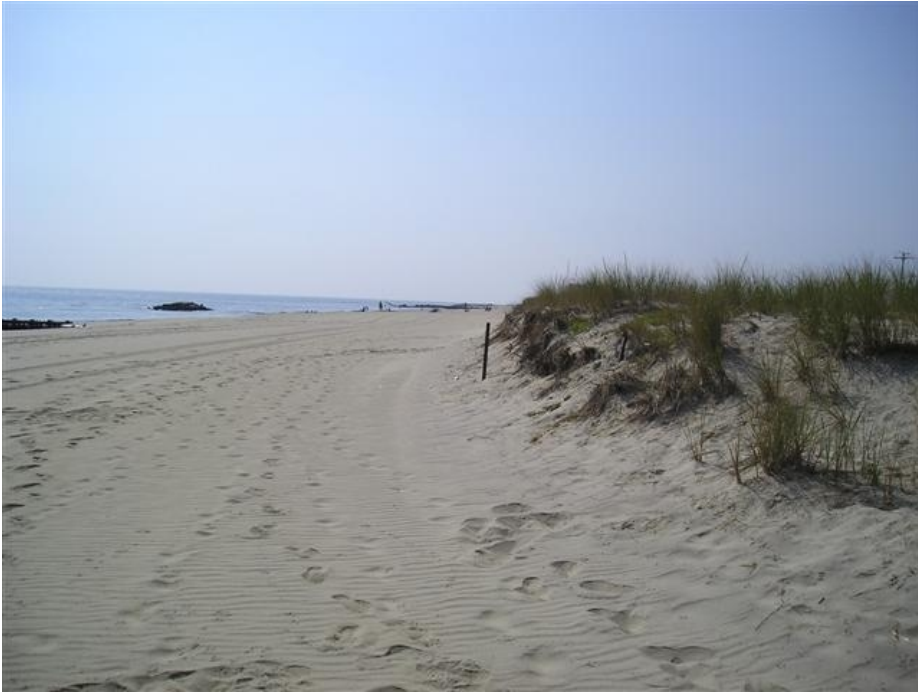
## 404 OCEAN AVENUE, LONG BRANCH - SITE 177

Relative stability has prevailed at site #177 since September 26, 2007. The beach and dune system are stable. Low recreational activity leaves the dune grass free to extend onto the beach, moving the dune seaward.

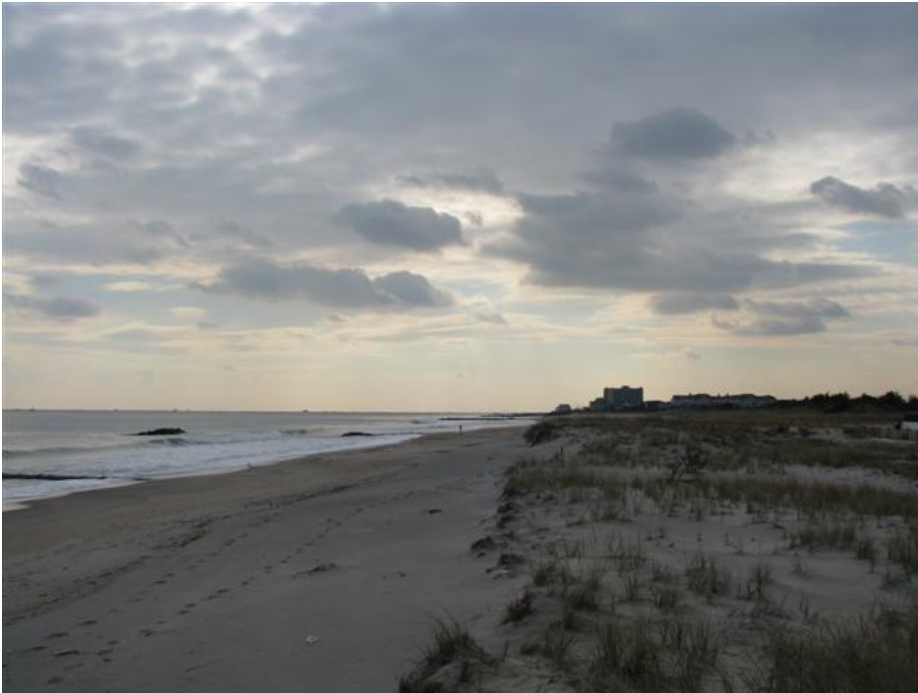
Changes up to November 20, 2008 resulted in a shoreline advance of less than a half foot, but a sand volume loss of 7.19 yds<sup>3</sup>/ft. made for a slight reduction in material. The site was essentially stable over this study interval.

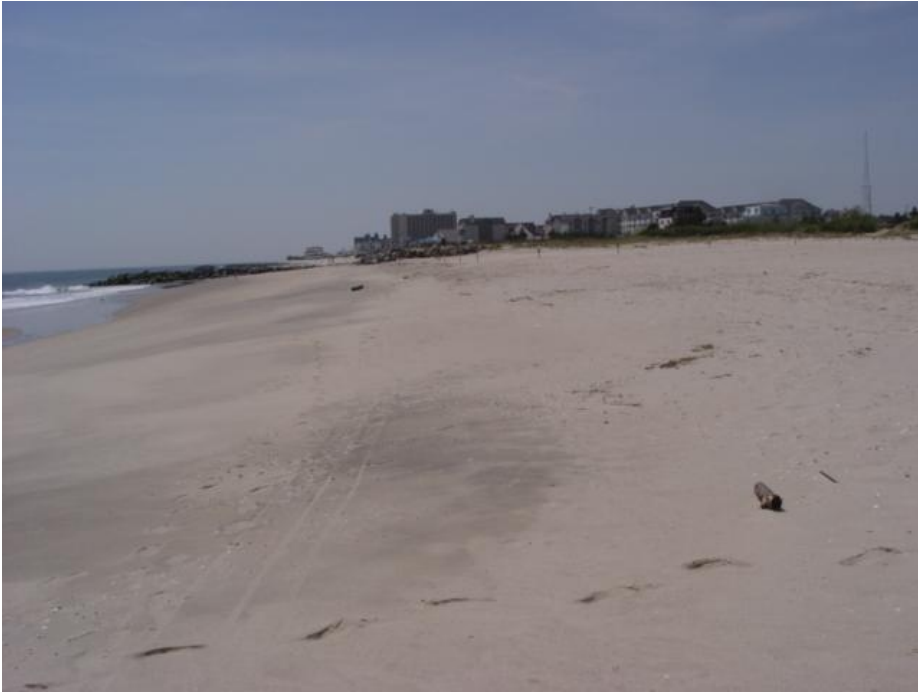
## SEVEN PRESIDENTS PARK, MONMOUTH BEACH - SITE 176

At the Seven Presidents Park the beach had a broad flat slope to the water from a narrow segment of flat dry beach. The dunes grew somewhat as well. This view was taken May 15, 2007.

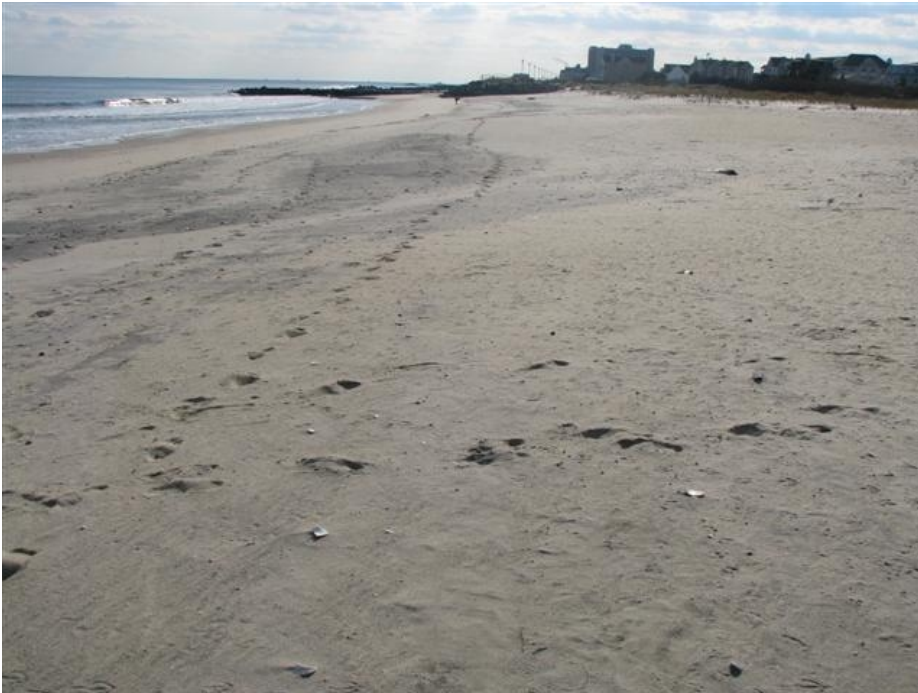
This November 17, 2008 view shows the same configuration after 18 months, but the beach was 14 feet narrower as the shoreline moved landward and 17.86 yds<sup>3</sup>/ft. of sand volume moved elsewhere. The rate of loss was relatively low.

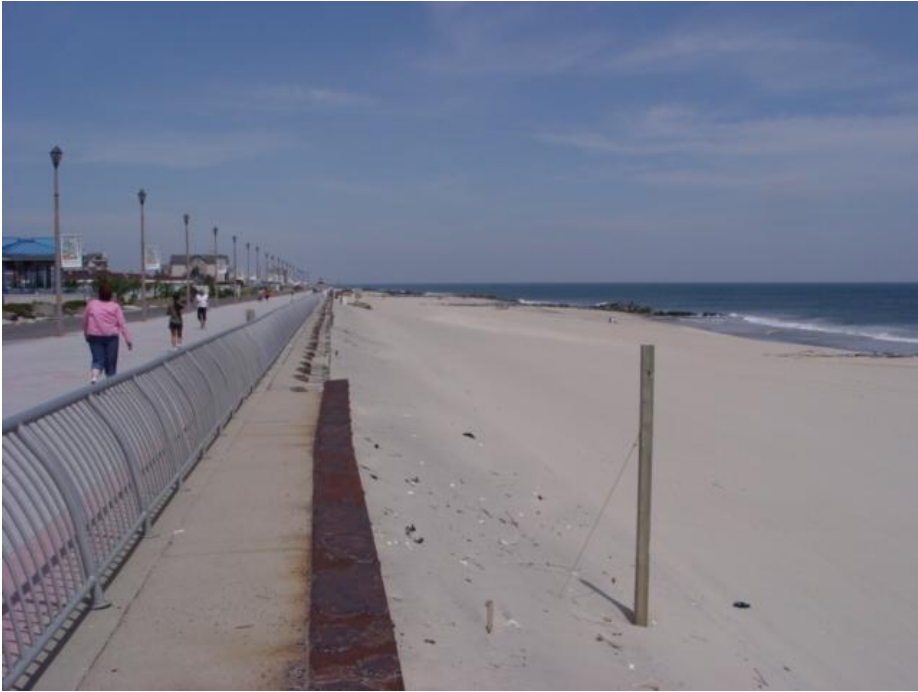
## BROADWAY AVENUE, LONG BRANCH - SITE 175

The old rusted steel showing in both photographs is the top of the 70-year old vertical steel bulkhead used to defend the uplands bluff. The view taken May 15, 2007 shows the sand ramped up to the top of the wall where it was once over 15 feet straight down to a tiny beach. No dunes ever developed at this site due to extensive recreational activity.

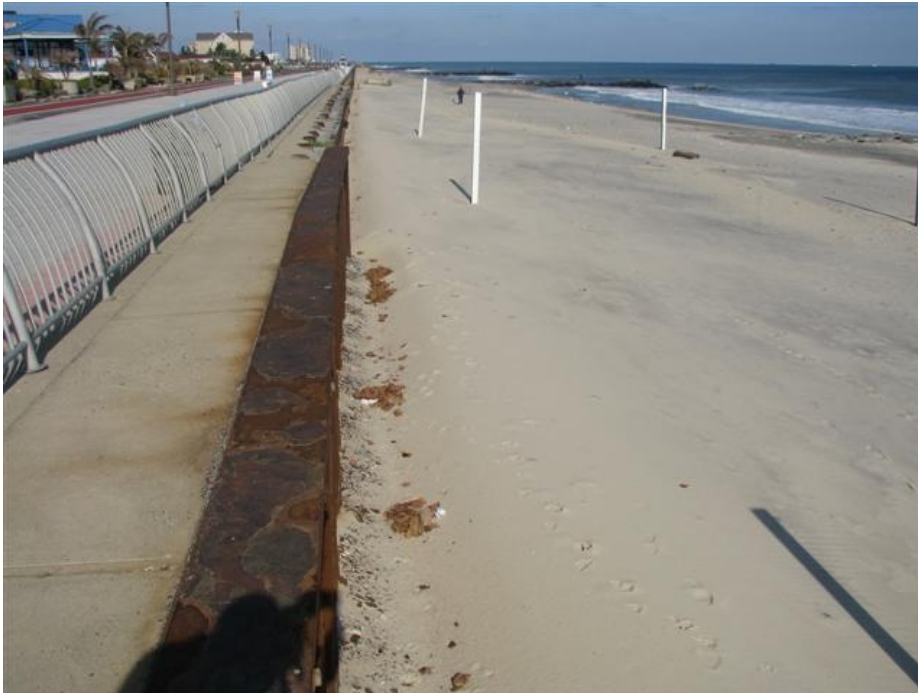
By November 17, 2008 the shoreline had advanced by 10 feet, but the sand volume had declined by 16.61 yds<sup>3</sup>/ft. This beach has narrowed since completed in 1997, but sand was placed to this point in 2009 as the ACOE performed a maintenance designed to offset the end effect losses from here south in Long Branch.

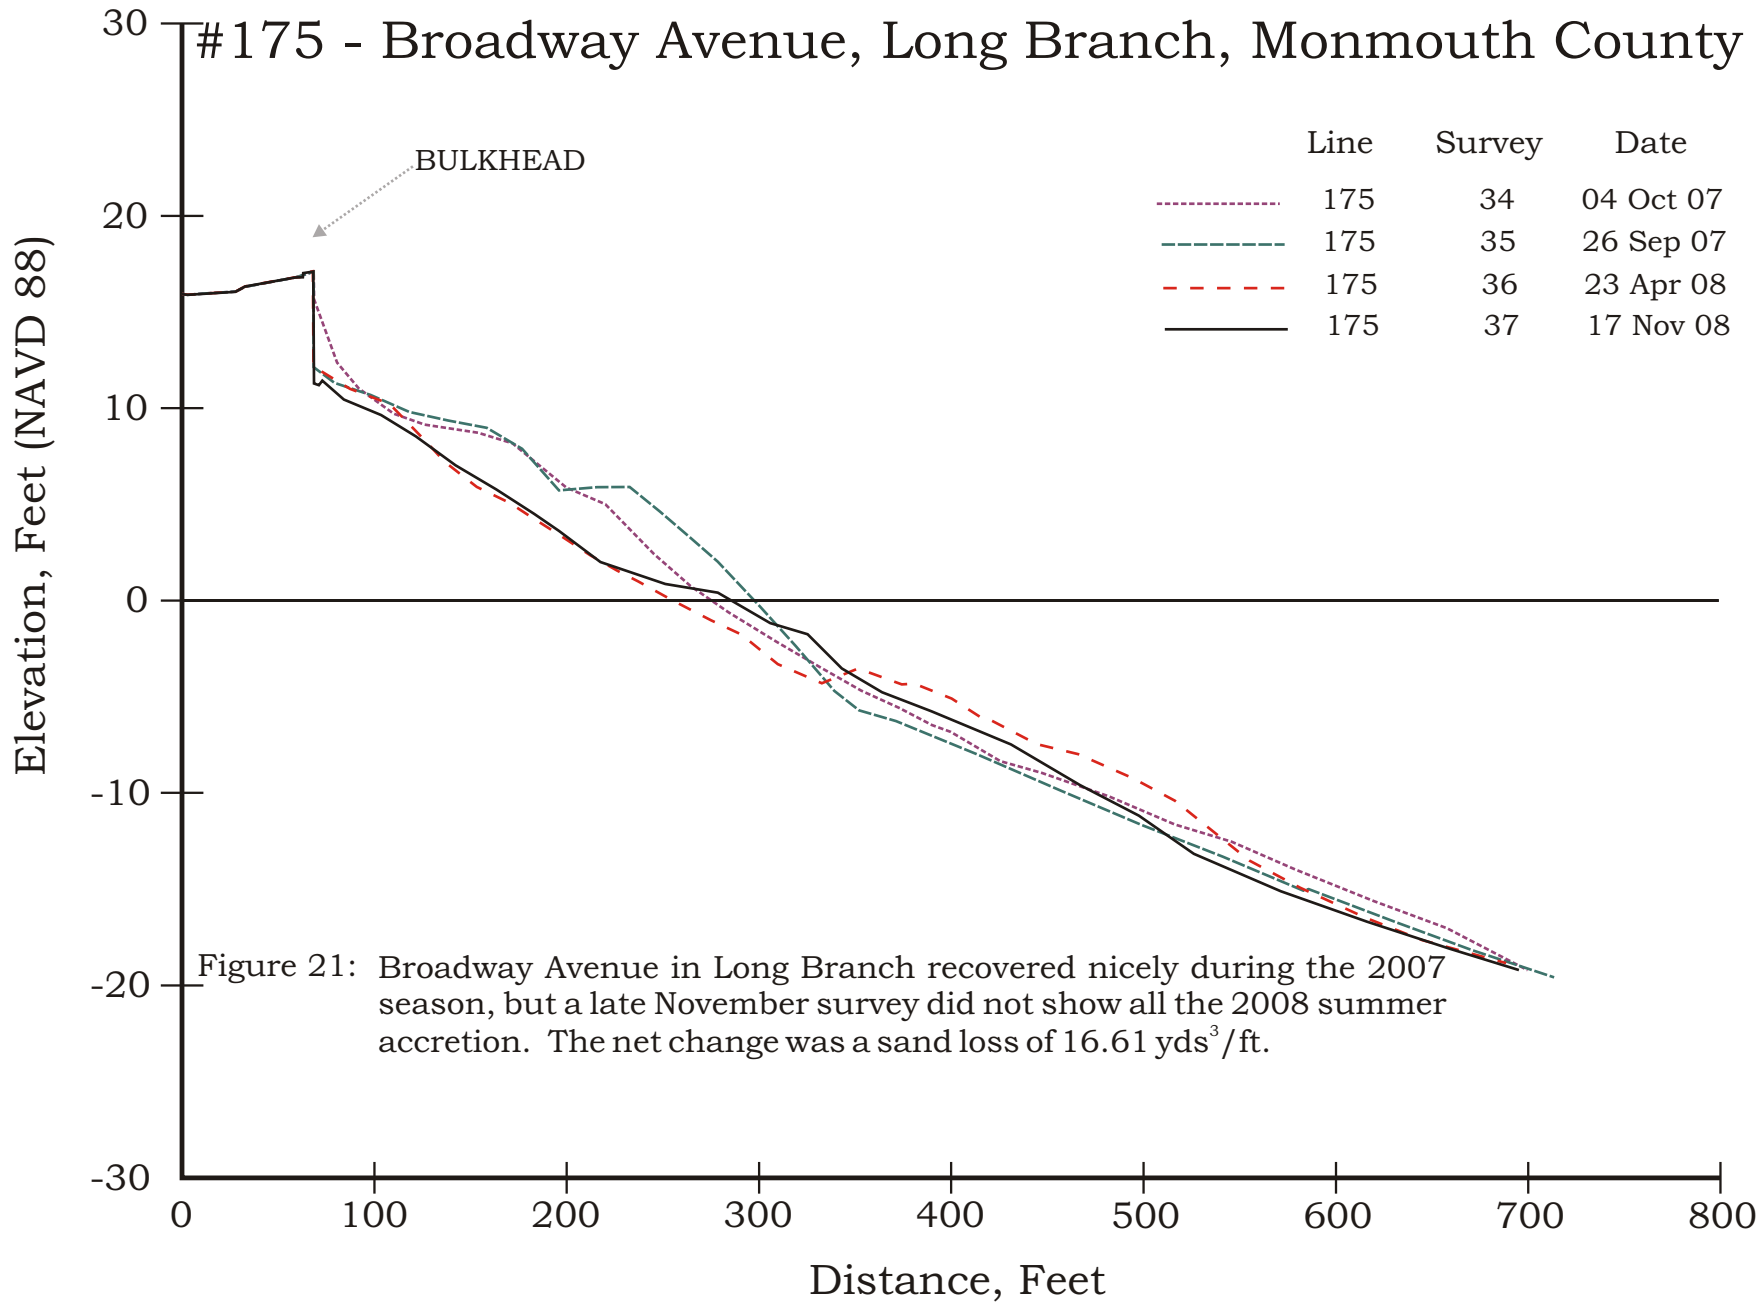
#175 - Broadway Avenue, Long Branch, Monmouth County

Figure 21: Broadway Avenue in Long Branch recovered nicely during the 2007 season, but a late November survey did not show all the 2008 summer accretion. The net change was a sand loss of 16.61 yds<sup>3</sup>/ft.

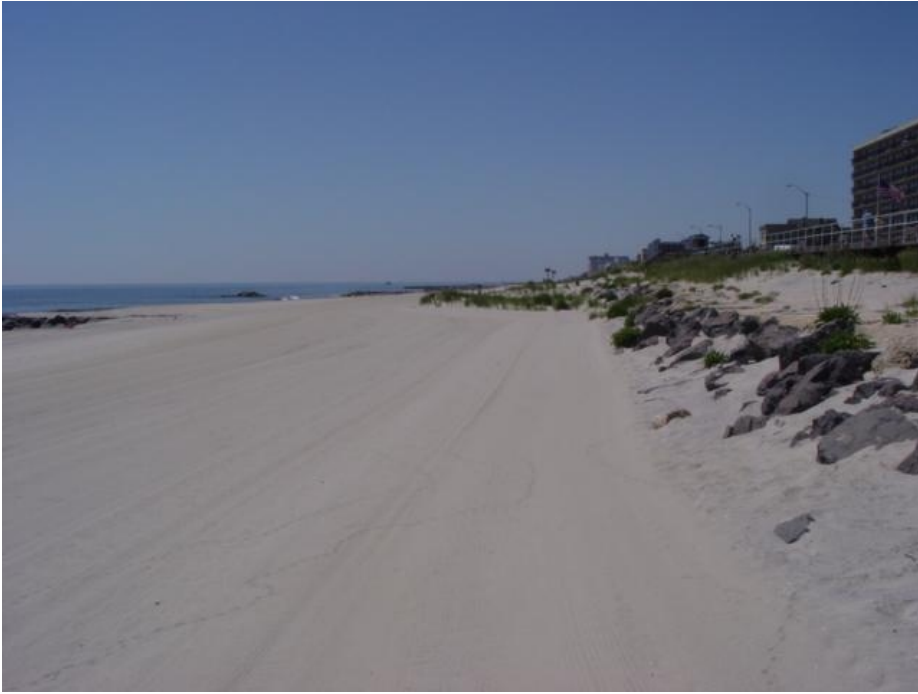
## MORRIS AVENUE, LONG BRANCH - SITE 174

This central area of the Long Branch municipal beach is defended by both groins and a rock sea wall at the bluff. Some retreat has occurred here since the artificial end of the project is but one additional survey site away to the south. This May 30, 2007 view shows the rocks and stray grass plants that have established up the slope toward the pedestrian walk.

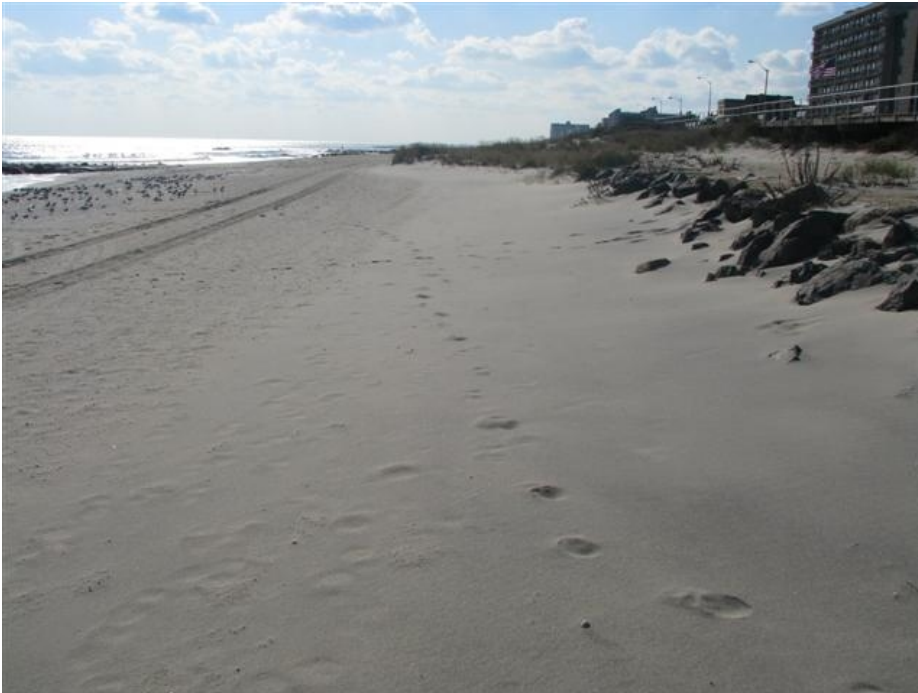
The November 17, 2008 view shows nearly a similar sight with a sand loss of 11.96 yds<sup>3</sup>/ft. and a 32-foot shoreline retreat. This area received sand in 2009 as the ACOE performed a maintenance on the southern end of the Long Branch beaches.

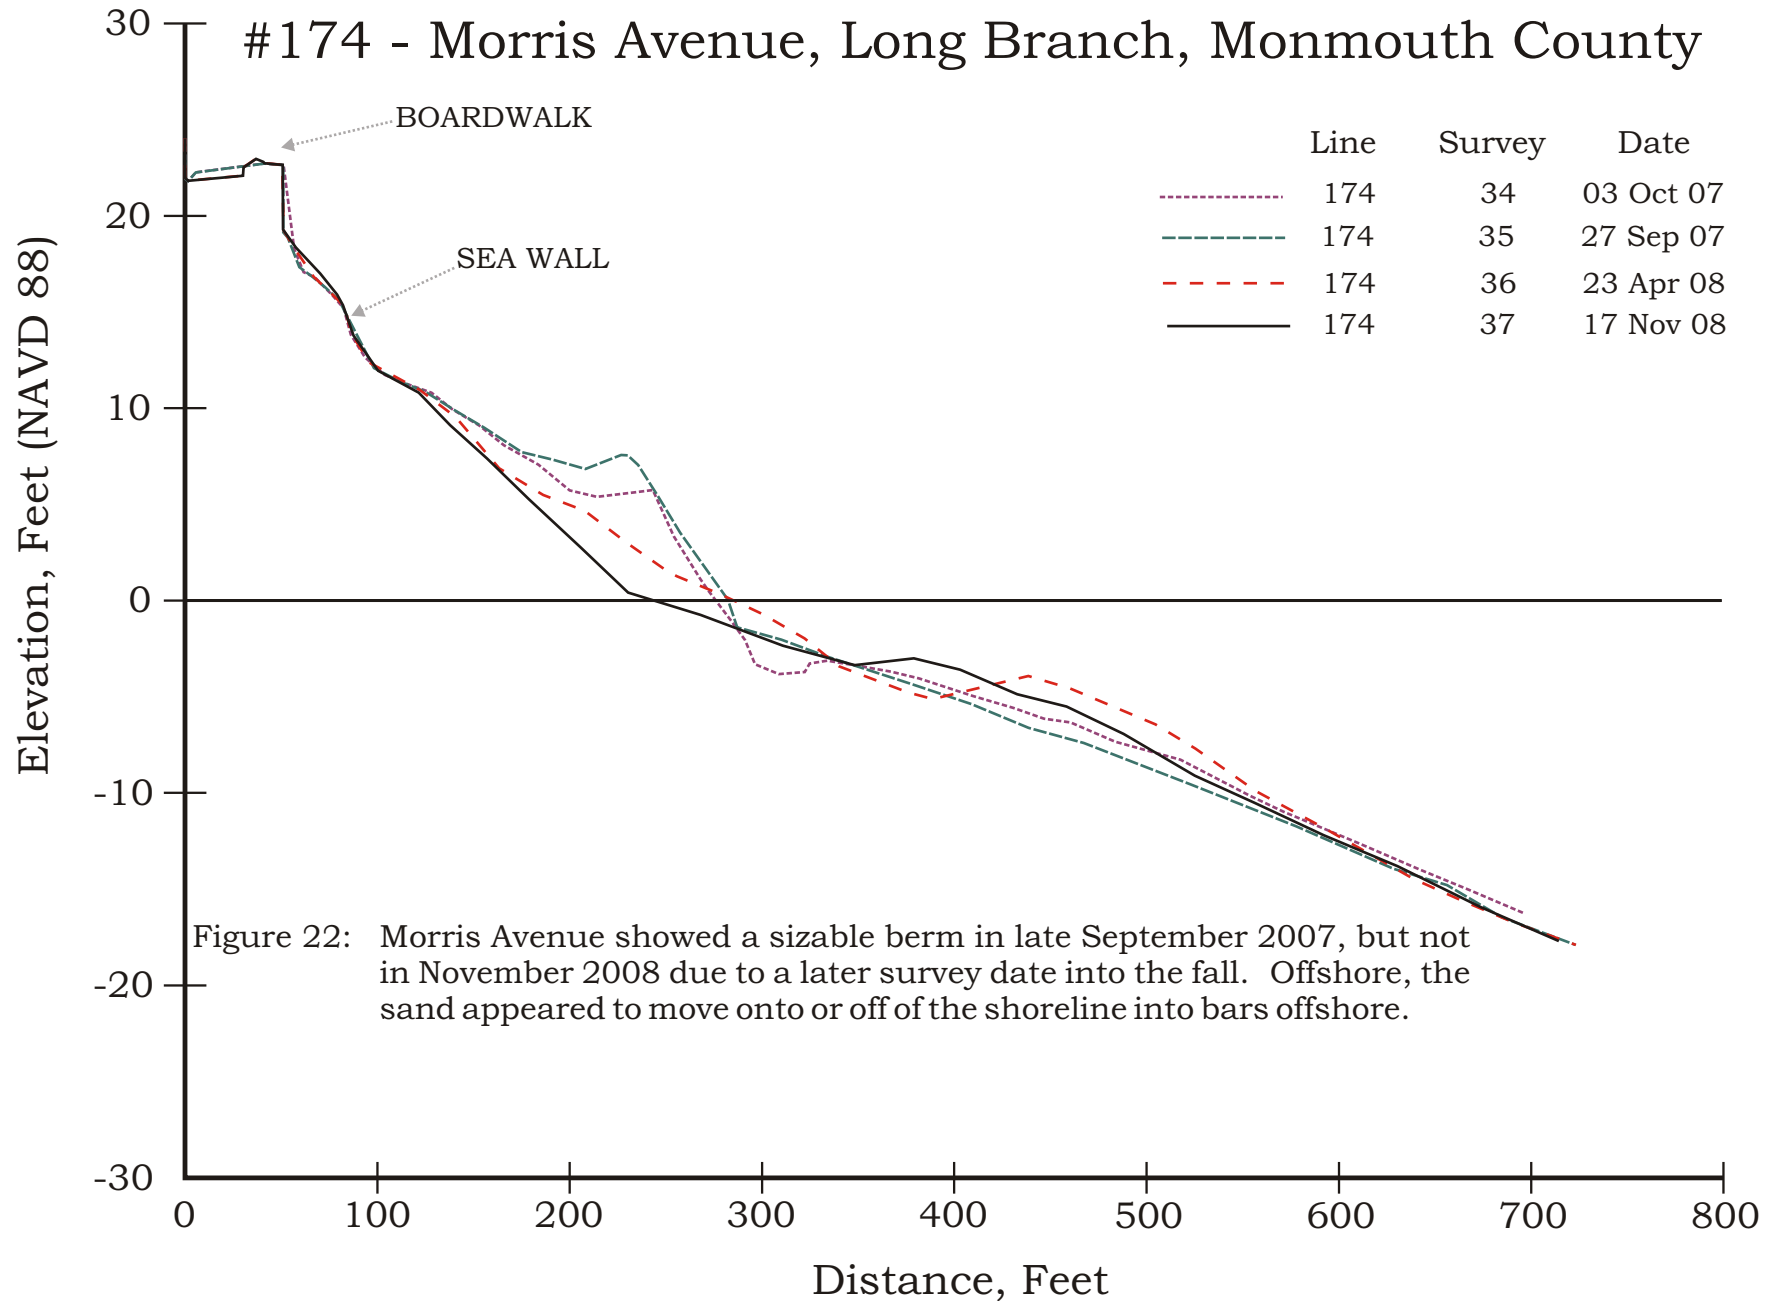
#174 - Morris Avenue, Long Branch, Monmouth County

Figure 22: Morris Avenue showed a sizable berm in late September 2007, but not in November 2008 due to a later survey date into the fall. Offshore, the sand appeared to move onto or off of the shoreline into bars offshore.

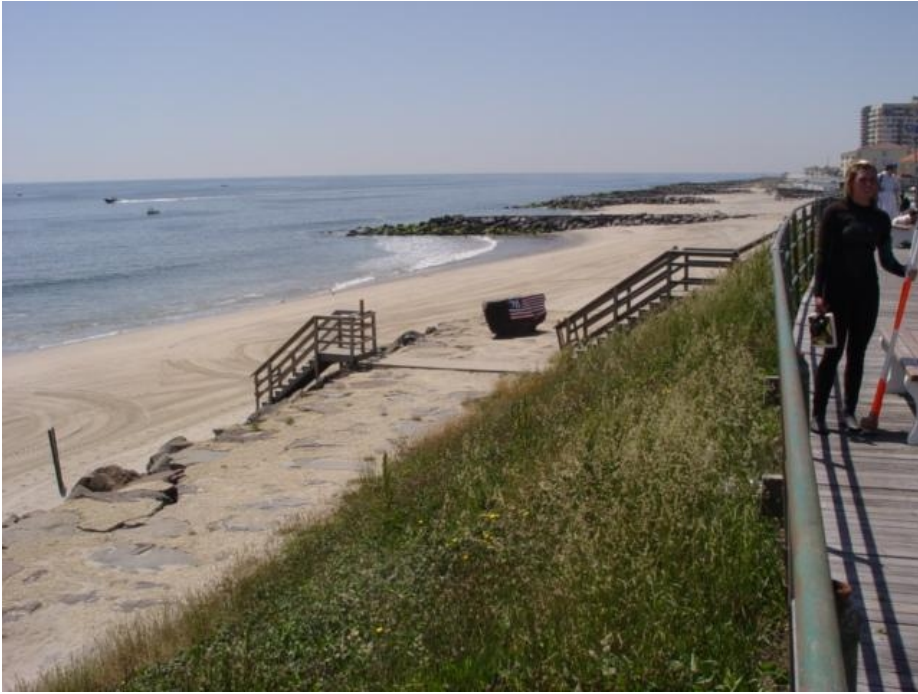
## WEST END AVENUE, LONG BRANCH - SITE 173

This is the southernmost survey site within the Long Branch to Sandy Hook segment of the Monmouth County beach fill. The deposition stopped just south of here due to real estate issues along privately owned oceanfront tracts in Elberon and Deal into Allenhurst. This view was taken May 30, 2007 and shows the top of the bluff, the rock sea wall and the remaining beach between the groins.

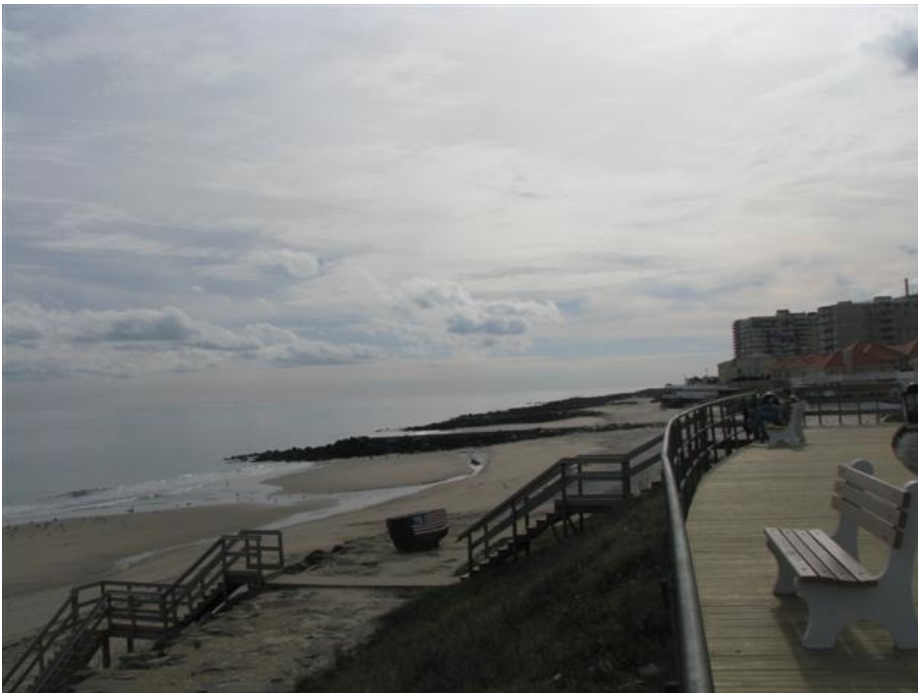
This view on November 12, 2008 shows that some changes did occur with a loss of 12.53 yds<sup>3</sup>/ft. and a 0.23-foot shoreline retreat. These losses were not terrific due to the presence of a strong shift in the equilibrium toward northern sand movement over the past 24 months. The 2009 beach restoration maintenance fill augmented this site substantially by March 2009.
