# New Jersey Beach Profile Network

## Monmouth County

Raritan Bay and Sandy Hook  
to Manasquan Inlet

**NJBPN Profile #'s  
187 - 256**

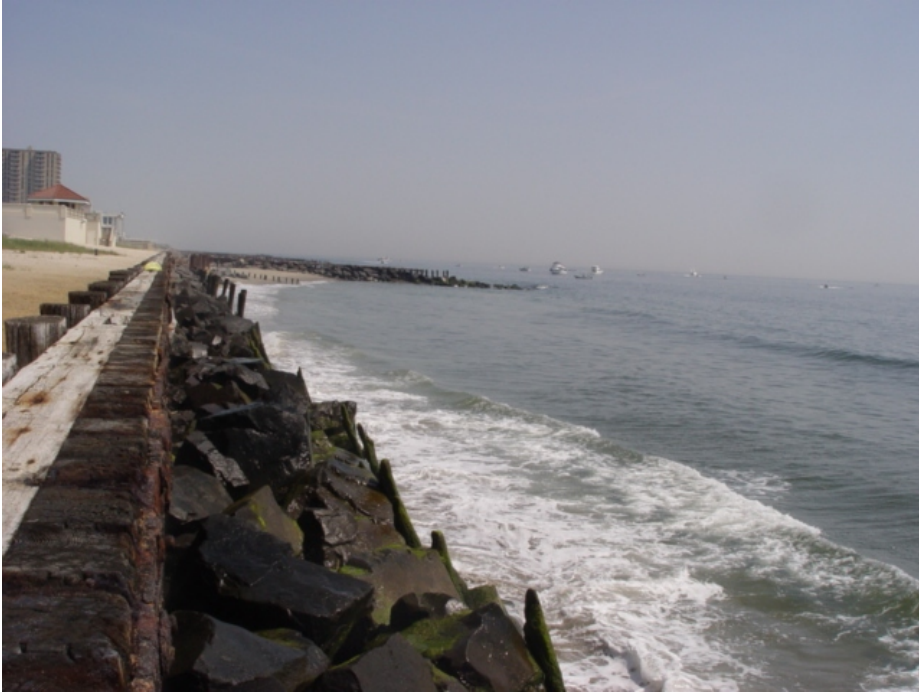
## PULLMAN AVENUE, ELBERON - SITE 171

Located on the highest elevation along the Monmouth County bluff, this site lies about a mile south of the southern end of the beach fill in Long Branch. On May 31, 2007 the waves were breaking just short of the rock revetment placed seaward of the ancient steel bulkhead at the bluff. Occasionally since the project was completed, there has been sand at the base of these rocks at high tide. The material comes and goes to the offshore.

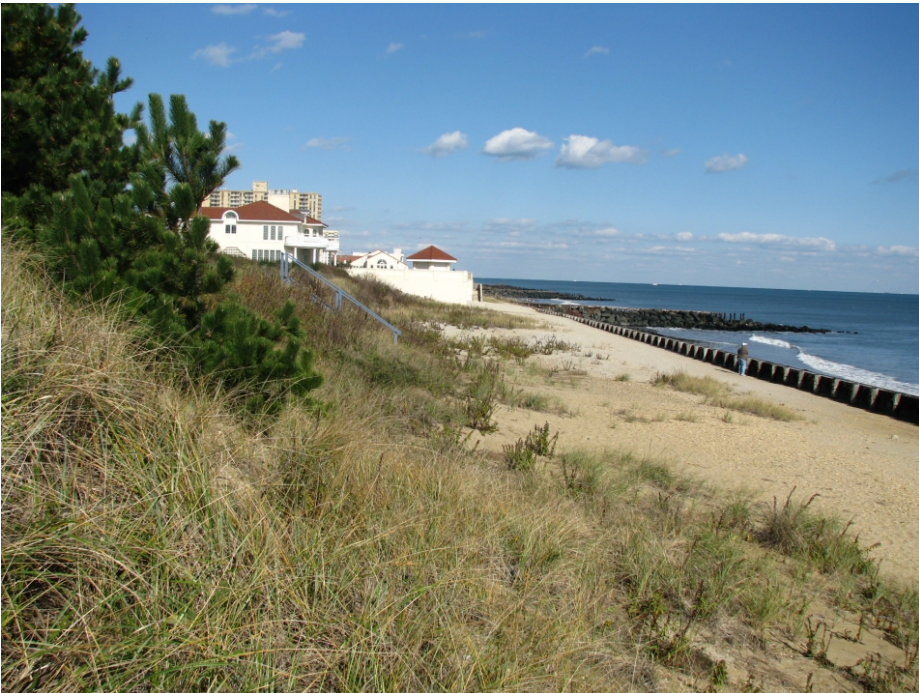
On November 10, 2008 the view shows the entire bluff, the flat terrace between the steel bulkhead and the bluff and a relative distant view of the shoreline. This area lost 3.91 yds<sup>3</sup>/ft. and saw a 1-foot shoreline advance in the zero elevation position. Change is relatively limited without any sizable source of sand.

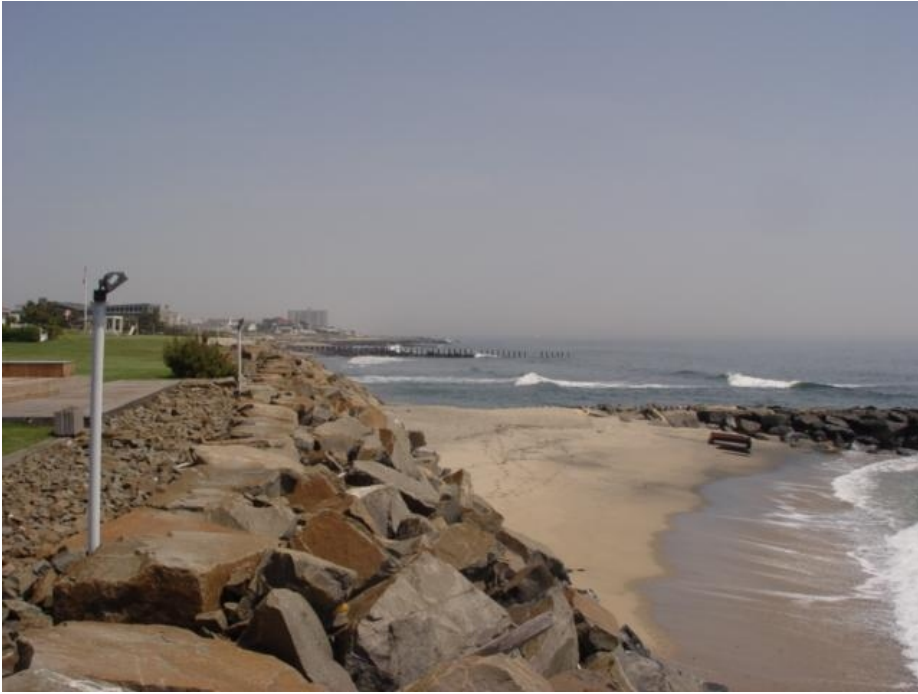
## ROOSEVELT AVENUE, DEAL - SITE 170

This view to the north along the rock-armored shoreline of Deal shows a small sand pocket trapped against the northern groin in the cell being surveyed on May 31, 2007. Sand shifts north to south within the cell, but little new material can move laterally along the shoreline. Groins every 700 to 1,000 feet make that impossible.

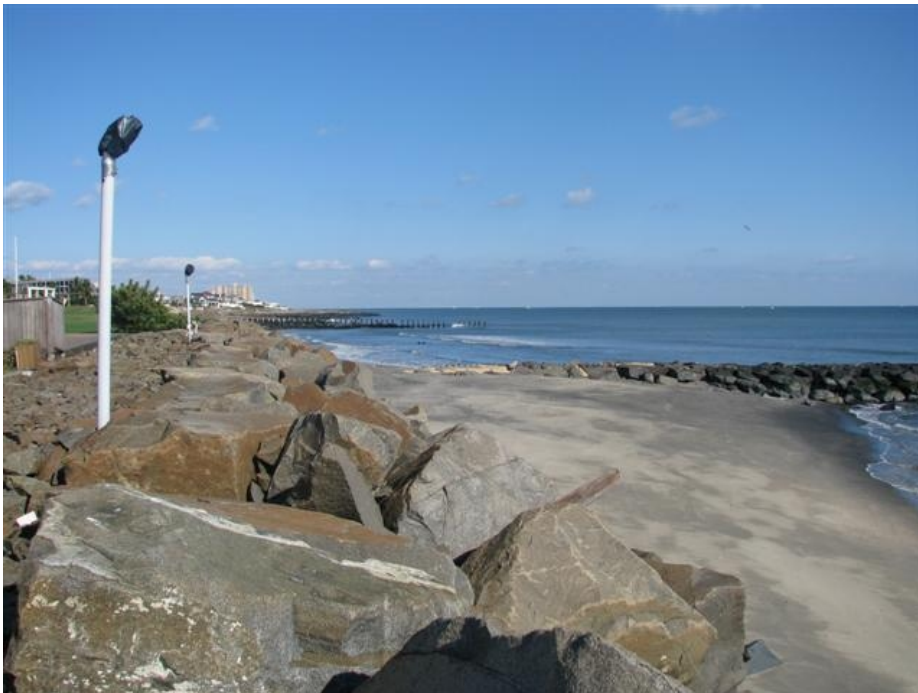
The November 10, 2008 view with the same perspective shows a pocket filled with a little additional sand. The net change in sand volume was 3.17 yds<sup>3</sup>/ft. The shoreline position at the profile line moved 7 feet seaward at the zero elevation. The seasonal comparisons showed small losses between May and October 2007 and between October 2007 and May 2008, followed by an 11.78 yds<sup>3</sup>/ft. gain between May and November 2008.

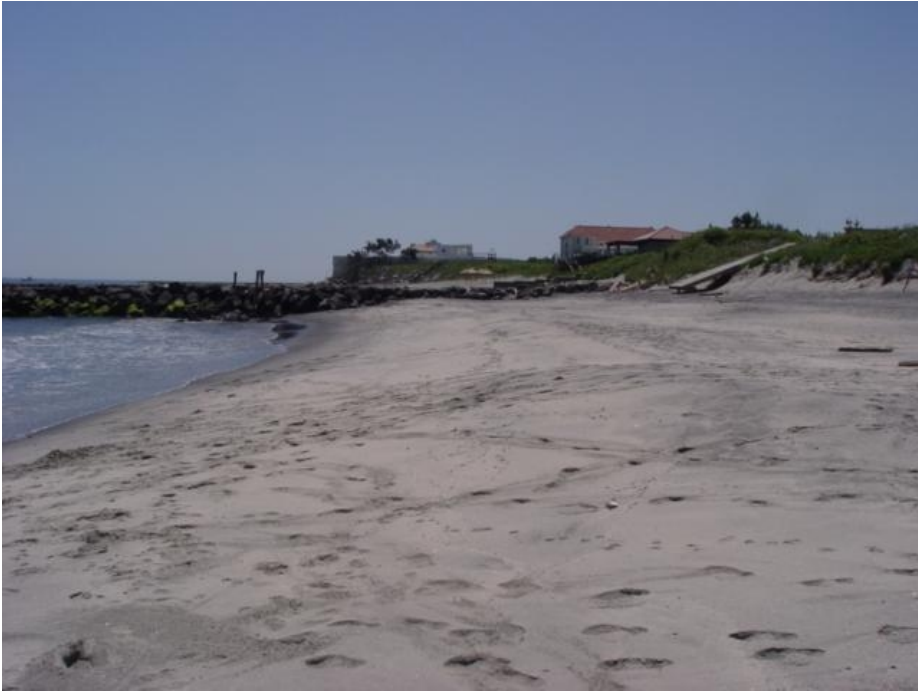
## DARLINGTON AVENUE, DEAL - SITE 169

Darlington Avenue in Deal has the best preserved bluff shoreline anywhere along the Monmouth County coast. On May 30, 2007 the beach had a berm protecting the toe of the bluff. The sand had ramped up the slope and was vegetated. Recently, owners have placed rock along the toe of the bluff to the south of the line at Darlington Avenue.

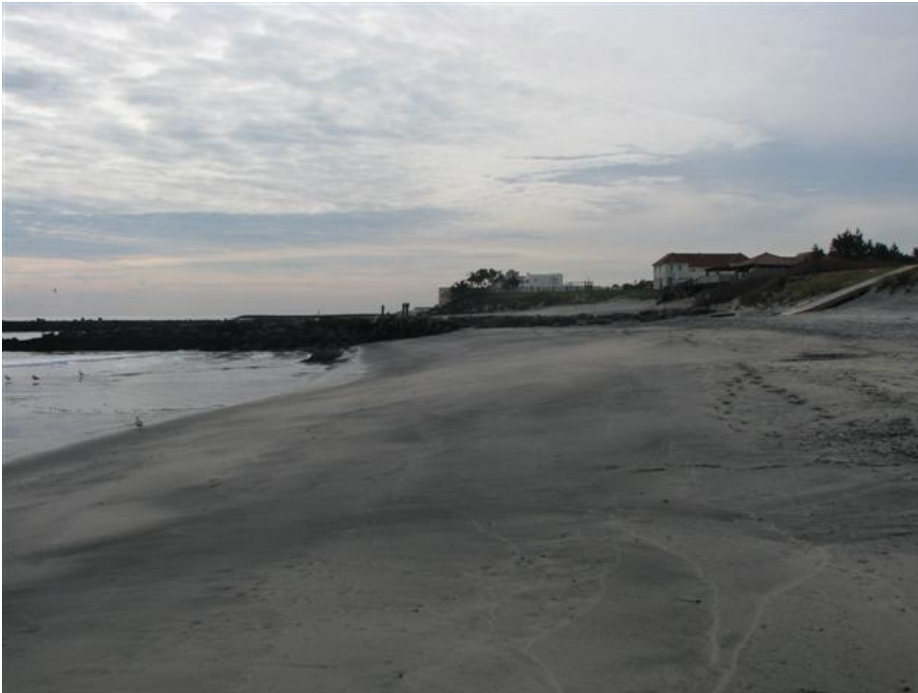
The 18 months of study found a sand volume gain of 4.78 yds<sup>3</sup>/ft. and a 12-foot shoreline advance by November 12, 2008. The groin complex to the south is in Allenhurst and effectively prevents any sand escaping from the Asbury Park to Manasquan segment of the Monmouth County project from ever reaching this site.

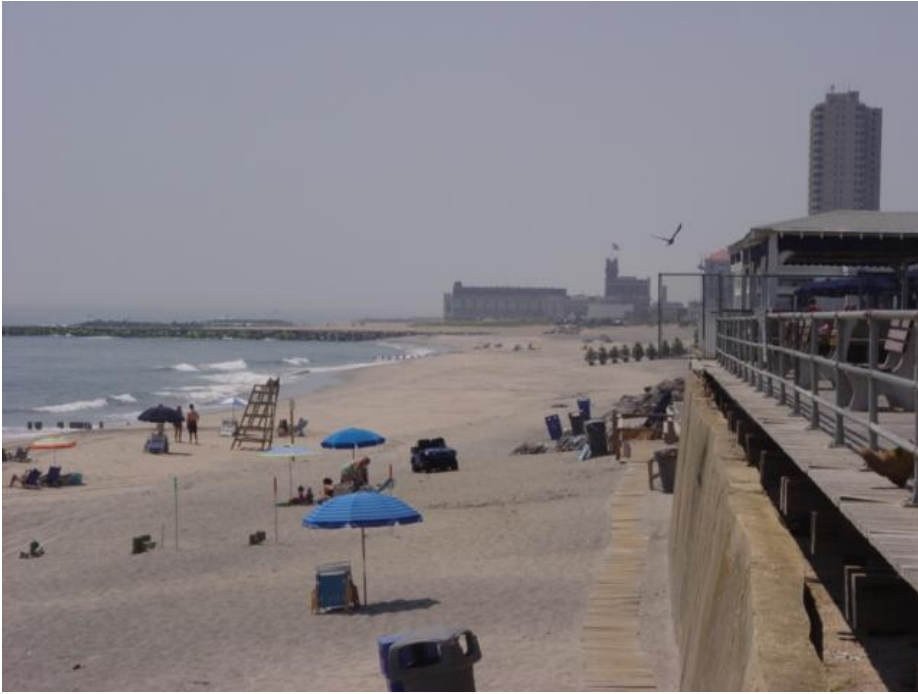
## CORLIES AVENUE, ALLENHURST - SITE 168

The Allenhurst beach is located in front of an old concrete seawall built to protect the easily eroded bluff years ago. It has survived many storms. By May 31, 2007 the beach was wider than it had been in decades due to sand escape from the groin seen to the south that retains the Asbury Park section of the Federal fill. For some reason neither Loch Arbor (a one-block wide oceanfront community) nor Allenhurst chose to participate in the US Army Corps Monmouth County project.

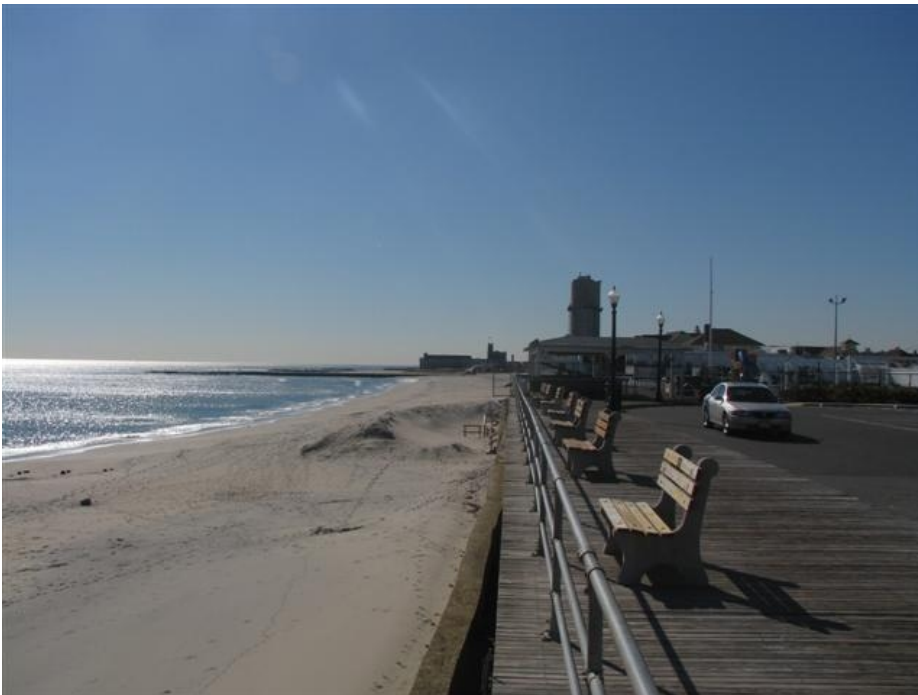
By October 31, 2008 the beach had gained 40.11 yds<sup>3</sup>/ft. while the shoreline advanced 11 feet. The upper photograph looks as if the beach were wider, but that photograph was zoomed in considerably compared to the one to the left. Sand has been trickling in from Asbury Park since 1999 as the past several years of monitoring has detected.

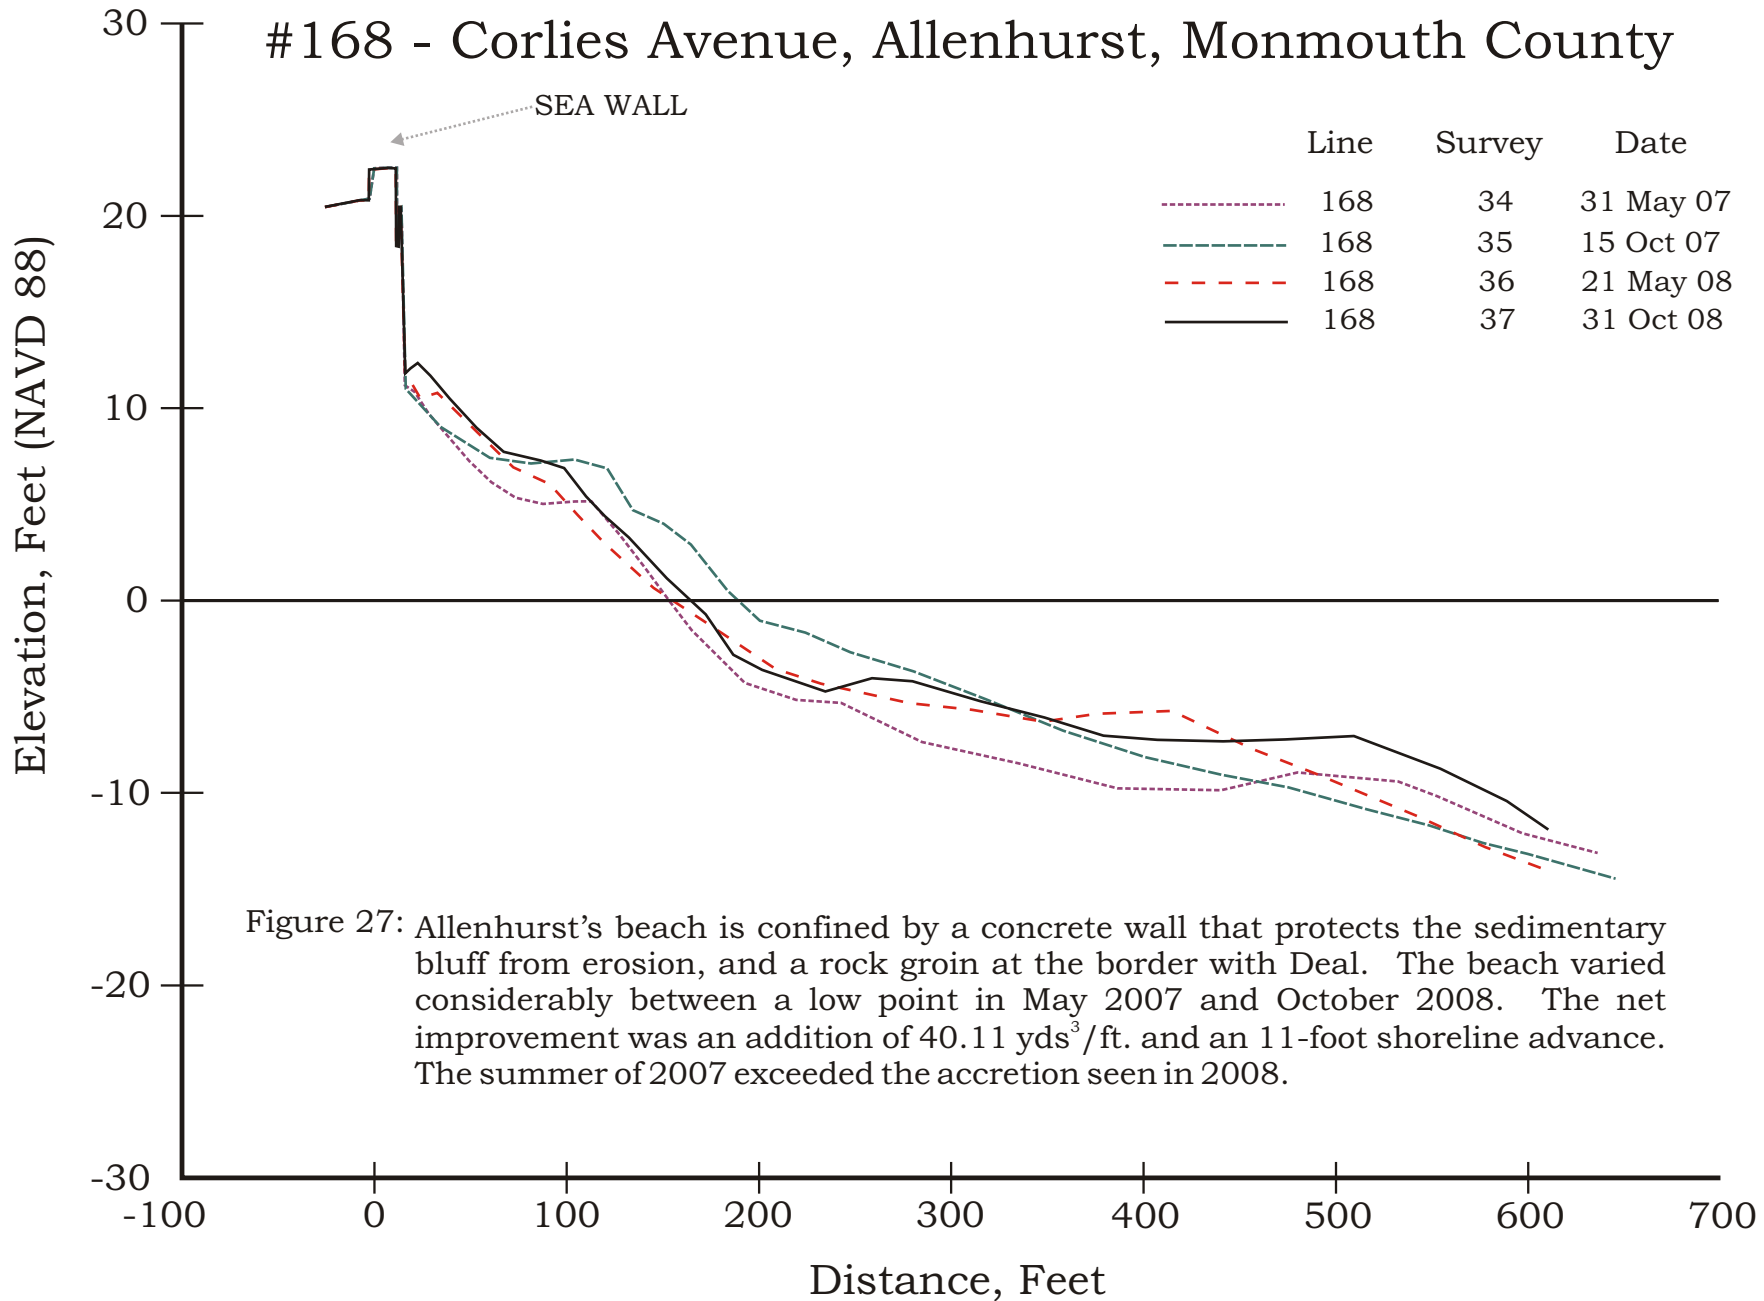
#168 - Corlies Avenue, Allenhurst, Monmouth County

Figure 27: Allenhurst's beach is confined by a concrete wall that protects the sedimentary bluff from erosion, and a rock groin at the border with Deal. The beach varied considerably between a low point in May 2007 and October 2008. The net improvement was an addition of 40.11 yds<sup>3</sup>/ft. and an 11-foot shoreline advance. The summer of 2007 exceeded the accretion seen in 2008.

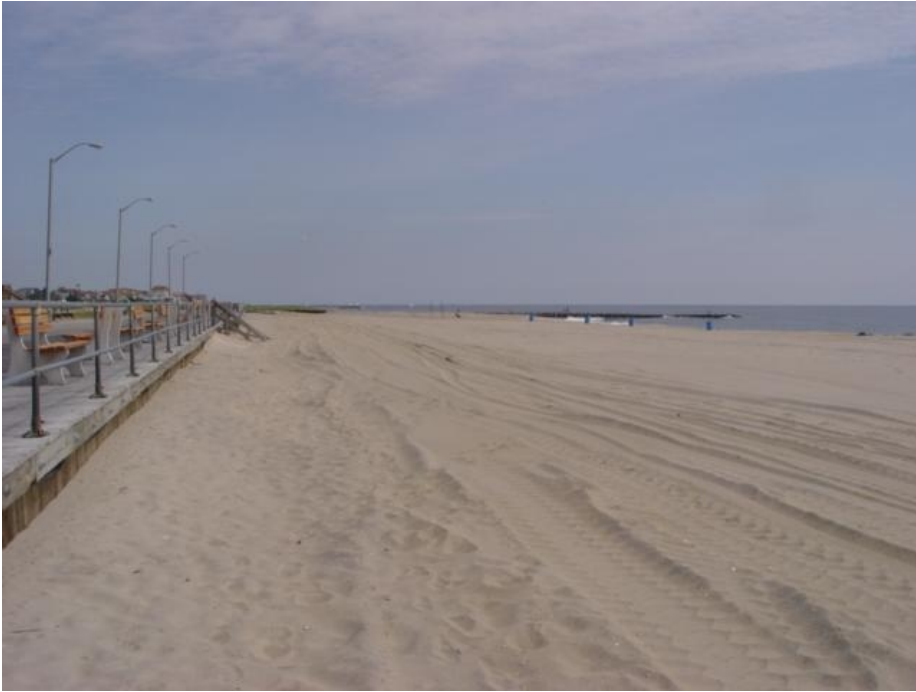
## 7th AVENUE, ASBURY PARK - SITE 267

Located at the northern end of the south segment of the Monmouth County project, this Asbury Park beach has retained most of the initial deposit of sand. No maintenance has been done since completion in 1999. This June 7, 2007 photograph shows no dune was ever created following the fill.

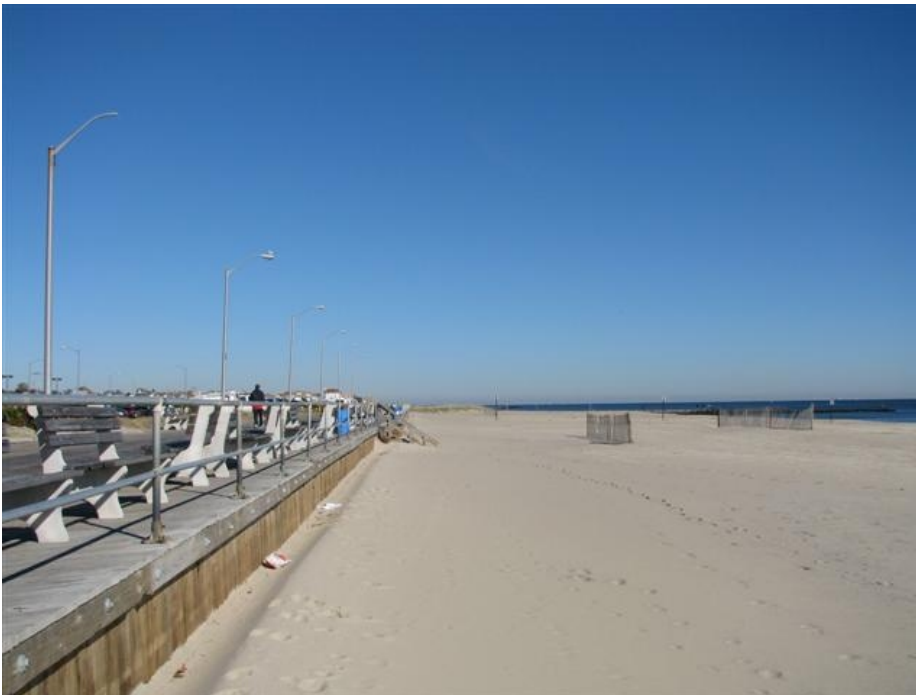
This beach lost 5.04 yds<sup>3</sup>/ft. by this October 31, 2008 photograph and the shoreline retreated less than a foot (-0.41 ft.). The rate of loss has been very low given that the groin is all that holds in the northern end of the fill project.

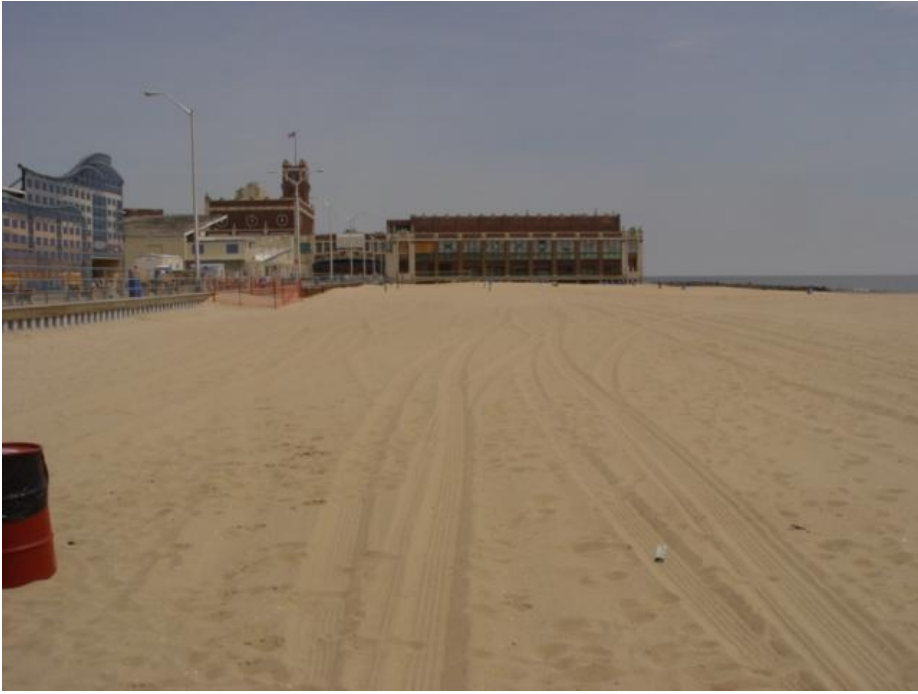
## 3<sup>rd</sup> AVENUE, ASBURY PARK - SITE 167

The middle of the Asbury Park beach is wide and very flat with no dune. The recreational use precludes a natural dune from forming and no municipal work was done to force a dune to grow near the boardwalk. The photograph was taken June 7, 2007.

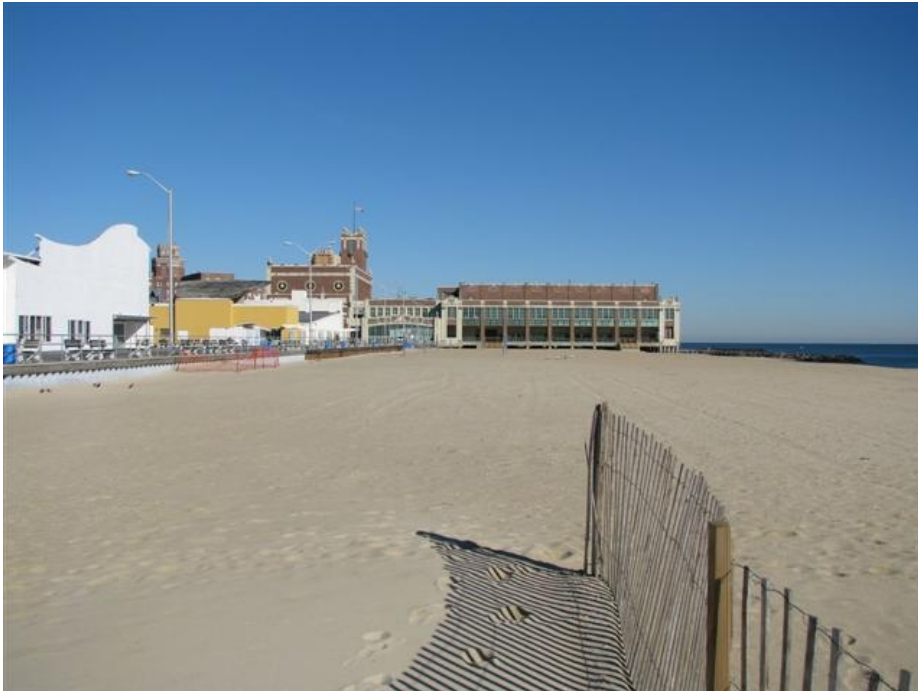
By October 31, 2008 the site had lost 8.57 yds<sup>3</sup>/ft. with a 1.5-foot retreat in the shoreline position.

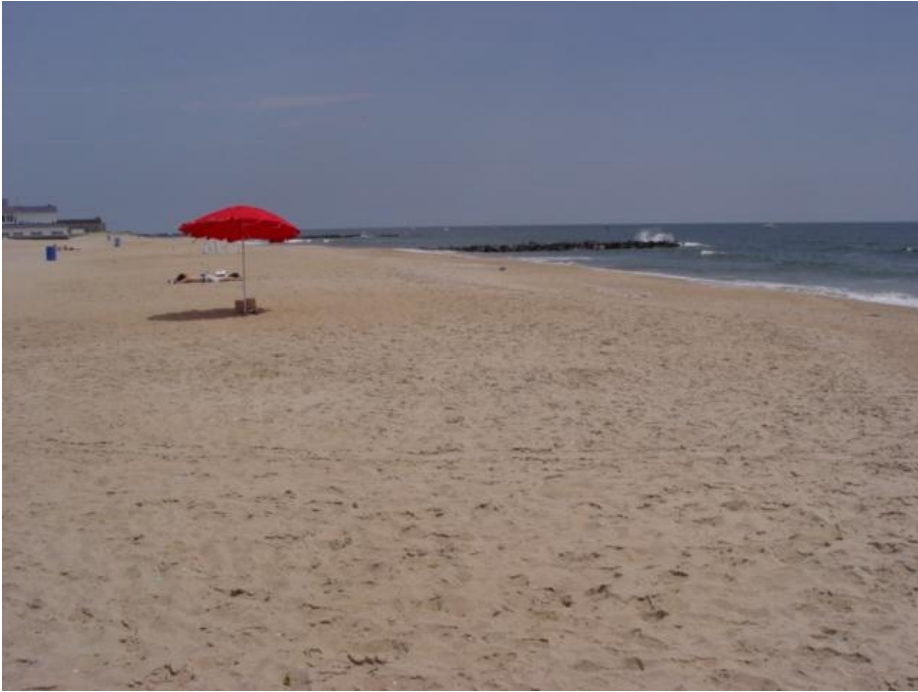
## OCEAN PATHWAY, OCEAN GROVE - SITE 166

Ocean Grove has an equally wide beach as Asbury Park, but took steps to create a dune between the beach and the boardwalk. This June 7, 2007 photograph shows just the berm and beachface looking north.

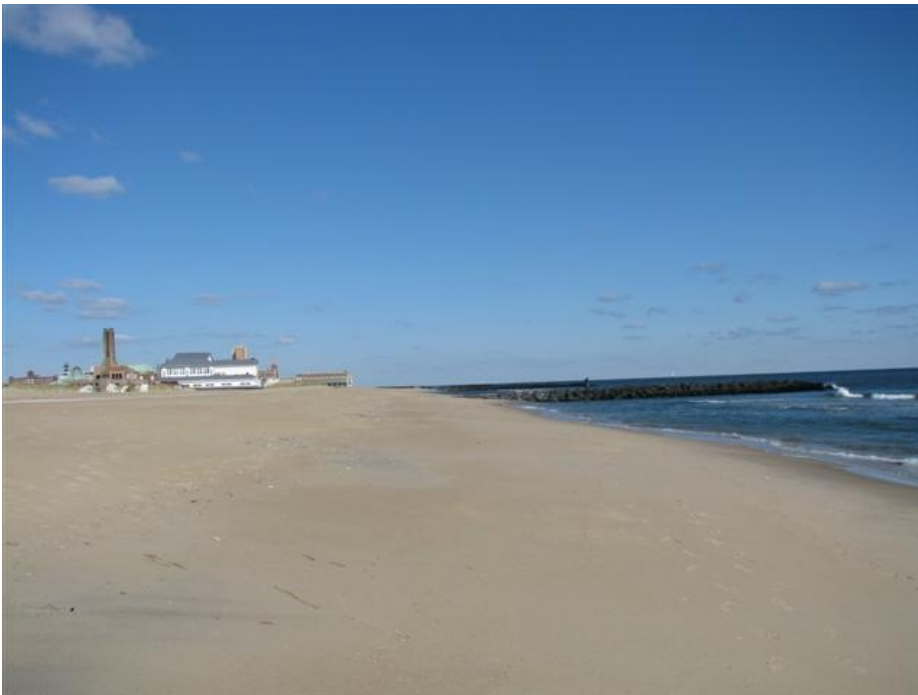
October 30, 2008 shows a small loss of 3.33 yds<sup>3</sup>/ft., but the shoreline advanced 10 feet seaward over 18 months. The beach width has remained nearly constant in width since 1999.

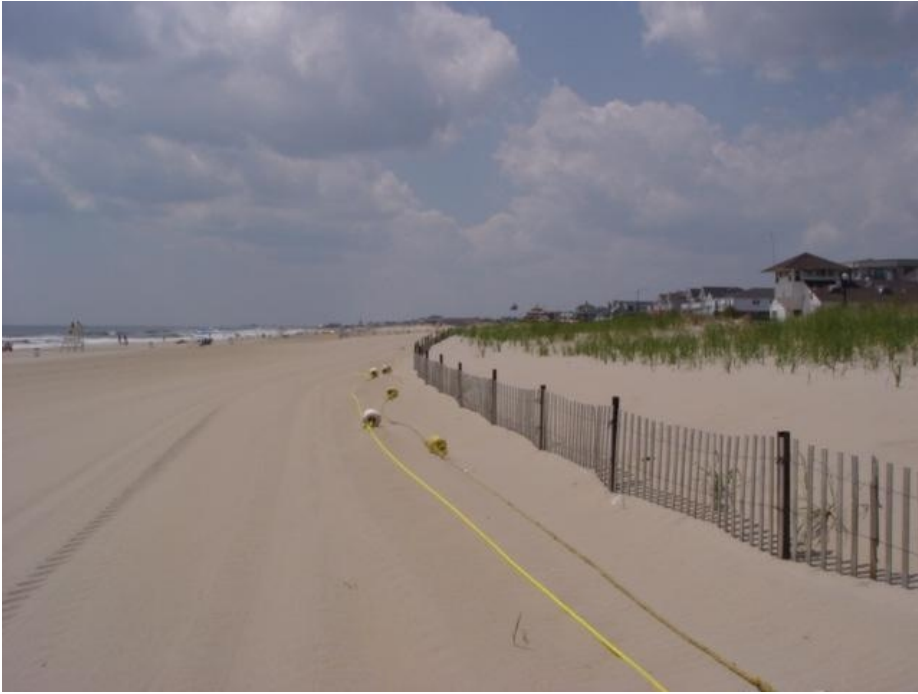
## McCABE AVENUE, BRADLEY BEACH - SITE 165

This location is far different from what it was in 1996 before the beach fill. The first step the community made was to pull the boardwalk back off the beach and replace it with a paver promenade on the top of the bluff between Ocean Avenue and the boardwalk. This provided an additional 40 feet of badly needed beach width. By this June 5, 2007 photograph the dune was well developed where the boardwalk once was and the filled beach extended 230 feet further seaward to the berm.

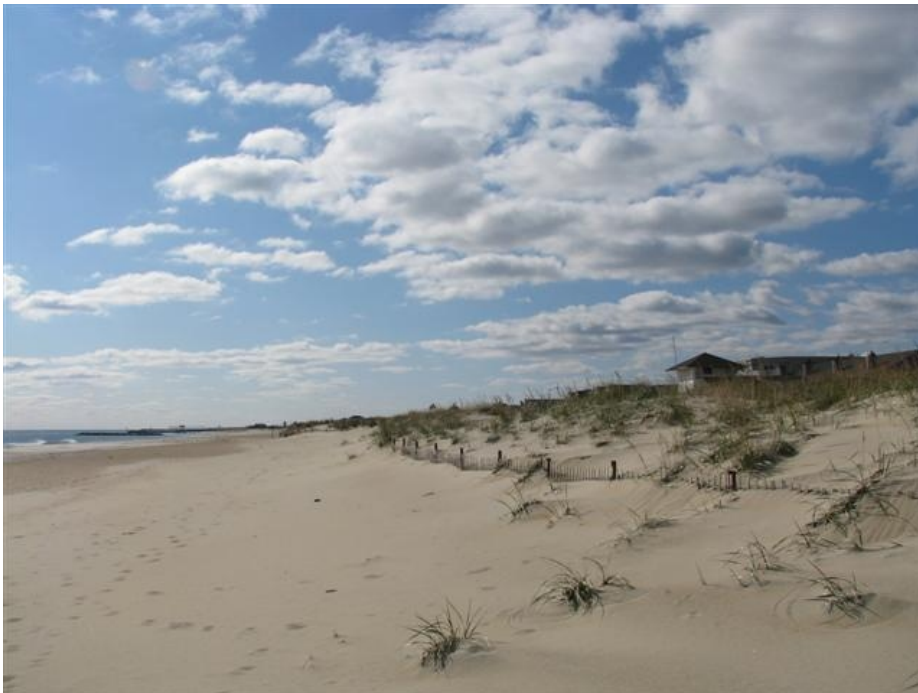
18 months later on October 30, 2008 the dune had grown substantially as can be seen by looking at the buried fence to the right and compare it to the view of the fence shown above-left. The beach retained its width, advancing 5 feet further seaward as  $1.95 \text{ yds}^3/\text{ft.}$  of additional sand volume was deposited along this shoreline. A very stable beach near the center of the project.

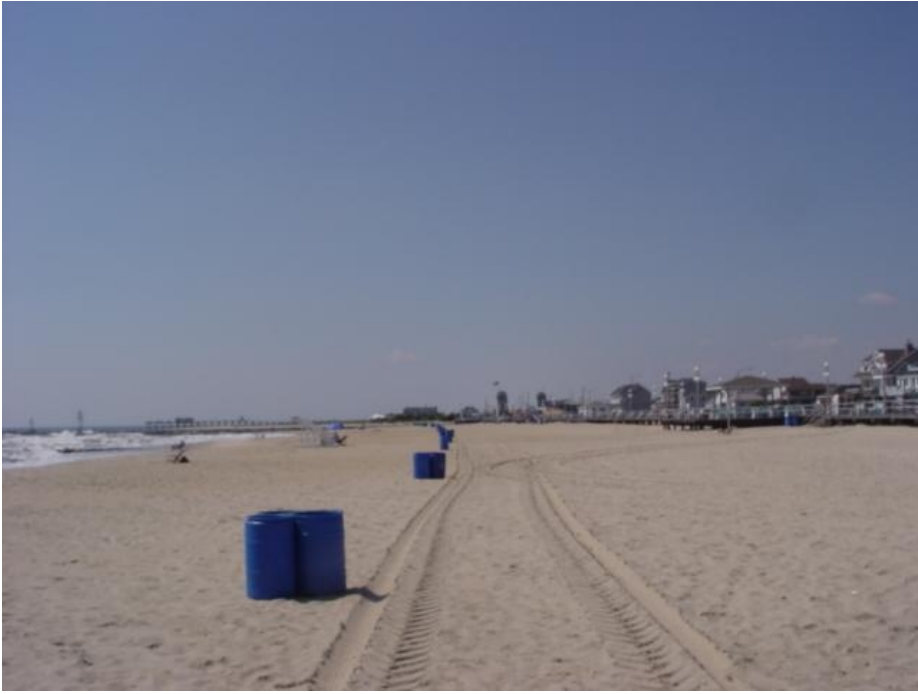
## SYLVANIA AVENUE, AVON BY THE SEA - SITE 164

This June 5, 2007 shot of the beach just prior to the summer tourist season shows the beach just north of the Shark River Inlet. This is the most significant barrier to the free movement of sand along this southern Monmouth County fill segment. No dune was built along this community's shoreline so all the fill-widened beach is available for blankets in the summer.

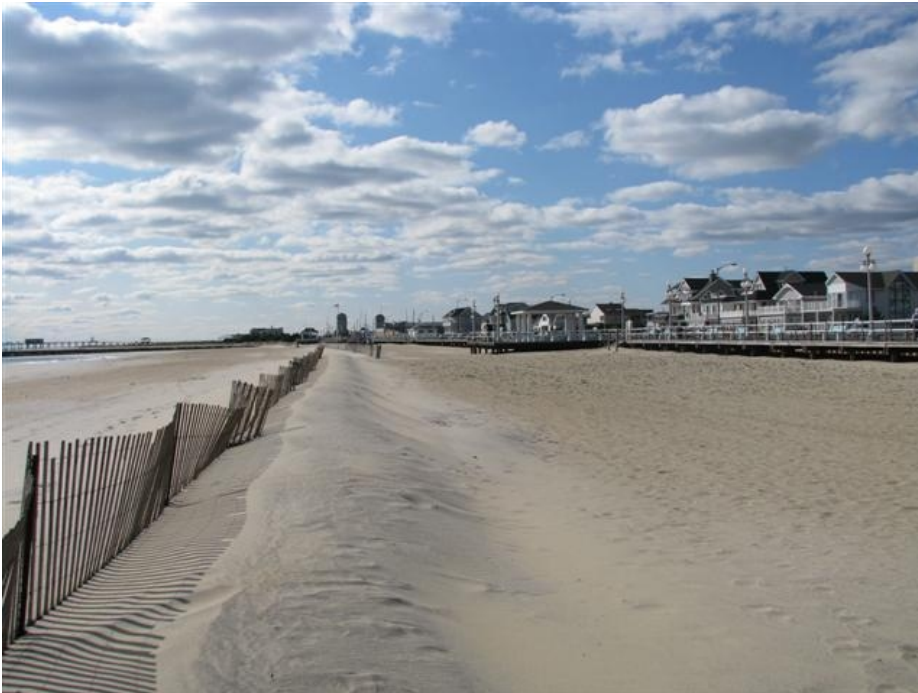
On October 30, 2008 the municipality had erected a shoreline-parallel fence to intercept wind-blown sand before it could be blown onto the boardwalk and across it into Ocean Avenue. In spite of its location, north of Shark River Inlet, this site managed a small  $1.95 \text{ yds}^3/\text{ft.}$  sand volume gain with a 5-foot shoreline advance.

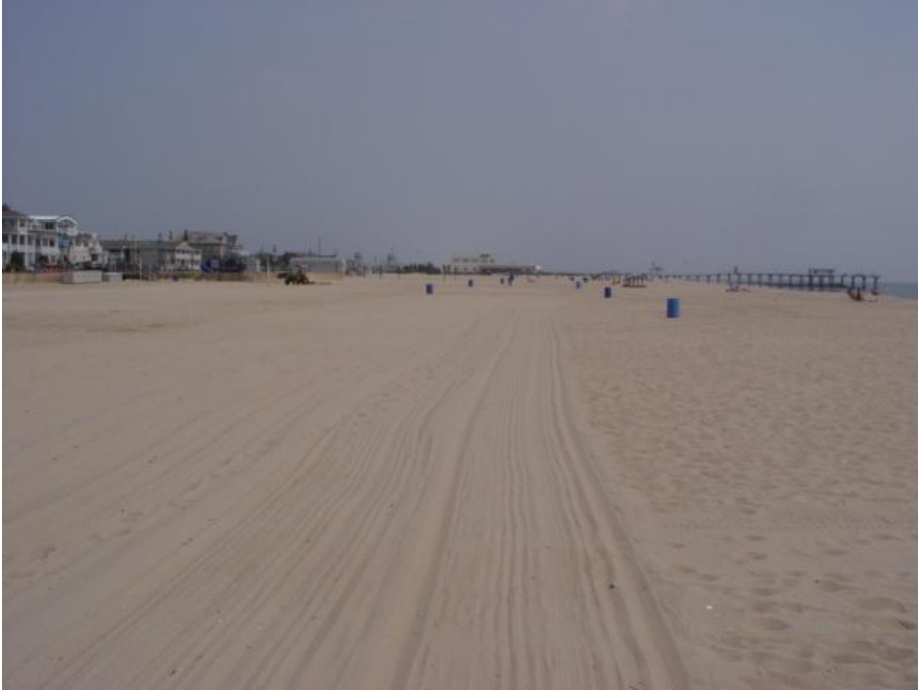
## 5<sup>th</sup> AVENUE, BELMAR - SITE 163

The northern Belmar beach lies just south of the Shark River Inlet and has historically trapped sand moving north. The northeast storms move it back south, but lately there have been few with any power. This photograph was taken June 1, 2007 and illustrates the 350-foot wide, flat beach with a token dune just east of the boardwalk.

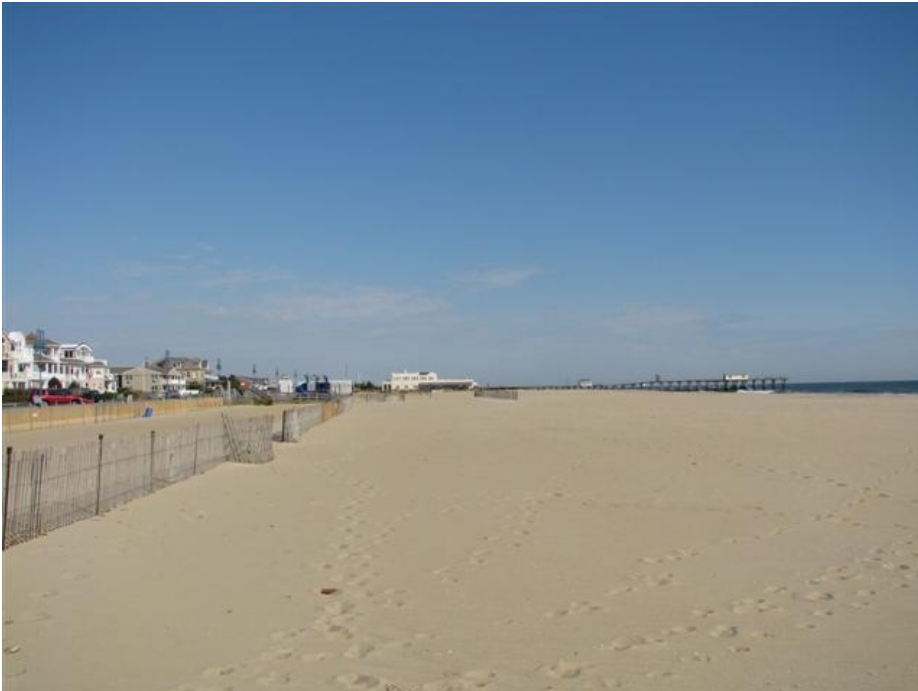
By October 21, 2008 the shoreline had gained 8.82 yds<sup>3</sup>/ft. as the beach widened by 30 feet. This picture was taken near the dune at the fence newly installed. This should dramatically widen the dune as sand gets trapped at the fence.

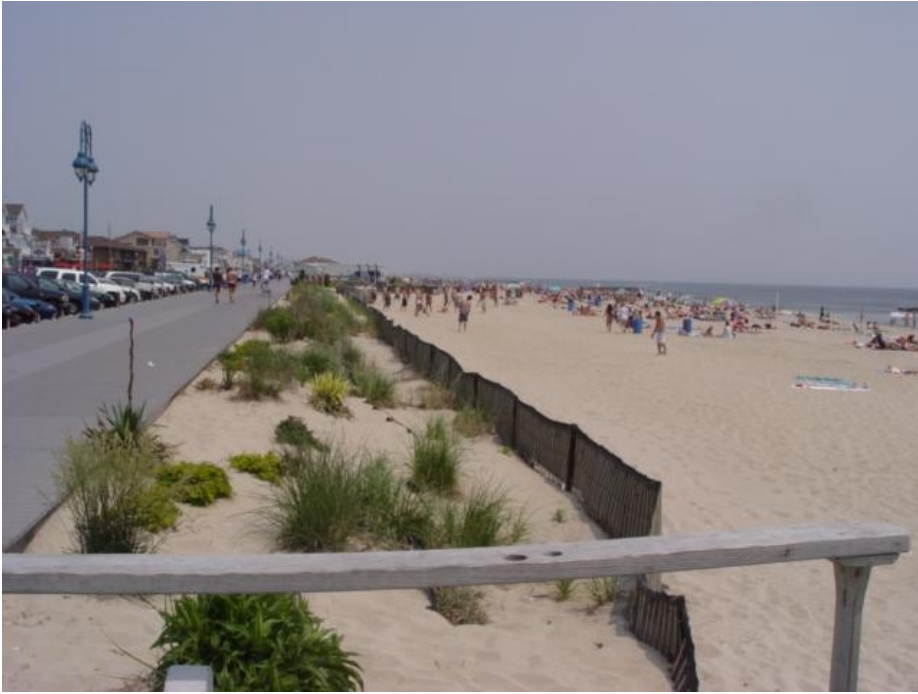
## 18<sup>th</sup> AVENUE, BELMAR - SITE 162

In southern Belmar the beach is a little narrower, but the “dune” represents a landscaping endeavor rather than the sand trapping/shore protection feature that is usually considered a dune. The picture to the right was taken June 1, 2007 as the summer season was just getting started.

By October 21, 2008 the municipality had installed three rows of fencing designed to trap sand out on the beach and provide an access pathway along the “landscaped” section shown above. Note how the landscaping plants have selectively taken over the planted section due to the demanding environment for growth in dry quartz sand. This beach gained 8.82 yds<sup>3</sup>/ft. as the shoreline advanced seaward by 30 feet.

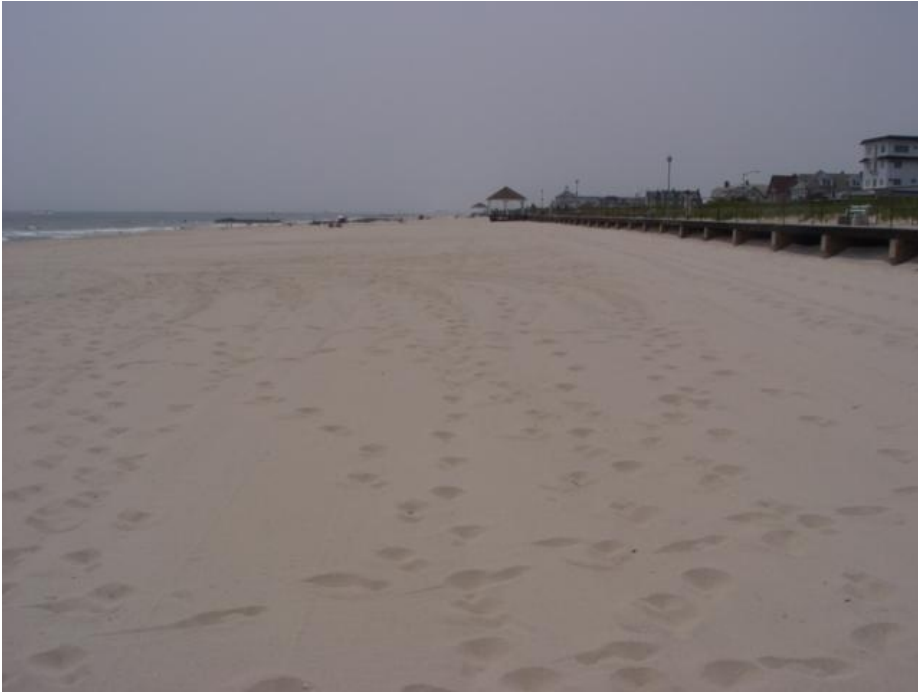
## BRIGHTON AVENUE, SPRING LAKE - SITE 161

The Spring Lake beach always had a dune located between the boardwalk and Ocean Avenue. This June 1, 2007 photograph was taken looking south in the middle of the berm. The beach here remains stable.

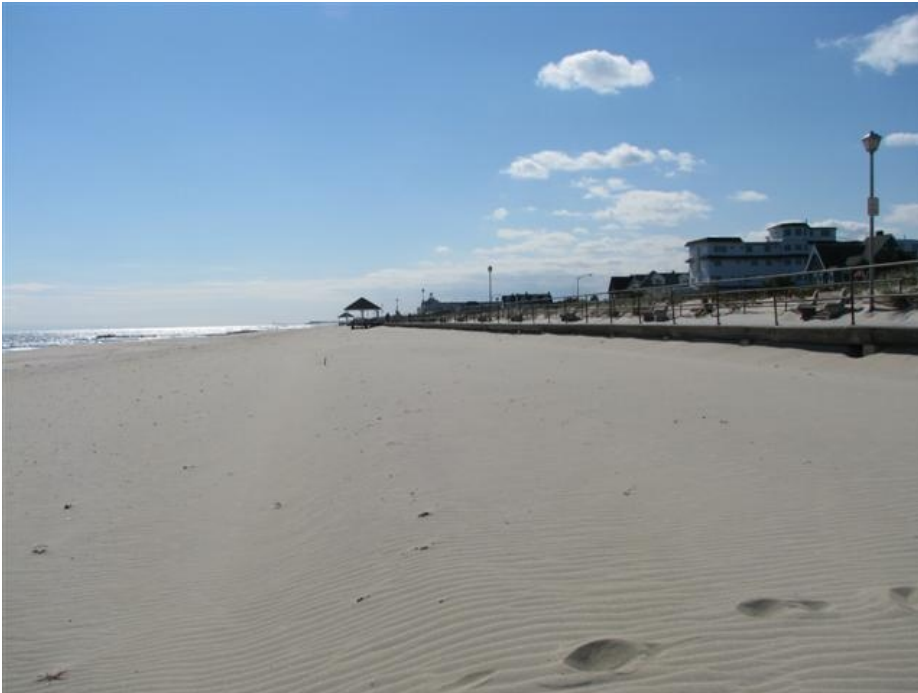
By October 17, 2008 the shoreline had gained  $15.03 \text{ yds}^3/\text{ft.}$  as the shoreline advanced 29 feet seaward. Sand filled in a gap between the boardwalk and the original dune to the point where it is encroaching on the western side of the walkway.

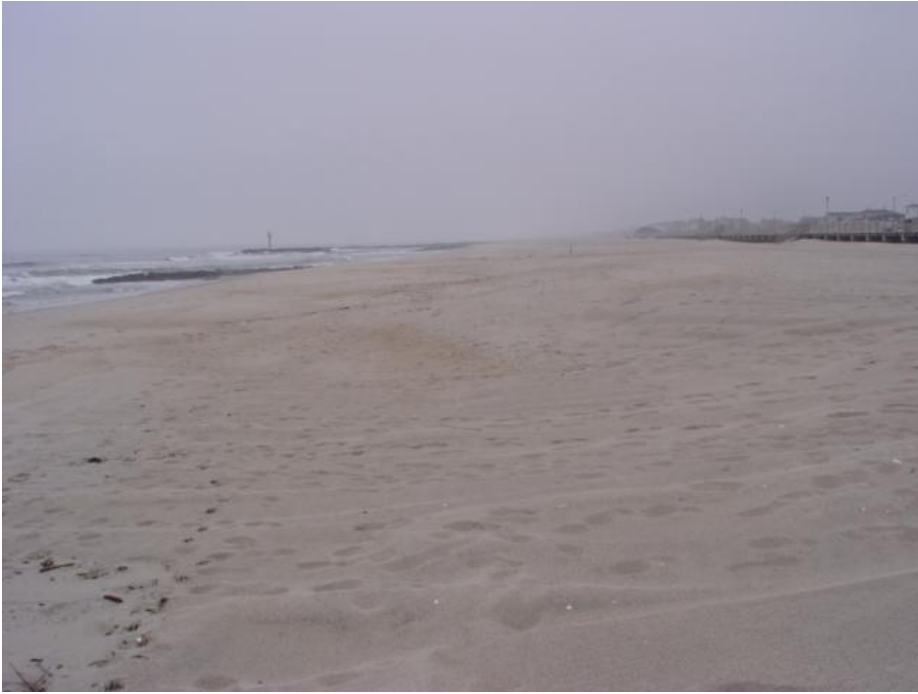
## SALEM AVENUE, SPRING LAKE - SITE 160

Southern Spring Lake had a similar configuration to the site #161 on April 2, 2007.

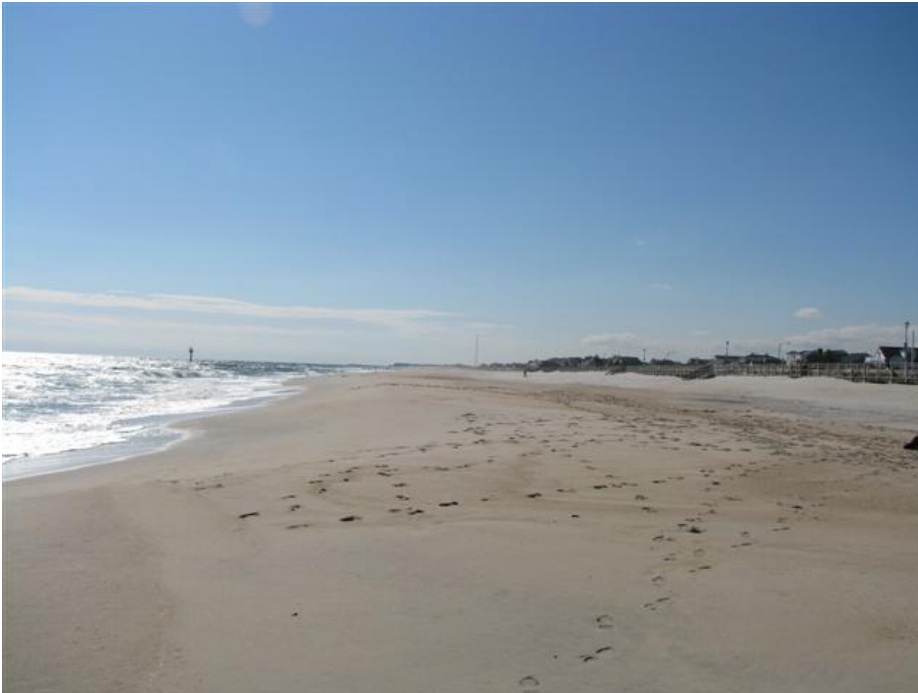
By October 17, 2008 the shoreline retreated just 6 feet and the total sand volume was only a tiny  $0.76 \text{ yds}^3/\text{ft.}$  decline in quantity. The same sand deposition was filling in the gap between the boardwalk and the dune. This is also a stable beach.

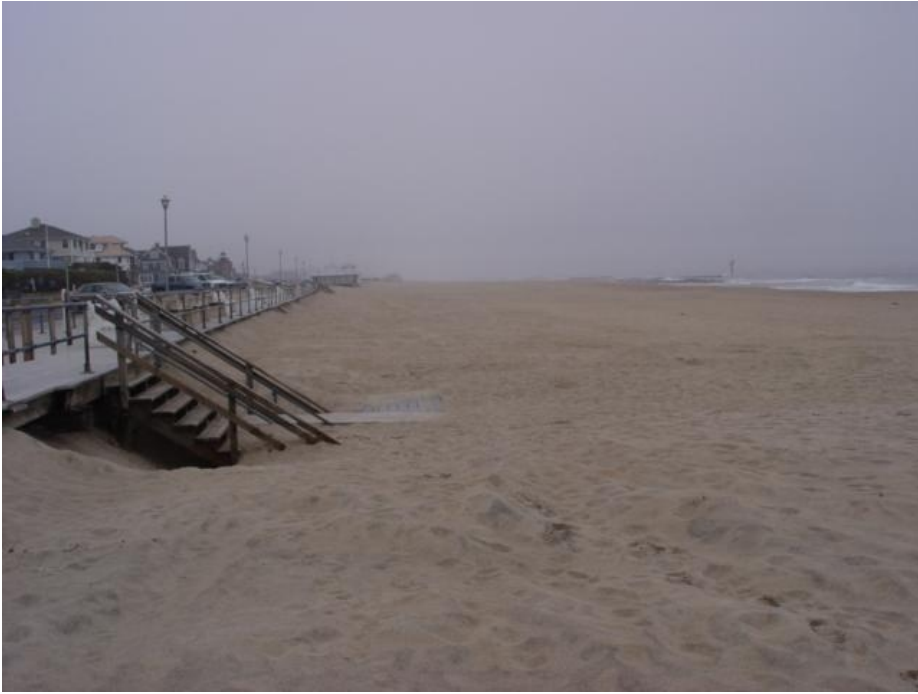
## NEW YORK AVENUE, SEA GIRT - SITE 159

New York Avenue is located in the public recreational section of the Sea Girt shoreline. This April 2, 2007 view to the north shows the beach and boardwalk. A dune is planned because wind transport is moving sand onto and under the boardwalk causing degradation of the structure. Sand also blows into Ocean Avenue and needs to be picked up annually.

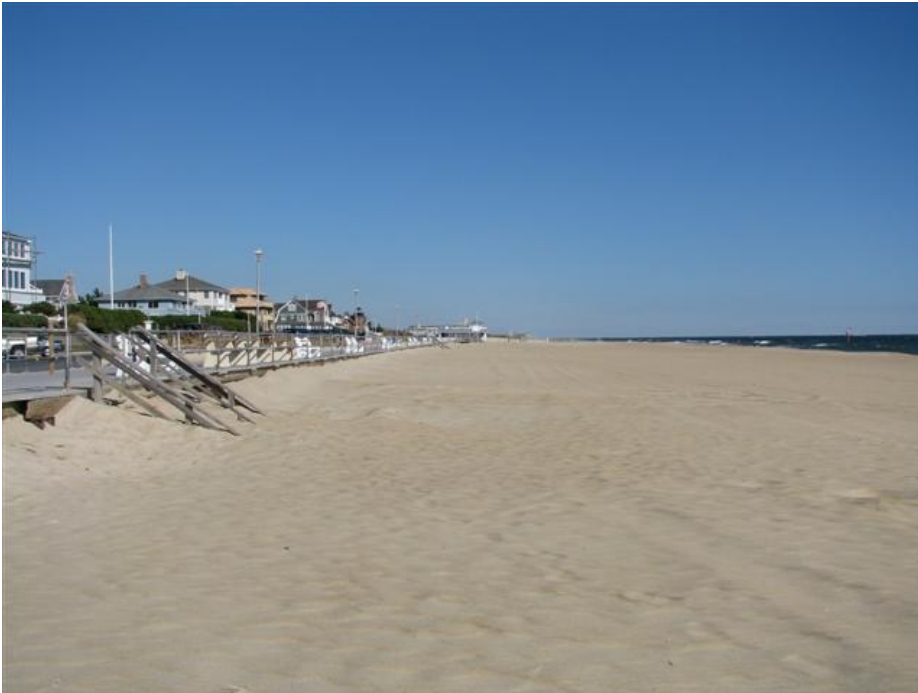
By October 17, 2008 the shoreline had lost 13.71 yds<sup>3</sup>/ft. and just over 4 feet of shoreline retreat. The dune has yet to be constructed due to conflict over design and issues with the NJDEP.

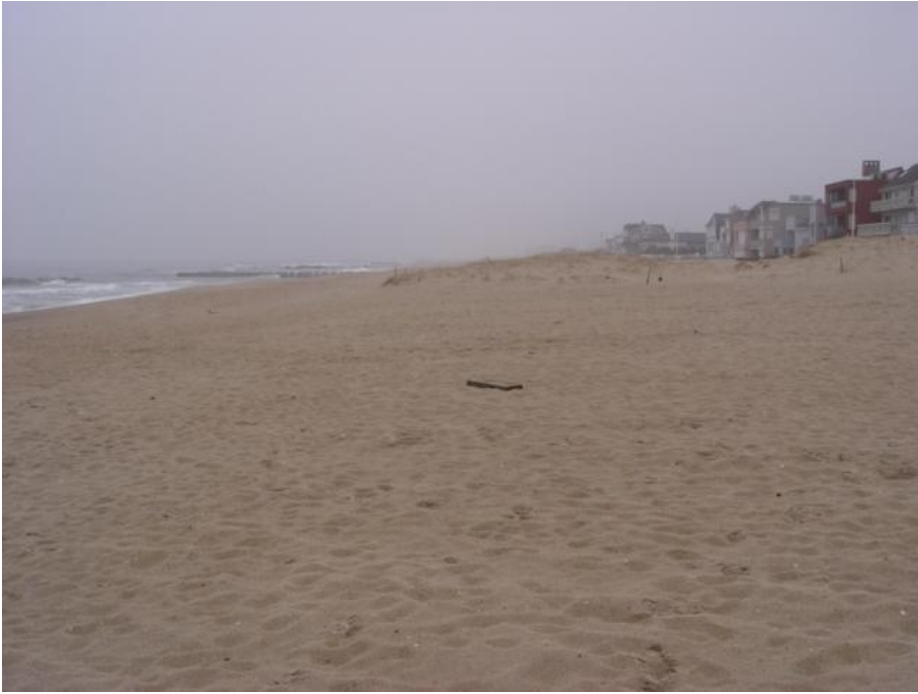
## TRENTON AVENUE, SEA GIRT - SITE 158

The Trenton Avenue site is near the southern boundary of Sea Girt and the NJ State Police training center between Sea Girt and Manasquan. The beach width is substantial as this view to the south on April 2, 2007 shows. The boardwalk has large dunes between it and the uplands bluff that was last touched by storm erosion during the December 1992 event. Since then the Federal beach restoration project has allowed accretion of dunes and the growth of grass reaching seaward of the elevated boardwalk.
