# New Jersey Beach Profile Network

## Monmouth County

Raritan Bay and Sandy Hook  
to Manasquan Inlet

**NJBPN Profile #'s  
187 - 256**

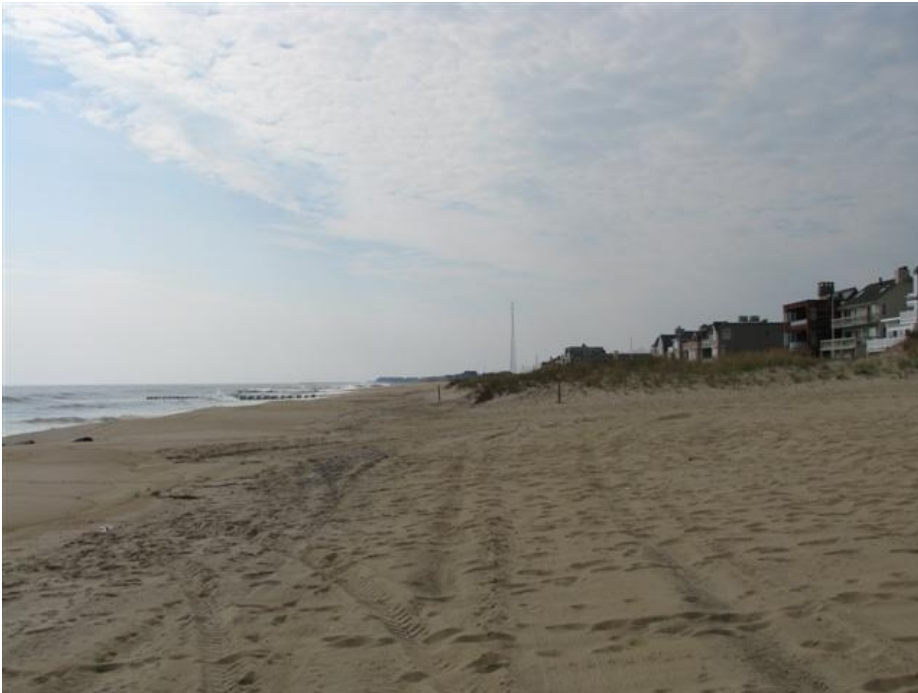
By October 16, 2008 the beach was wider by 40 feet and the sand volume increased by 32.41 yds<sup>3</sup>/ft. The dune in the middle of the picture gained volume and produced a denser growth of grass.

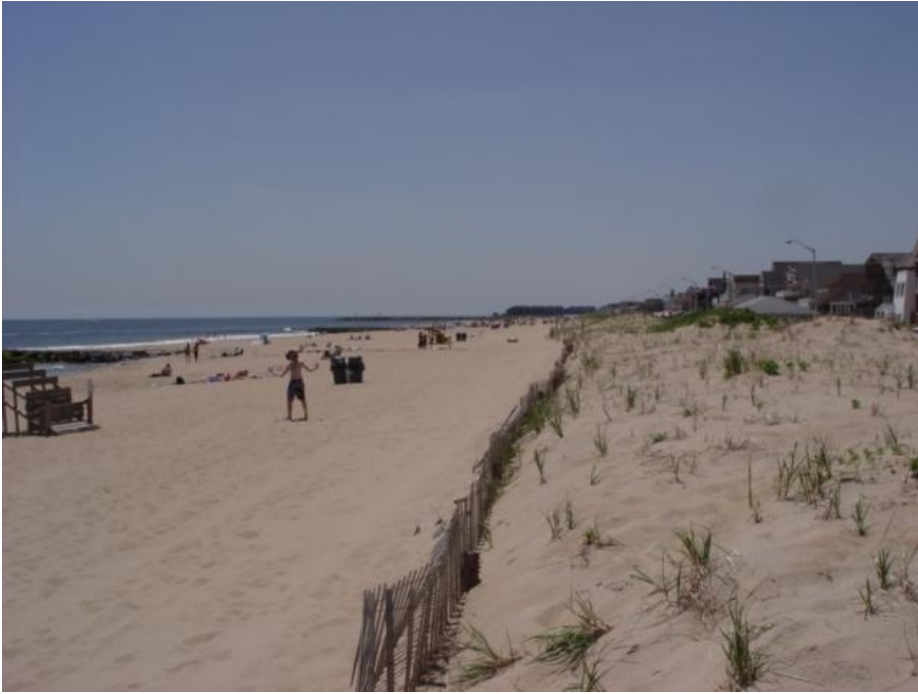
## RIDDLE WAY, MANASQUAN - SITE 157

Located in the middle of the Manasquan shoreline, Riddle Way has a dune that dates from prior to the December 1992 storm. Today it is five times the size and sand volume as the system that barely survived that storm. The beach on May 29, 2007 shows a sparsely vegetated dune with a substantial dry beach seaward of the dune fence.

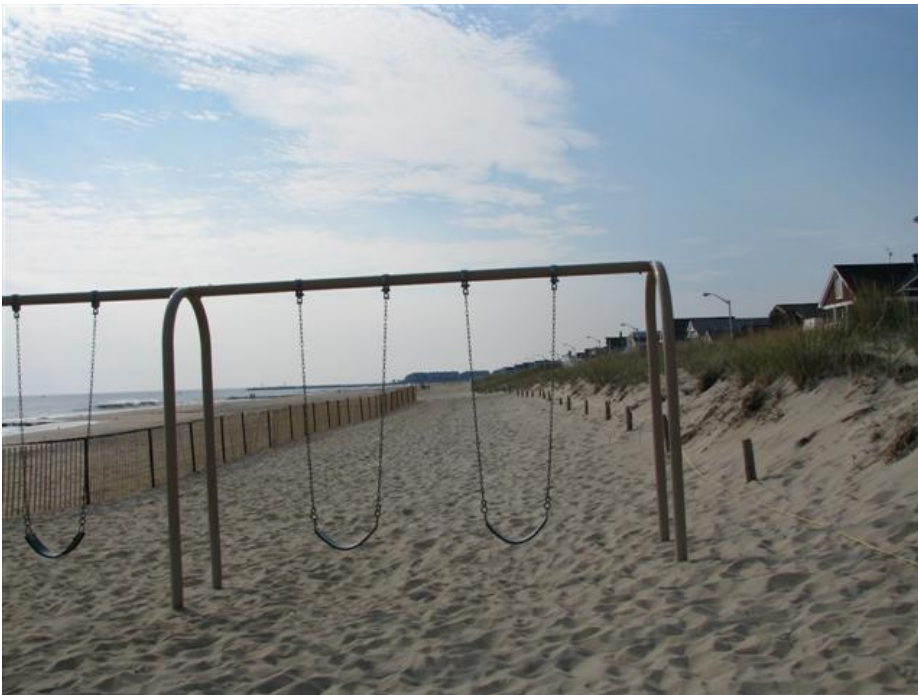
By October 26, 2008 the dune vegetation had grown substantially vertically at the fence line shown above. Minor sand volume was added ( $0.84 \text{ yds}^3/\text{ft.}$ ) to the entire profile cross section. The municipality installed a line of fencing to trap sand on the beach during the coming winter. This is in an attempt to prevent the dunes from continually increasing in elevation and blocking the view of the ocean at the line of private homes landward of a paved promenade between the dune and the homes. This fence array will be removed in the late spring of 2009.

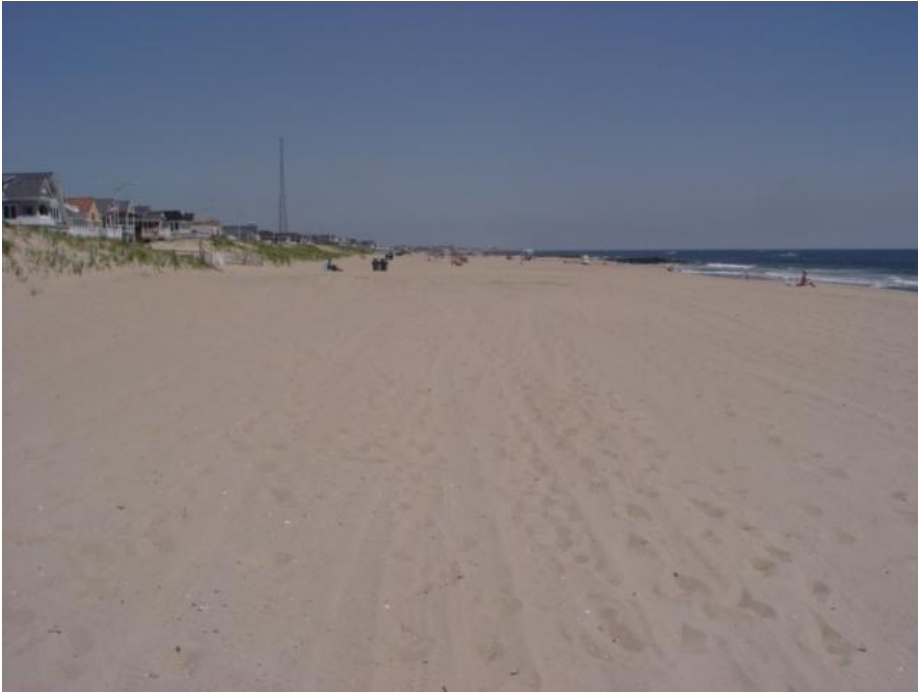
## POMPANO AVENUE, MANASQUAN - SITE 256

This site was established following dramatic changes observed after the 1992 northeast storm. Sites near both sides of each inlets were needed to follow the more dynamic changes noted at the 11 NJ inlets. Pompano Avenue is two - three blocks from the north jetty to Manasquan Inlet. This May 29, 2007 picture is a view to the north along the middle of the berm. The dune appears to the left and the beach extends across the field of view.

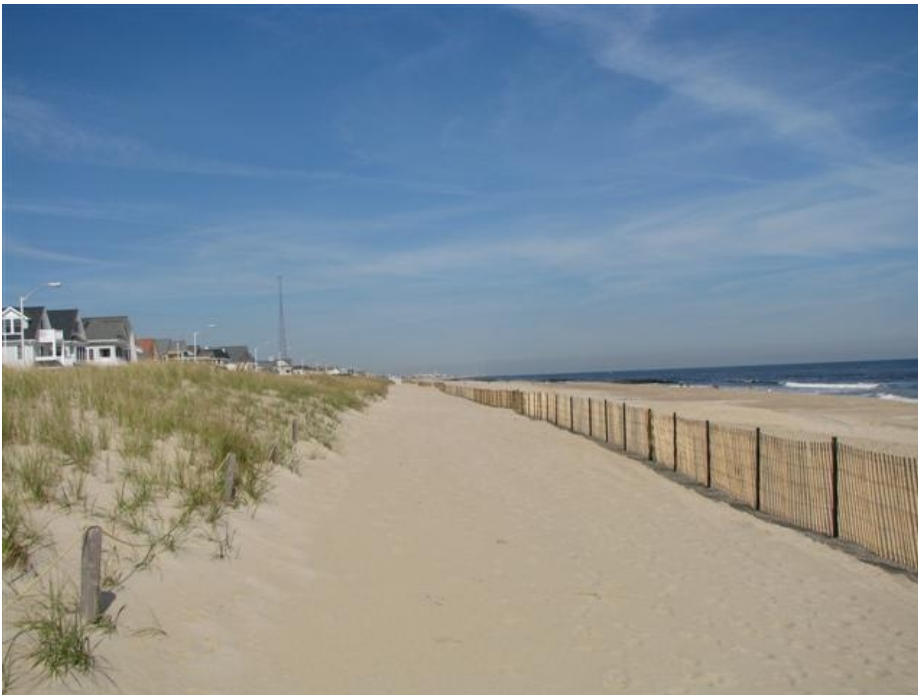
On October 15, 2008 the sand had ramped up to the dune fencing and the Borough erected a row of fence about 50 feet seaward of the existing fence to trap the sand prior to it adding to the dune volume. The 18-month change observed just in the dune covers 308 feet of the cross section to elevation 11.34 feet at the seaward dune toe. The sand volume change was just  $-0.07 \text{ yds}^3/\text{ft.}$  for that time period across that distance. Most of the citizen complaints appear to have resulted from a banner year of grass growth, not a large volume of added sand increasing the dune height.
